Specifications

The CV30 is a reliable, full port control valve in a compact package featuring balanced plug control trim for excellent throttling or on/off control of fluids. The adjustable top works are designed to save space while leaving enough room to mount a controller. The soft seat design achieves repeatable bubble tight shut-off while remaining out of the flow path. The CV30 is ideally suited for a wide range of applications such as pressure control, level control, or flow control.

Model CV30 Maintenance

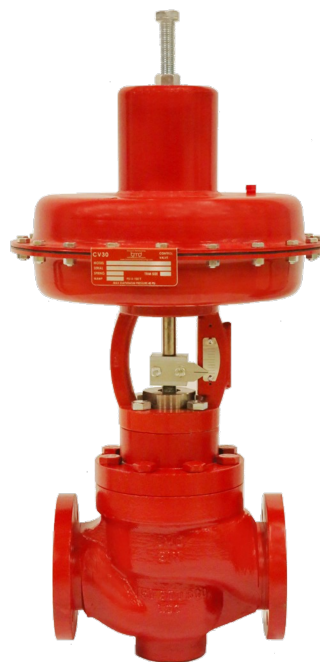
Figure 1.

CV30 Reverse

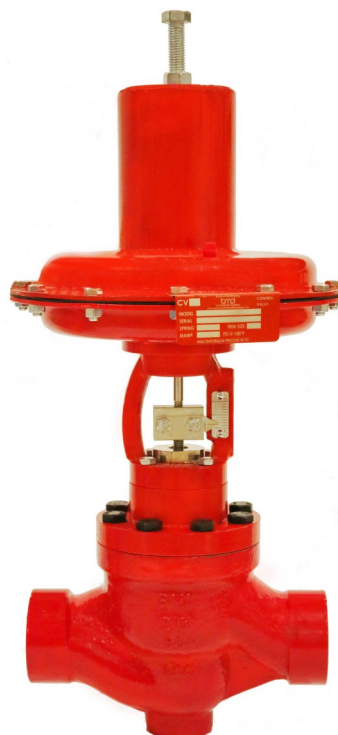
Figure 2.

Model CV30 Installation

When installing the CV30, make sure to follow best piping practices. The CV30 is designed to be installed with flow under the seat. Be sure to have the valve oriented accordingly. Thread in a 1/4" NPT fitting into the spring/diaphragm actuator (Upper housing for direct, lower housing for reverse). Connect an instrument that provides a pneumatic signal to the CV30. If installing a CV30 with an electric actuator, wire the actuator according to valve operation needs.

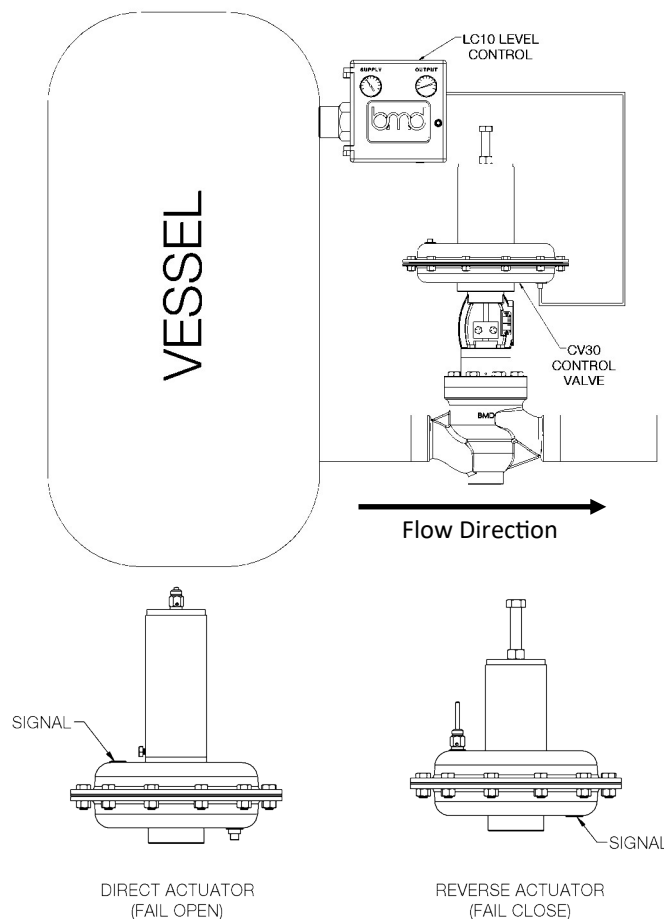
Figure 4.

Model CV30 Operation

When connecting a pneumatic signal it is important to understand the differences between a reverse and direct acting actuator. If it's reverse acting (fail close) the signal needs to be connected to the port in the lower housing. For a direct acting (fail open) the signal needs to be connected to the port in the upper housing. See figure 4.

The CV30 operates by receiving a pneumatic signal that, depending on the action of the actuator, will open or close the valve. For Reverse acting as shown in figure 4 the pneumatic signal enters in the lower housing. The pressure builds and overcomes the spring force allowing the plug to lift off the seat. For Direct acting as shown in figure 4 the pneumatic signal enters into the upper housing. The pressure builds and overcomes the spring force causing the plug to lower onto the seat.

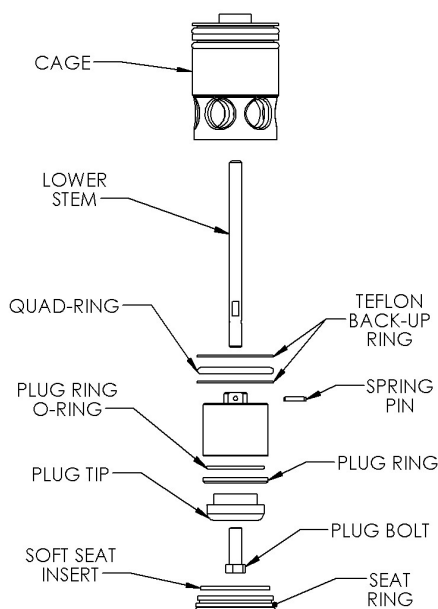
Figure 6.

Soft Seat Trim Assembly

Optionally, individual parts could be changed without using the Trim Replacement Kit. Before replacing any trim parts, follow the previous procedure until the Trim Assembly has been removed from the Body, see Figure 6 for a Trim Breakdown, Figure 7 for the Metal Seat Option. Use the Seat Removal Tool, See Table 1, and remove the seat from the cage and inspect for damages. Remove the Plug/Stem Assembly from the Cage and inspect the Plug Ring for damage. For the Metal Seat option, the Plug and Seat Ring must be replaced as a pair as the two parts are lapped against one another.

Includes Trim Assembly* (Figure 6.), Cage O-rings, Body O-ring, Packing Plug O-ring.

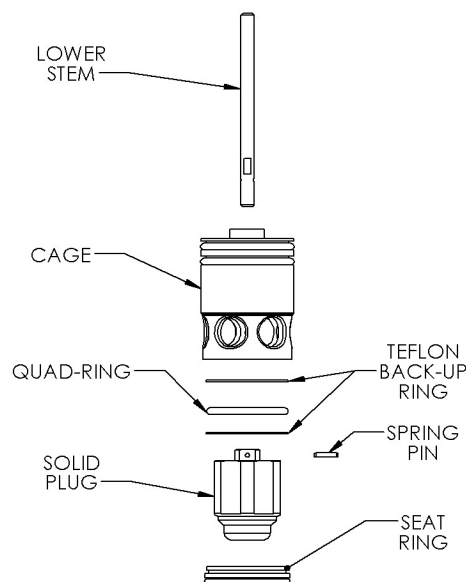
Figure 7.

Metal Seat Trim Assembly

*Metal to Metal Trim Assembly (Figure 7.)

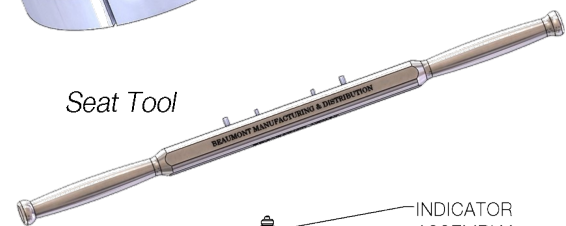
Figure 8.

Cage Tool

Seat Tool

TOOLS		
SIZE	CAGE PULLER	SEAT TOOL
2 INCH	T174	T089
3 INCH	T175	
4 INCH	T176	
6 INCH	T177
