# PROPERTY INSPECTION REPORT

351 Cherokee Ave. SE Atlanta, GA. 30312

May 10, 2025

1599

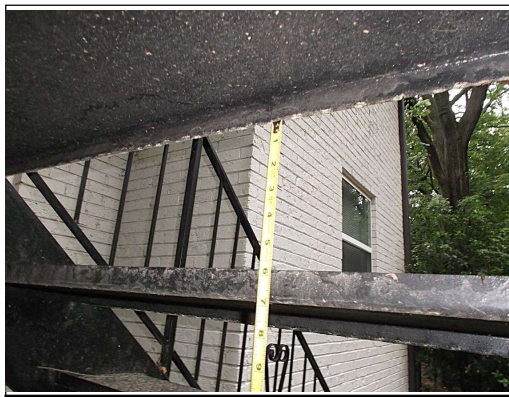
The metal stairs at the rear of the building leading up to the 2nd level condos have spaces wider than 4 inches between each step (6 inches wide)(building code states spaces between risers shall not let a sphere 4 inches pass through). The metal stairs at the front for condo 10, 12 and 14 have spaces between steps wider than 4 inches. The rear metal stairs are slippery if wearing rubber bottom shoes or sneakers, when they are wet.

Stairs have spaces more than 4 inches wide

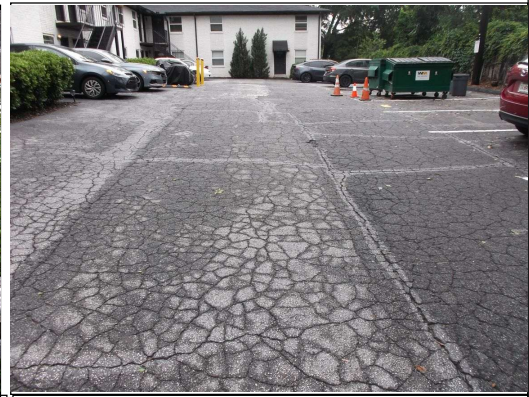
The parking lot asphalt surface has moderate cracking, few pot holes and weathering.

Parking lot has moderate cracking, wear...

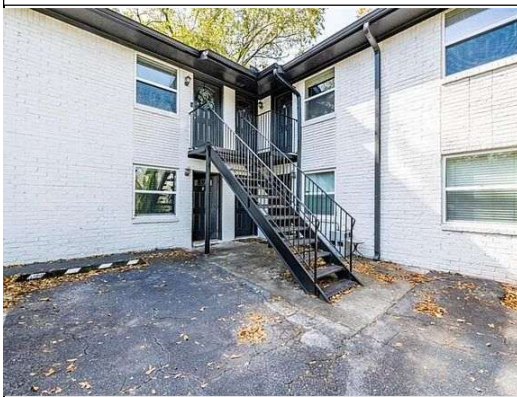
Openings between steps 6 inches #10, 12, 14

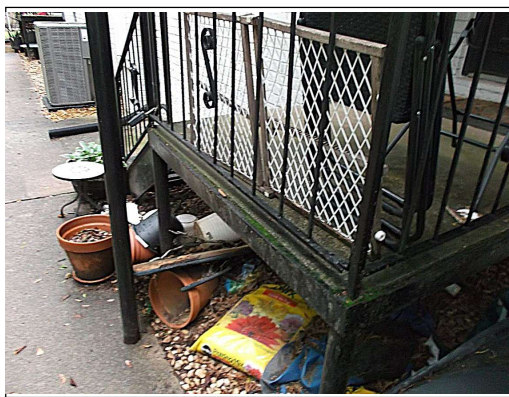
The rear metal porch for condo 13 have rail corner posts that has rusted through and detached from the floor.

Rail posts at #13 rusted through and loose

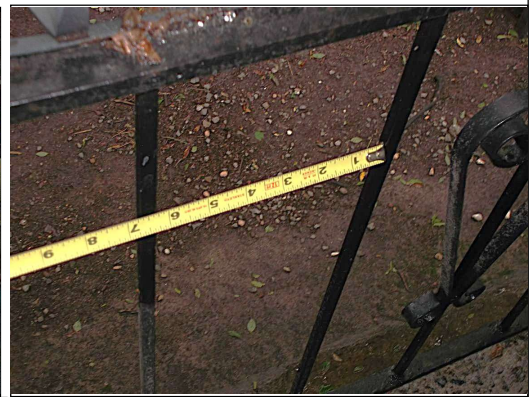
The spaces between rail guards for the stairs and landings at the rear of the building at each entry are wider than 4 inches (5 to 6 inches).

Rail guards 6-1/4 wide units 6 and 8

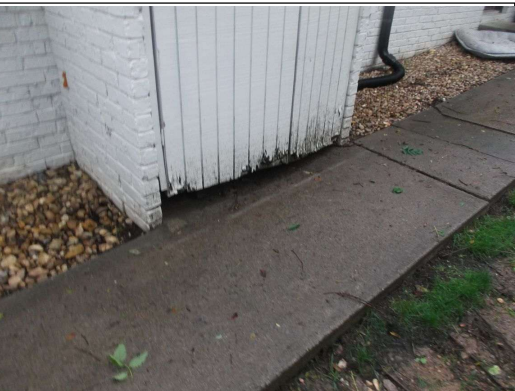
The wood doors are rotted at the bottoms at the electrical meters service, main breaker rooms.

Doors rotted at the 1st meter room

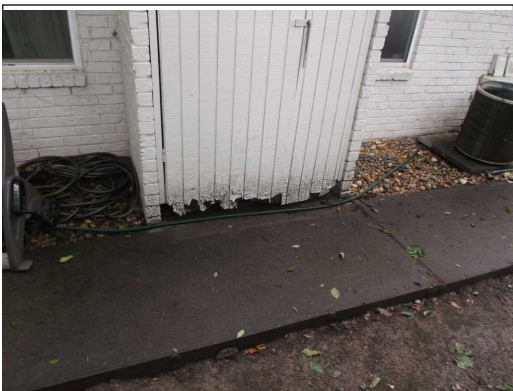
Doors rotted at the 2nd meter room

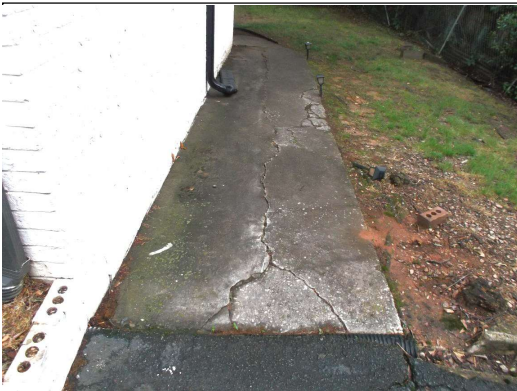
The walkway at the right side of the building leading to the rear yard has broken sections, cracking and a trip hazard where the drain pipe travels across between the asphalt driveway and the walkway. The walkway at the rear of unit 15 is settling, heaving and holding water.

Walkway at right side cracks, broken, slope

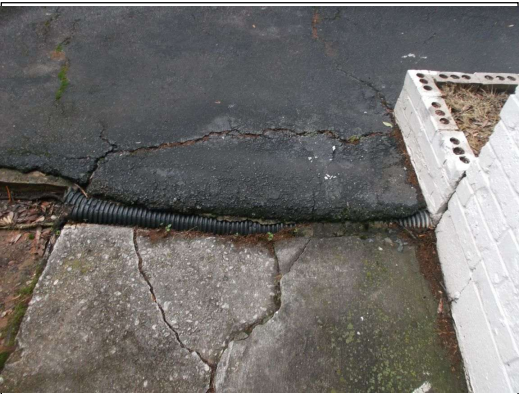
Walkway at the driveway broken trip hazards

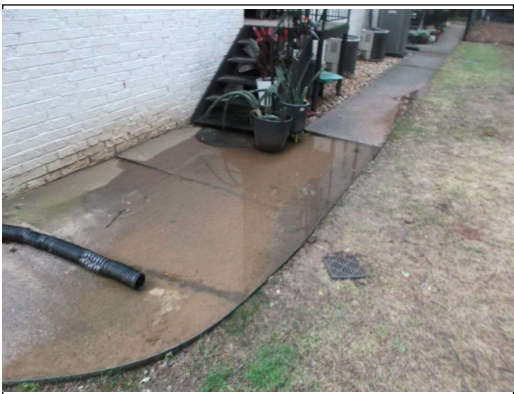
Walkway behind 15 settling, trip hazard, water
