# Mt Vernon Hermitage Condo Wind Mitigation 6370 1st St

## Wind Mitigation Inspection Report

By: Fair Wind Inspections Inc.

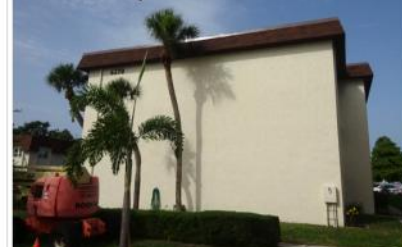
Geometry Picture

Roof Geometry: Flat  
Total Non-Hip: N/A Total Perimeter: N/A  
Less Than 2:12: N/A Total Area: N/A

Entire roof structure is flat. Shingle mansards are decorative

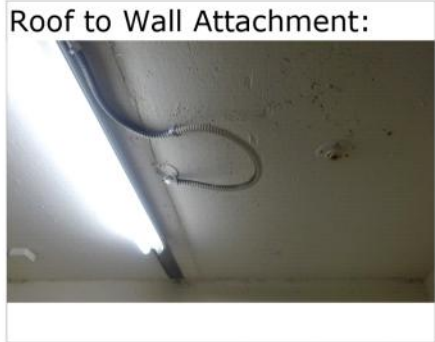
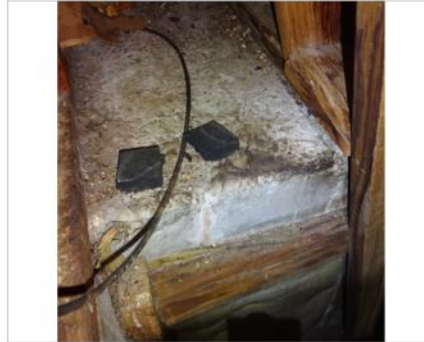
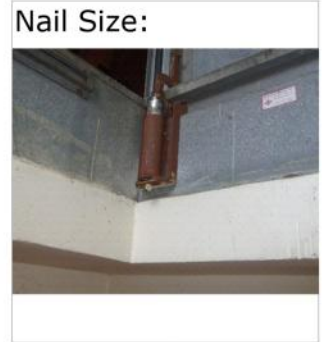
Flat concrete roof deck present
