Mt Vernon Hermitage Condo Association

Wind Mitigation Inspection Report

By: Fair Wind Inspections Inc.

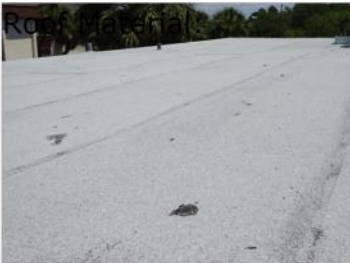
Date Replaced: Feb 17, 2019
Permit With: City of St. Petersburg
Permit Number: 19-2001141
Covering: Shingles

Roof surface is in good condition

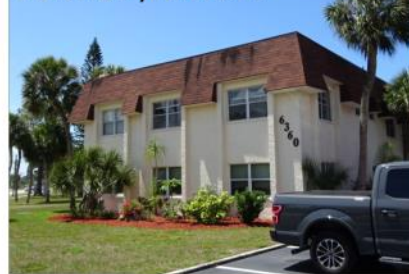
Geometry Picture

Roof Geometry: Non-Hip
Total Non-Hip: N/A Total Perimeter: N/A
Less Than 2:12: N/A Total Area: N/A

Gable end walls and/or non-hip features are greater than 10% of total perimeter

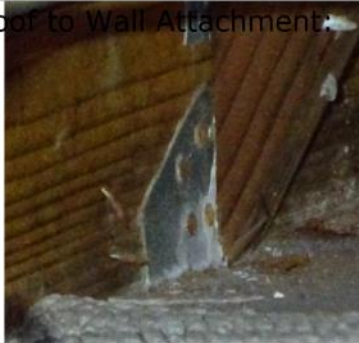
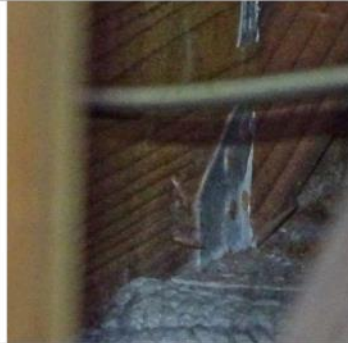
Roof to Wall Attachment:

- ☒ B. Clips
 - ☒ Metal connectors that do not wrap over the top of the truss/rafter, **or**
 - ☒ Metal connectors with a minimum of 1 strap that wraps over the top of the truss/rafter and does not meet the nail position requirements of C or D, but is secured with a minimum of 3 nails.

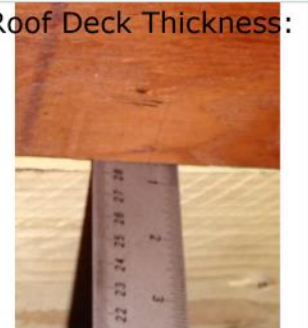
Roof Deck Thickness:

Underside of roof is in good condition

- ☒ C. Plywood/OSB roof sheathing with a minimum thickness of 7/16" inch attached to the roof truss/rafter (spaced a maximum of 24" inches o.c.) by 8d common nails spaced a maximum of 6" inches in the field. -OR- Dimensional lumber/Tongue Groove decking with a minimum of 2 nails per board (or 1 nail per board if each board is equal to or less than 6 inches in width). -OR- Any system of screws, nails, adhesives, other deck fastening system or truss/rafter spacing that is shown to have an equivalent
