Annual Environmental Management Report July 2020 – June 2021 Rev 1

Name of Operation	Nowra Brickworks Quarry
Name of Operator	South Coast Concrete Crushing & Recycling Pty Ltd
Development consent / project approval #	07_0123
Name of holder of development consent / project approval	South Coast Concrete Crushing & Recycling Pty Ltd
Mining Lease #	ML 5087 / ML 6322 / ML 531
Name of Holder of mining lease	Abib Pty Ltd
Water Licence #	10BL602172
Name of holder of water licence	South Coast Concrete Crushing & Recycling Pty Ltd
MOP/RMP start date	1 st September 2015
MOP/RMP end date	31 st August 2022
Annual Review start date	1 st July 2019
Annual Review end date	30 th June 2020
<p>I, Budd Green, certify that this audit report is a true and accurate record of the compliance status of South Coast Concrete Crushing and Recycling for the period July 2020 – June 2021 and that I am authorised to make this statement on behalf of South Coast Concrete Crushing and Recycling</p> <p>Note.</p> <p>a) The Annual Review is an 'environmental audit' for the purposes of section 122B(2) of the Environmental Planning and Assessment Act 1979. Section 122E provides that a person must not include false or misl

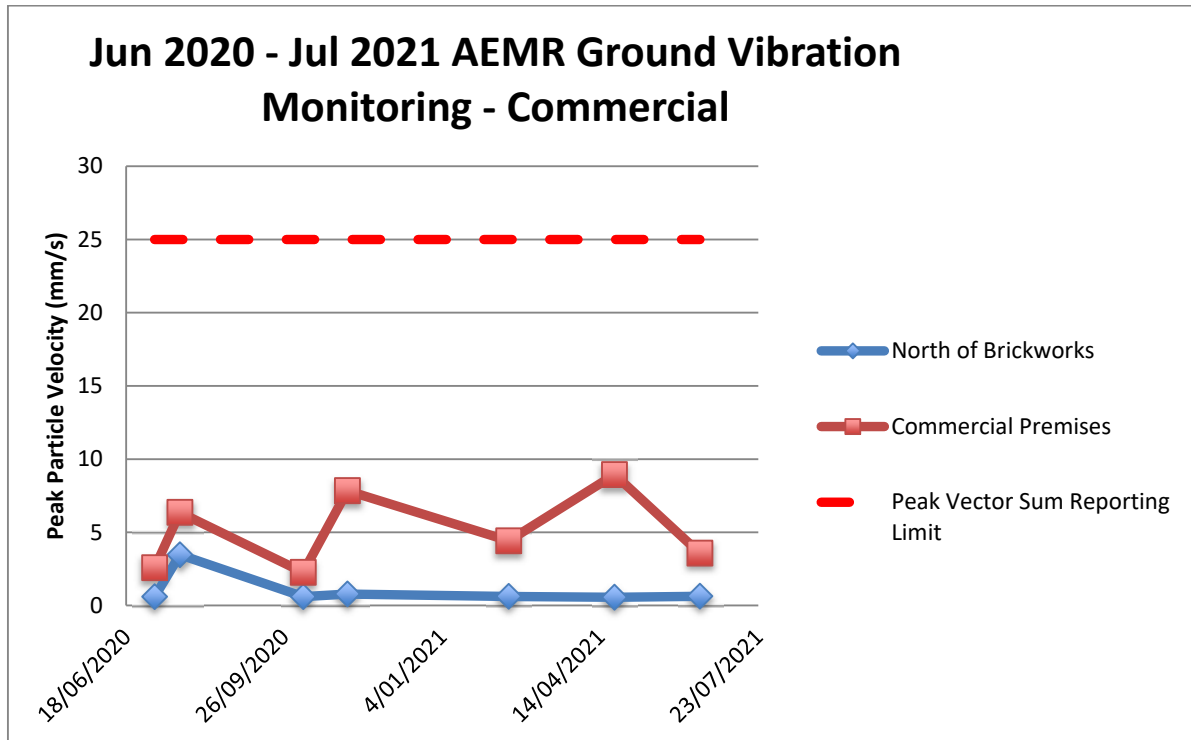
Chart 2 - Commercial Ground Vibration

July2020 – June2021 AEMR Ground Vibration – Results – Commercial			
Date	North of Brickworks	Commercial Premises	Peak Vector Sum Reporting Limit
6/07/2020	0.602	2.576	25
22/07/2020	3.464	6.359	25
8/10/2020	0.605	2.263	25
5/11/2020	0.784	7.841	25
15/02/2021	0.62	4.419	25
23/04/2021	0.563	8.943	25
16/06/2021	0.632	3.57	25

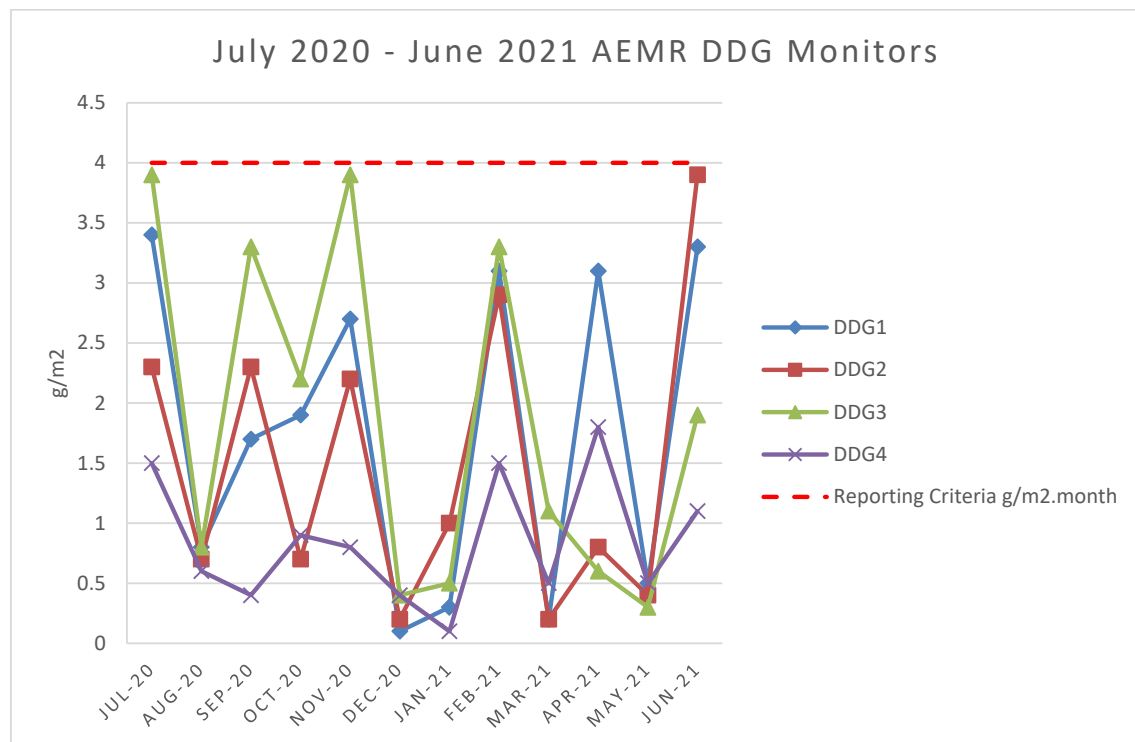
Chart 5- DDGs

The DDG reporting criteria of 4 g/m².month was not exceeded during the July 2020 – June 2021 AEMR reporting period. There were some instances of close results and air quality will continued to be addressed and managed on the site to minimise the impact of generated dusts.

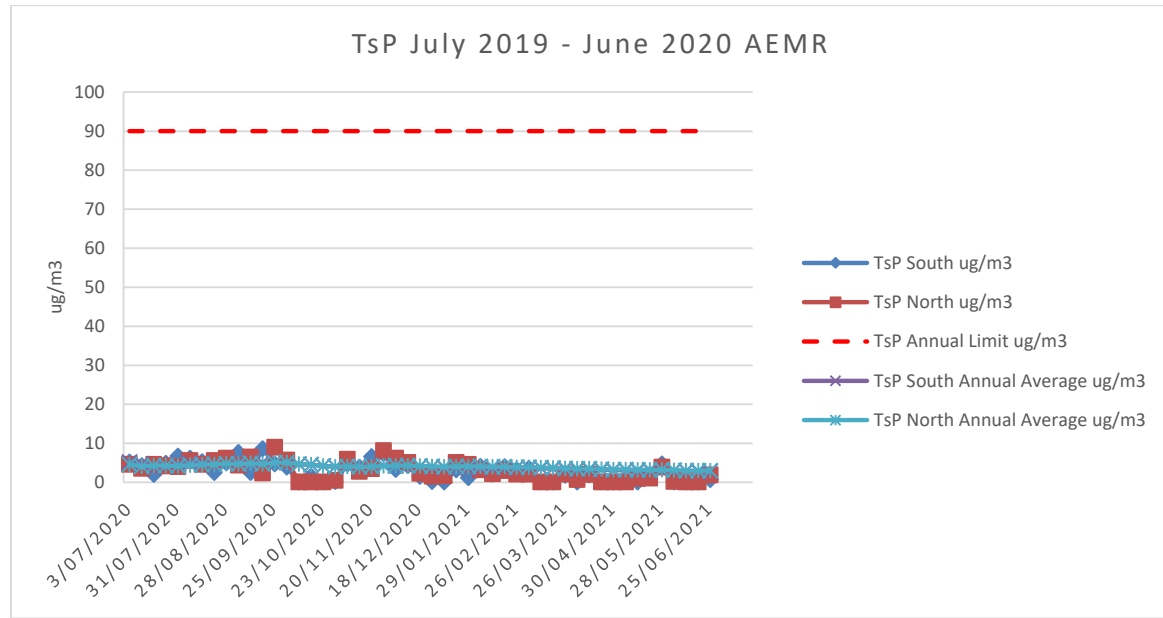
Chart 6 - TsP

TsP Annual Average – South (2.8 ug/m³) a reduction of 2.8 ug/m³ from the previous reporting period.

TsP Annual Average – North (3.0 ug/m³) an increase of 3.2 ug/m³ from the previous reporting period

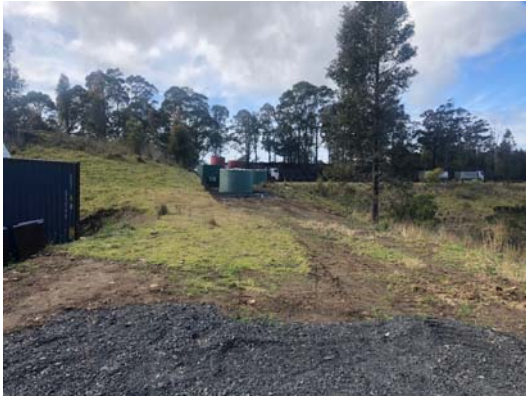
Figure 1

July 2020

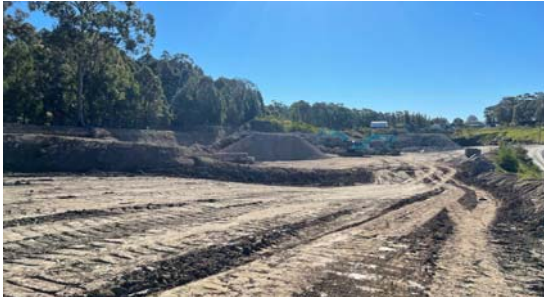
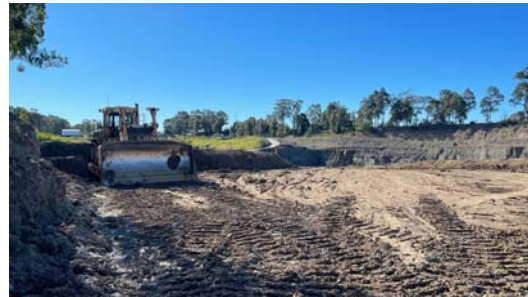
June 2021

The site is generally in healthy condition. Weed control activities will continue during the July 2021-June 2022 AEMR reporting period and the site will be monitored every 6 months for any new or increase in weed populations.

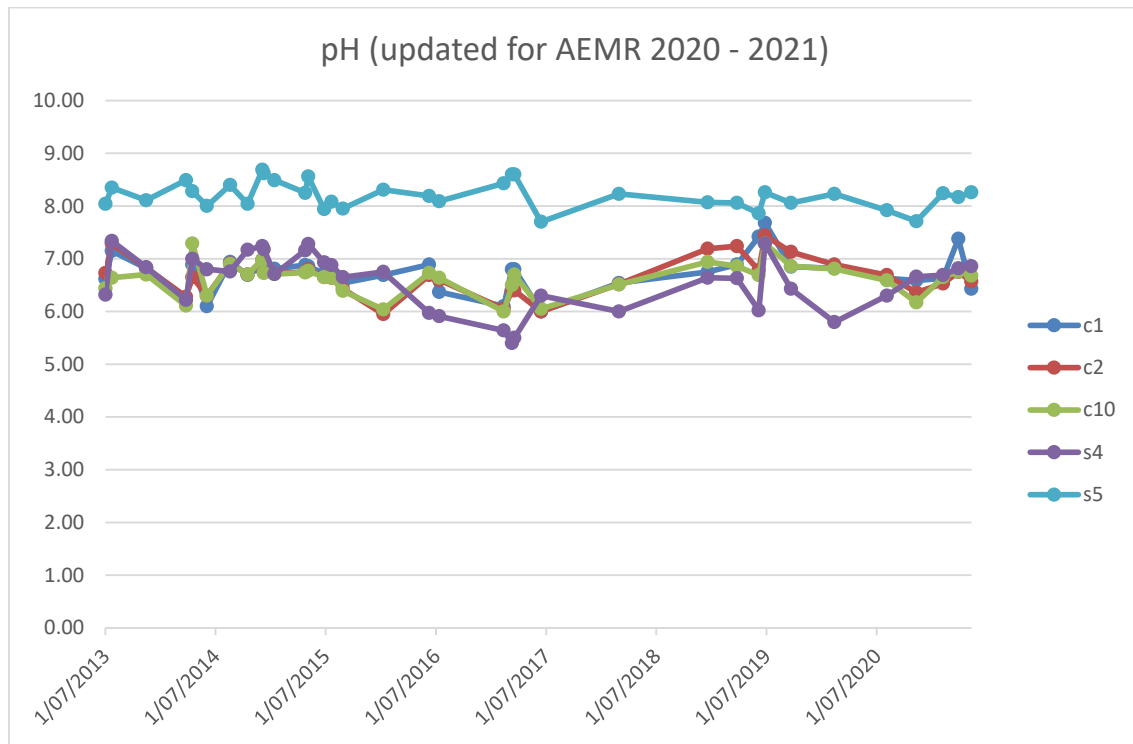
Chart 8 - Surface Water pH

The pH of the water within the quarry extraction area (S5) was found to be in the 7.71- 8.26 range which is consistent with previous collected baseline data, while water within the creek had results ranging from 6.17 – 7.38. (see chart below).

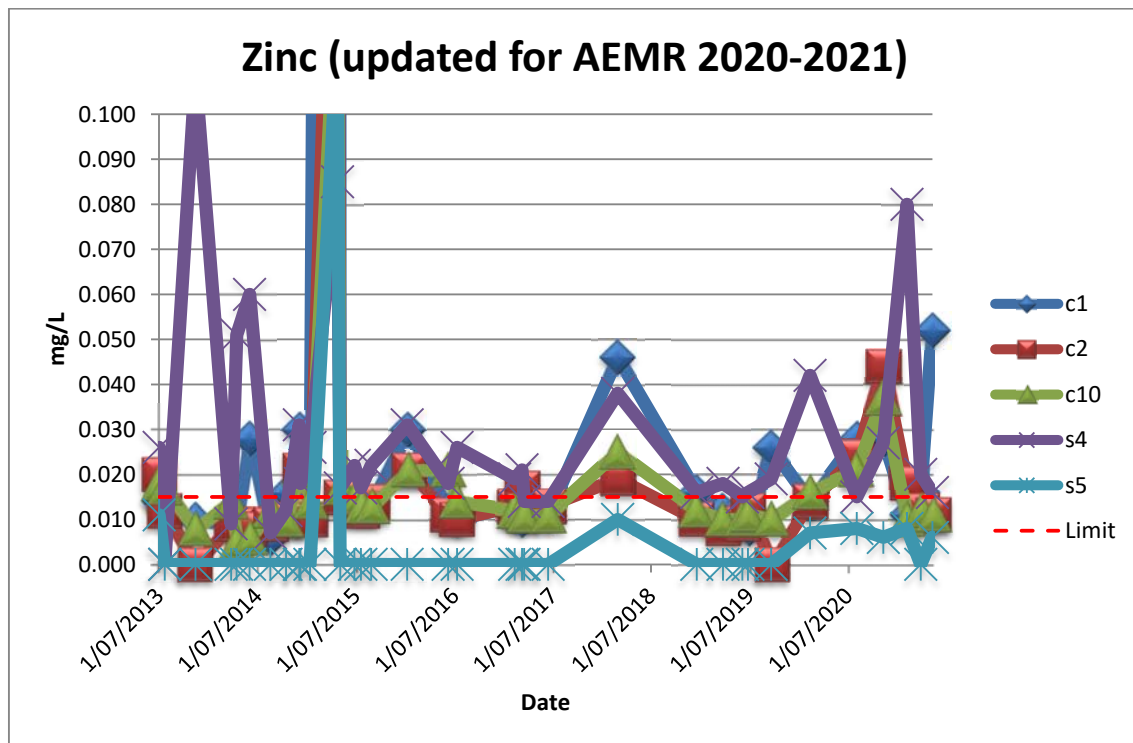
Chart 10 - Surface Water Zinc

The results within the creek are generally following the creek control point (C1). C1 results were above the reporting limit of 0.015 in all but 1 reporting period with a significant reading in the 4th quarter. The highest results were recorded at the control point C1 with results very similar or decreased downstream.

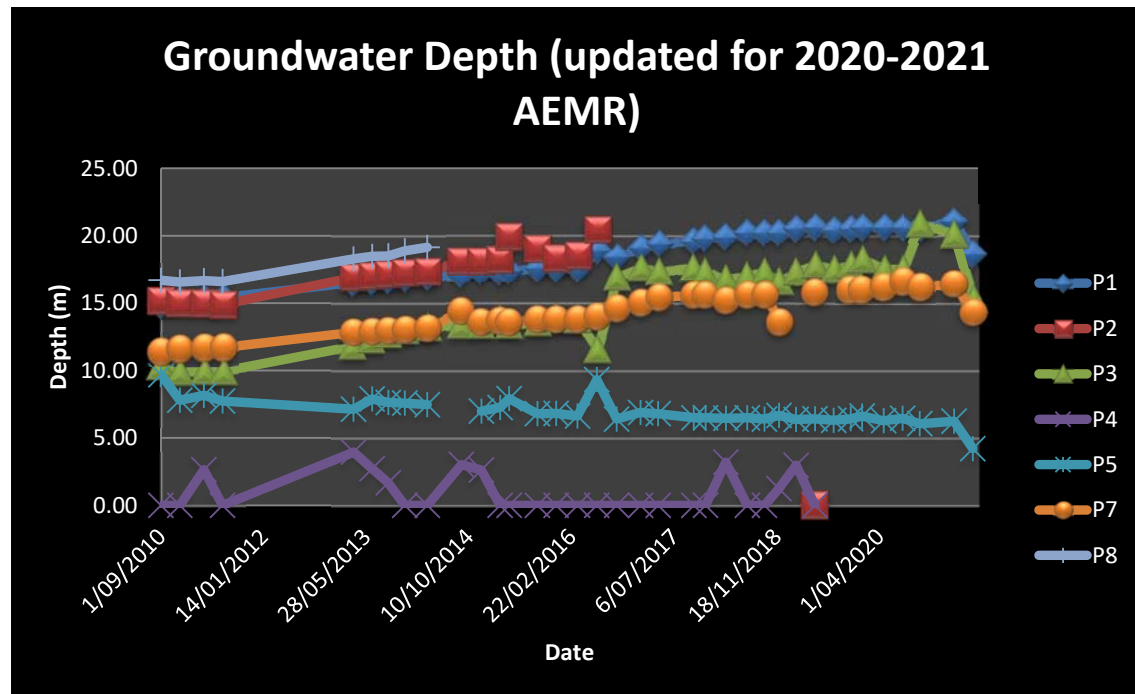
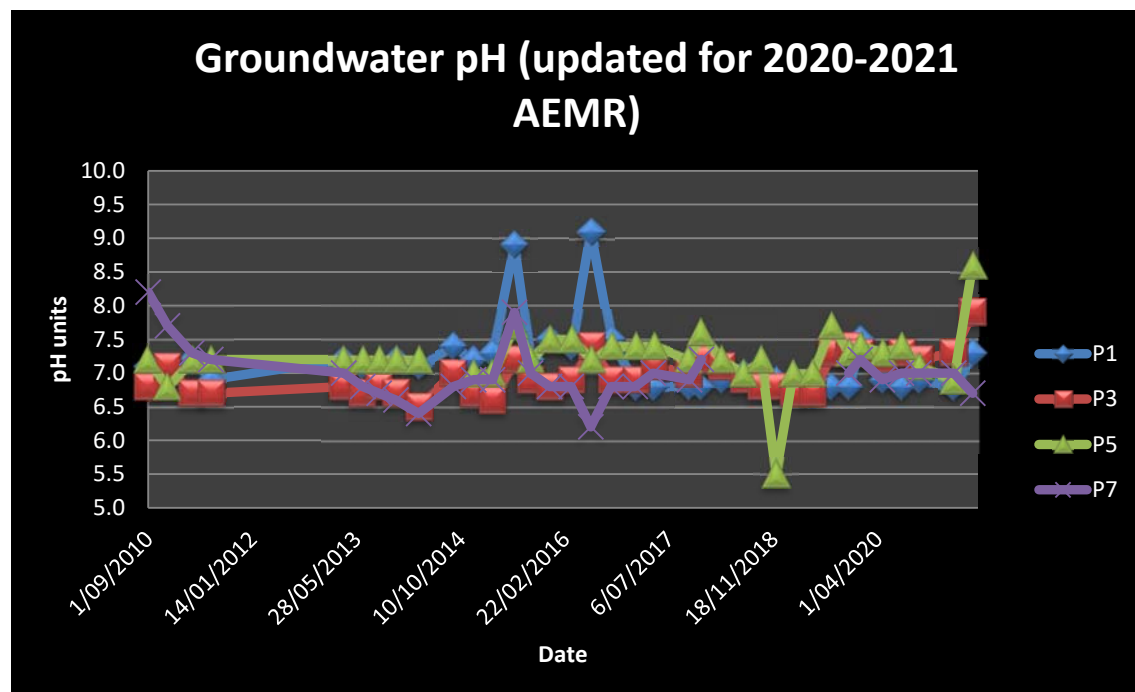
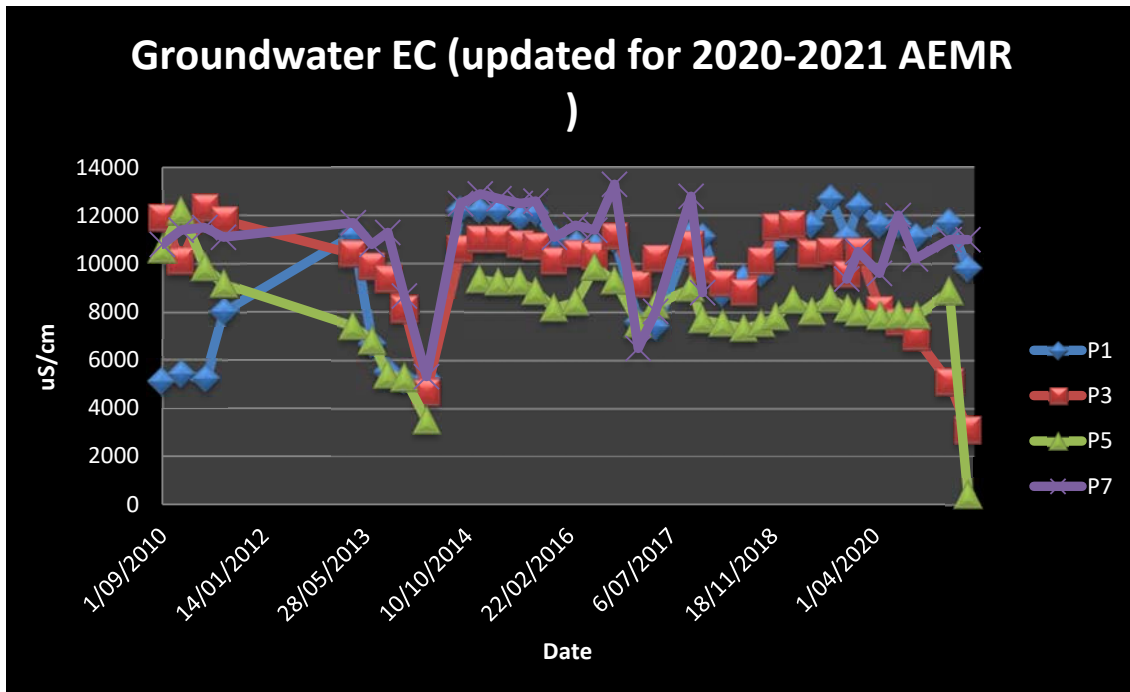
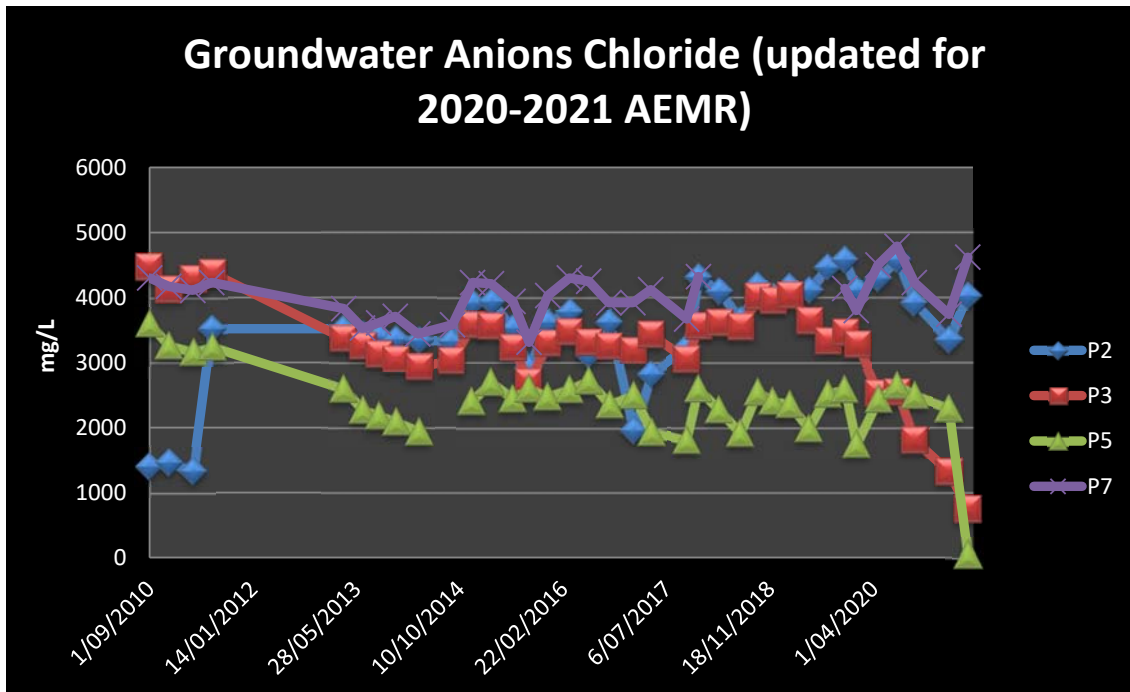
Samples of Chart results for groundwater monitoring carried out during the AEMR reporting period (2019-2020). The results have been included with the baseline charts to allow ease of analysis showing change over time

Groundwater monitoring results indicate potential impact or affect of rainwater results on piezometers P3 and P5 arrangements have been made for verification and assessment of the wells in these locations, as they may have potentially been damaged. SEEC will also be engaged to review the results and provide commentary. Monitoring will continue as per the EMS (GHD). Results will continue to be graphed for ongoing analysis and ease of reference for any correlation in change.

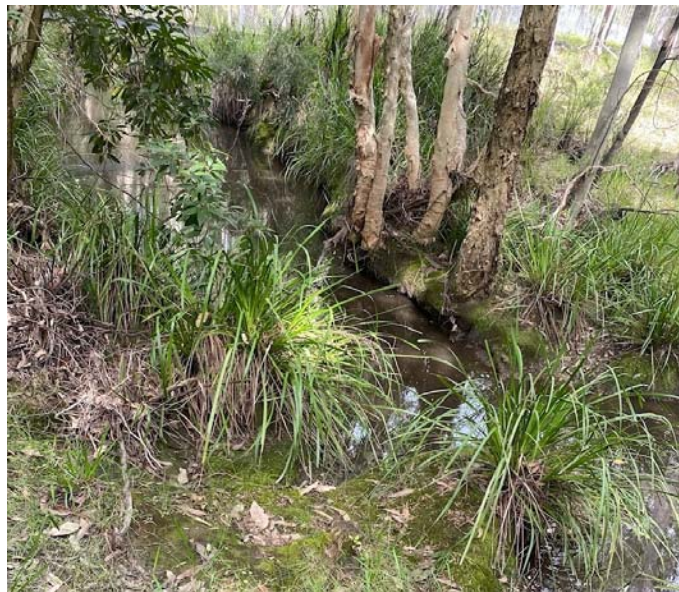
Figure 3 - Monitoring Location C1 – 21st Feb 2021

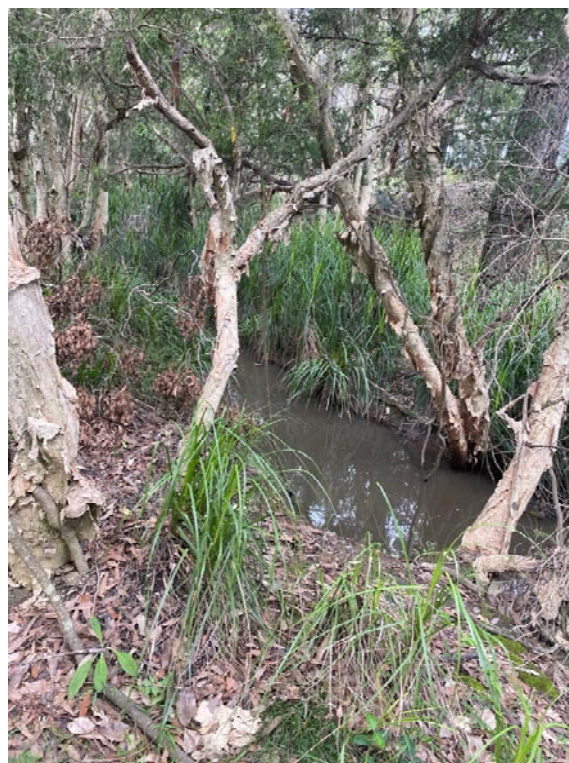
Figure 4 - Monitoring Location C2 – 21st Feb 2021

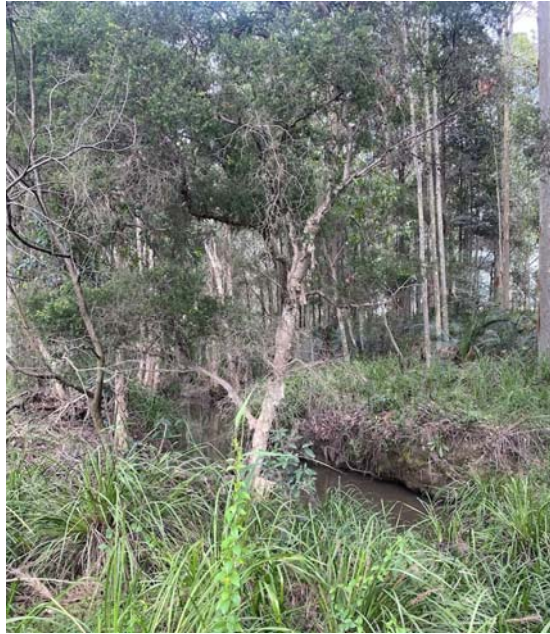
Figure 5 - Monitoring Location C10 – 21st Feb 2021

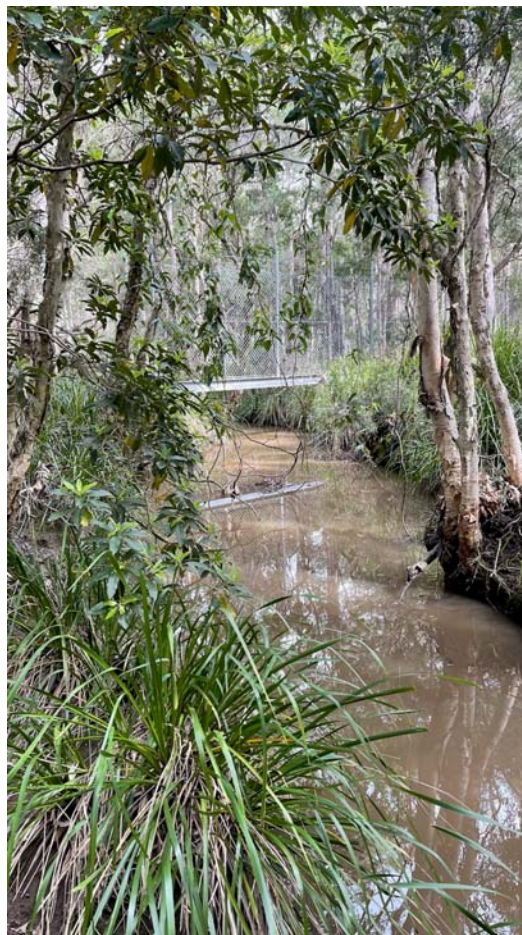
Figure 6 - Monitoring Location C1 21st May 2021

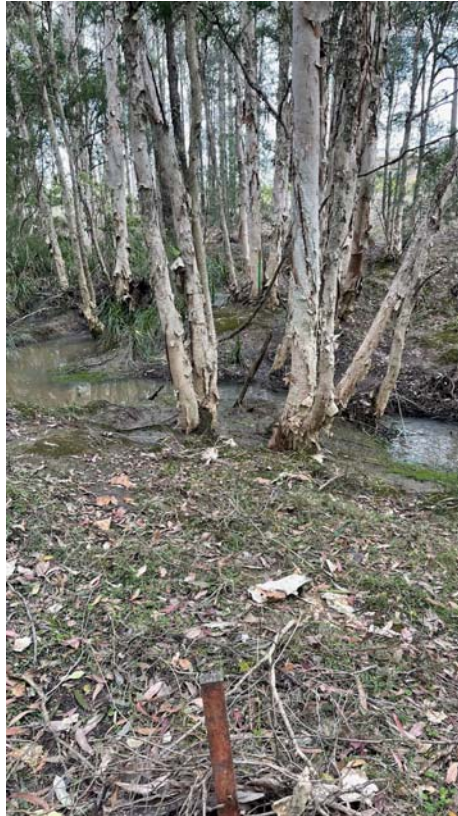
Figure 7 - Monitoring Location C2 21st May 2021

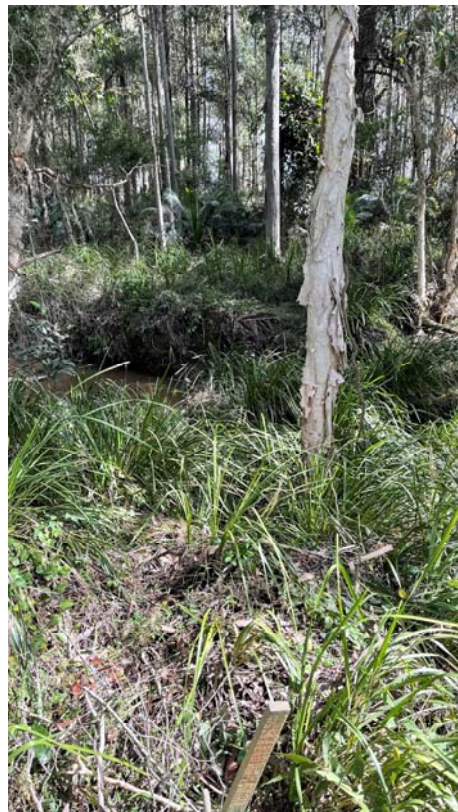
Figure 8 - Monitoring Location C10 21st May 2021
