## Annual Environmental Management Report July 2022 – June 2023

| Name of Operation | Nowra Brickworks Quarry |
| Name of Operator | South Coast Concrete Crushing & Recycling Pty Ltd |

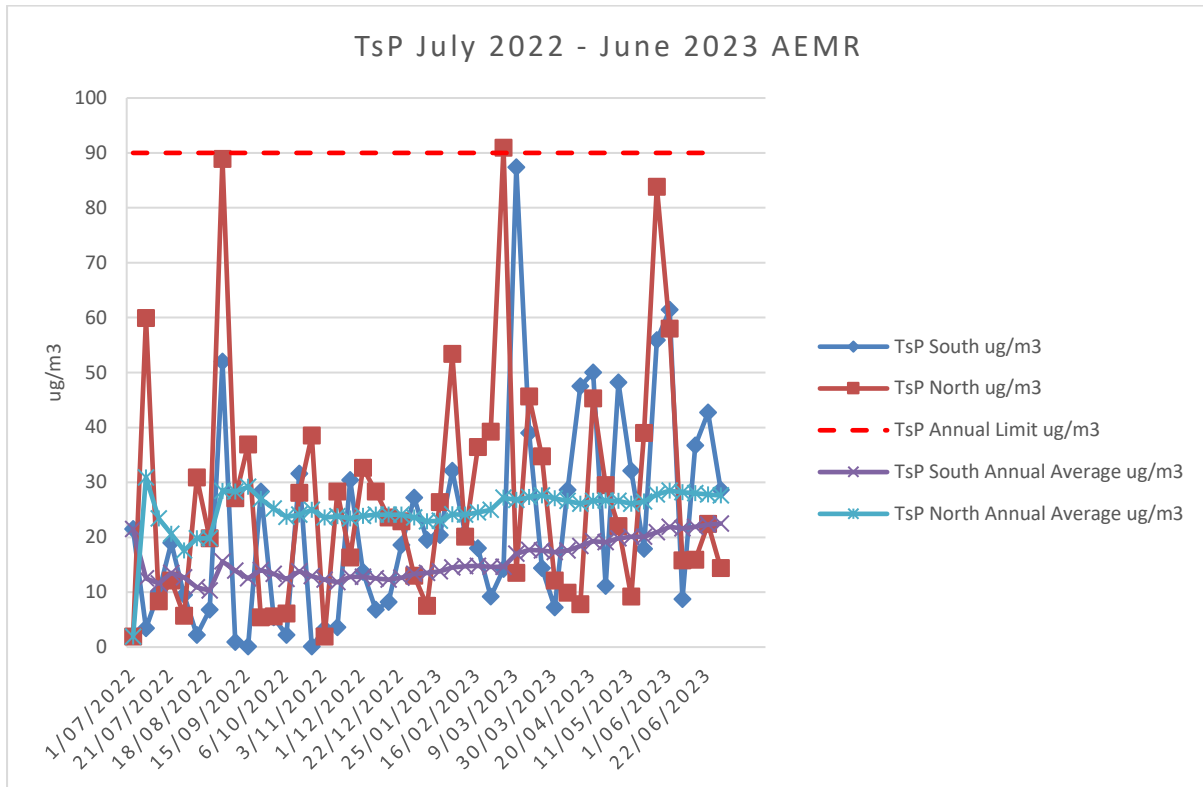
Chart 6 - TsP

TsP Annual Average – South (22.5 ug/m<sup>3</sup>) an increase of 12.0 ug/m<sup>3</sup> from the previous reporting period.

TsP Annual Average – North (27.6 ug/m<sup>3</sup>) an increase of 15.2 ug/m<sup>3</sup> from the previous reporting period.

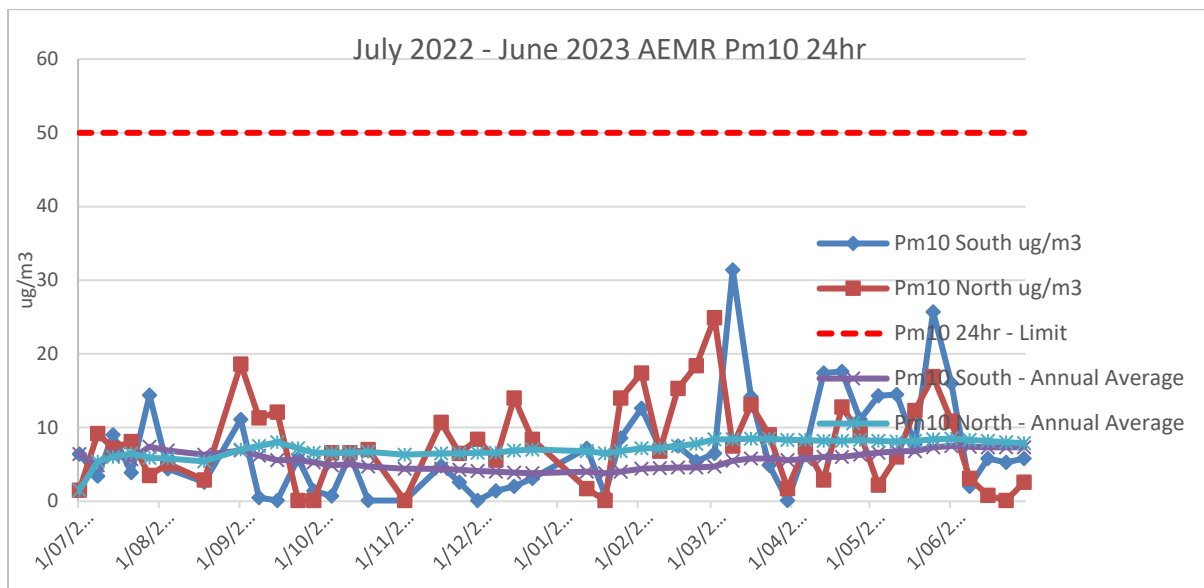
Chart 7 - Pm10 24hr and annual average

Pm10 Annual – South (7.3ug/m<sup>3</sup>) an increase of 0.01ug/m<sup>3</sup> for the reporting period.

Pm10 Annual – North (7.9ug/m<sup>3</sup>) with no increase for the reporting period.

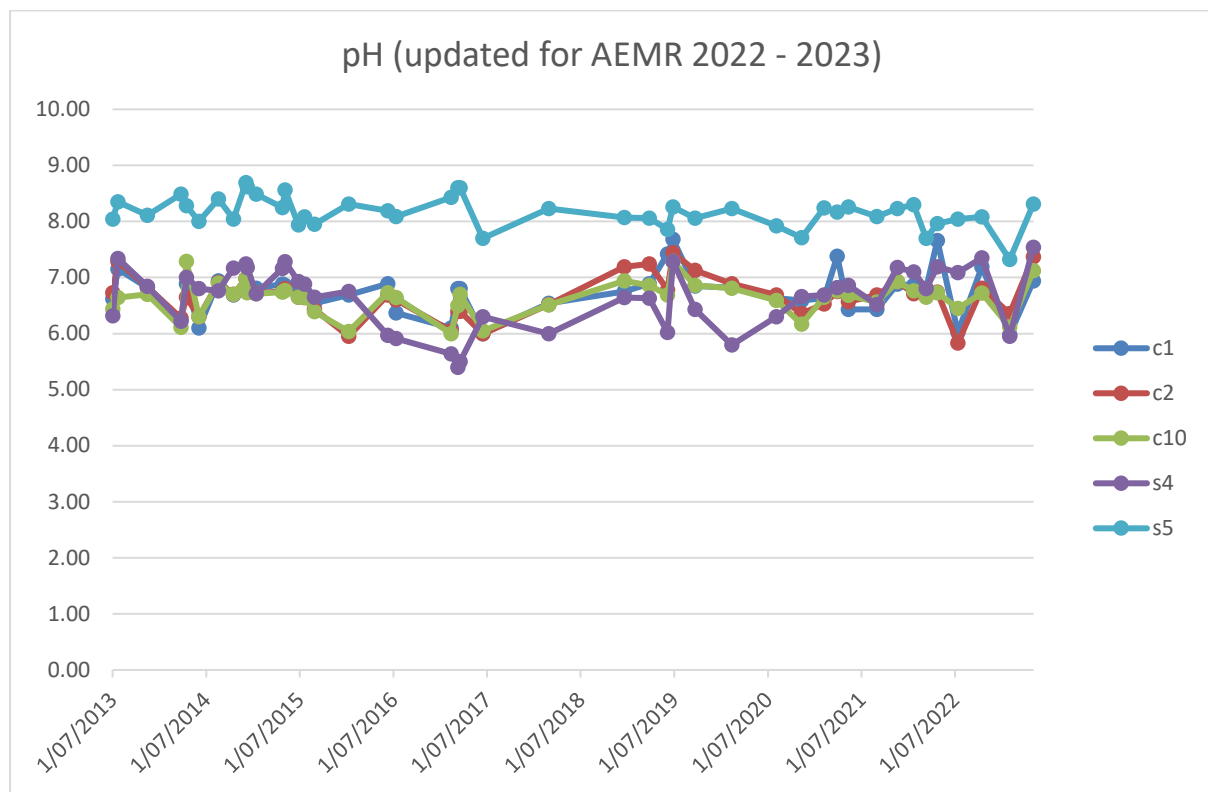
Chart 8 - Surface Water pH

The pH of the water within the quarry extraction area (S5) was found to be in the 7.32- 8.30 range which is consistent with previous collected baseline data, while water within the creek had results ranging from 5.83 – 7.37. (see chart below).

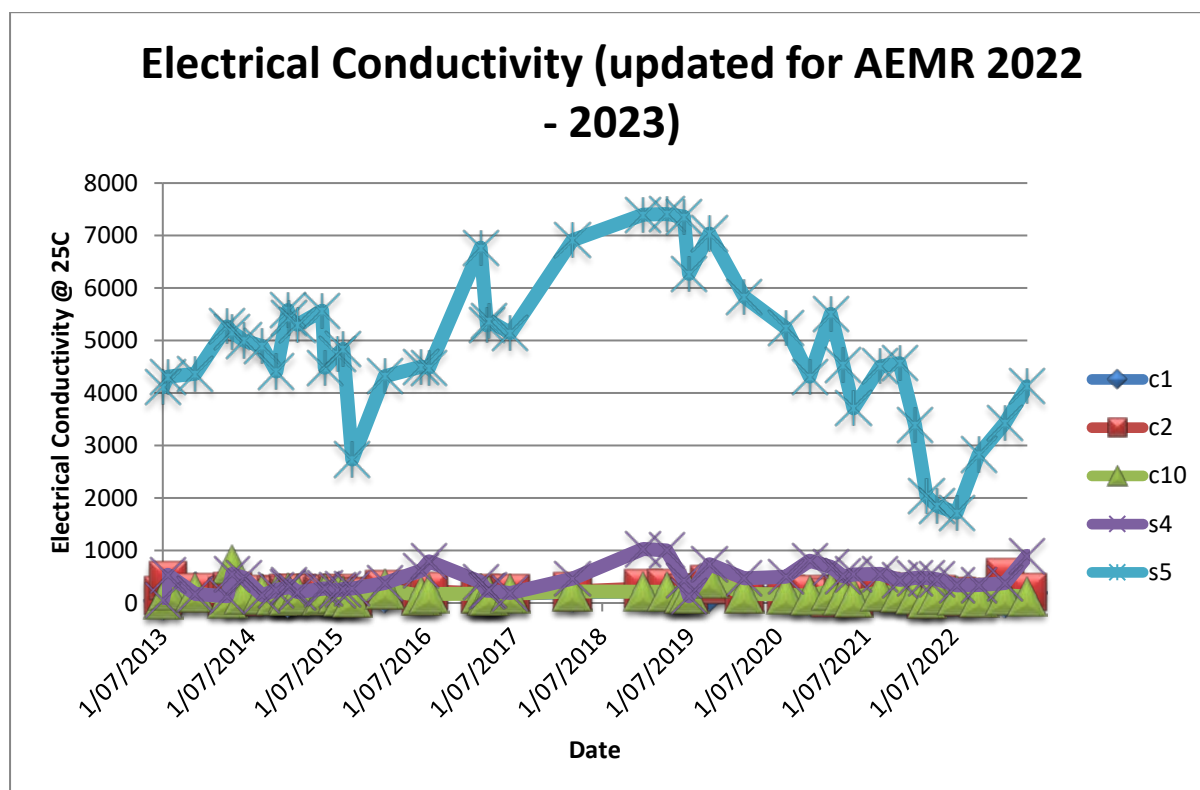
Chart 9 - Surface Water EC

Electrical conductivity of the water within the quarry (test location S5) recorded EC values up to 4130 us/cm and had reduced to 1720. The results in the creek (97-496) were found to be very low and show no correlation with the water within the quarry. (see chart below)

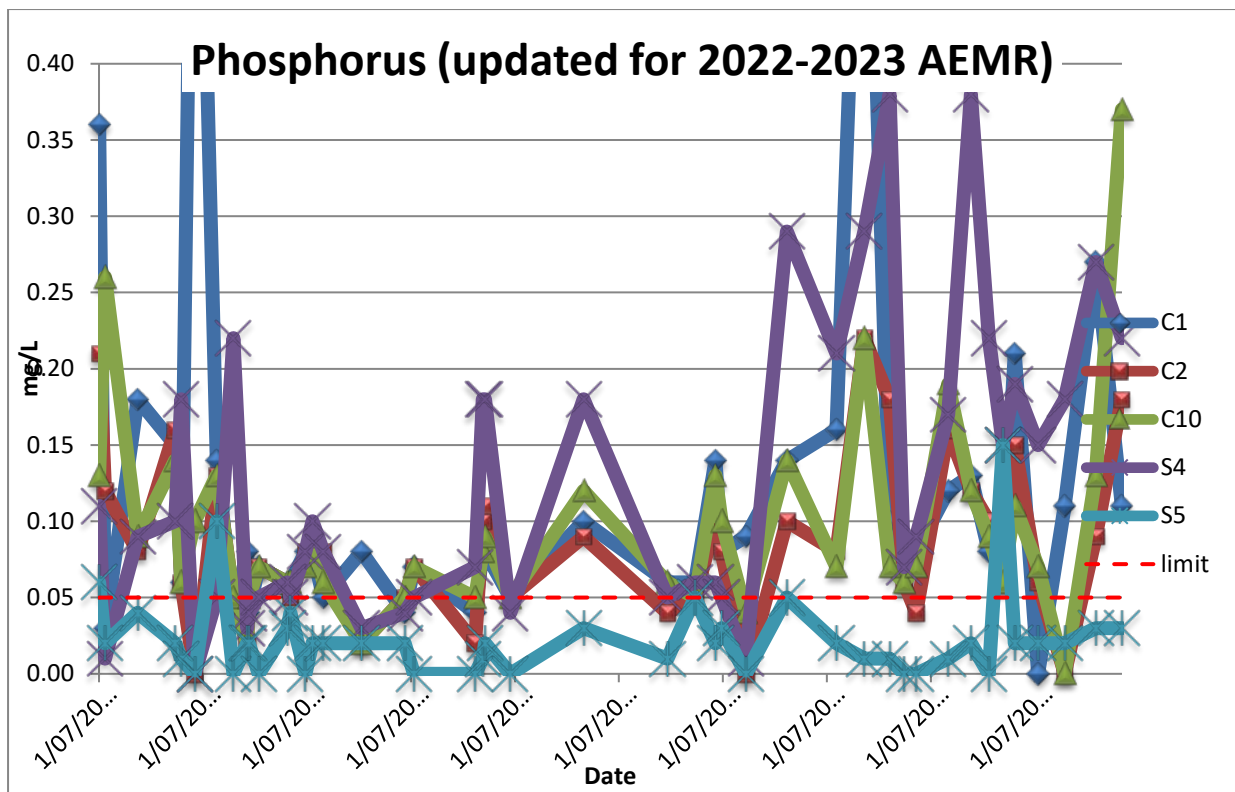
Chart 11 - Surface Water Phosphorus

Highest recorded results in the reporting period were identified at C1 and S4 the main water body within the quarry S5. While C1, C2 and C10 were all closely correlated with C2 being the lower value but above the reporting threshold.
