Project No.: BBSS 01-02-01

## **TEST & EVALUATION REPORT**

Screening Evaluation of Shingle Rejuvenator

August 15, 2018

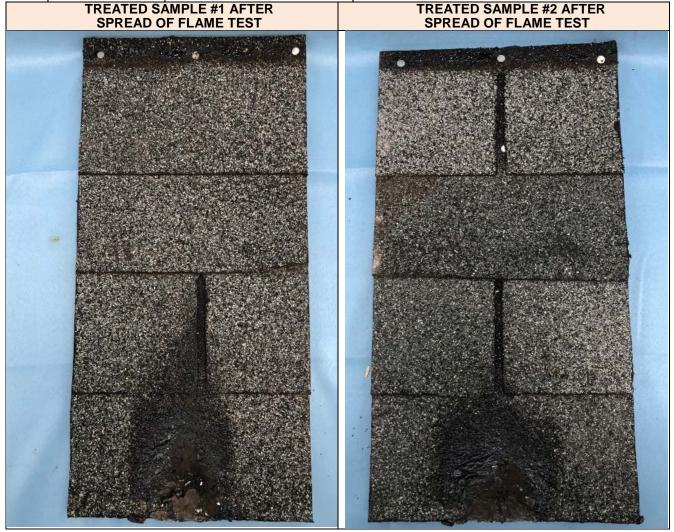
#### A1. Spread of Flame Test per ASTM E108M - Treated Samples

Spread of flame covered less surface area (a distinct benefit). This is worthy of further investigation.

#4		1.04	1.42			
		Avg.		1.01	1.38			
Hail Impact (Steel Ball Test), in.		#1	UL 2218	0.103	0.129			
		#2		0.103	0.095			
		#3		0.135	0.138			
		Avg.		0.113	0.121			
Spread of Flame, Width cm. x Length cm.		#1	E108M	10x10	-

#2		8x9	-			
		#3		-	12x12
