Koolau Roof Tech

9/24/2021 | 13 Photos

Sample Photo Assessment Report

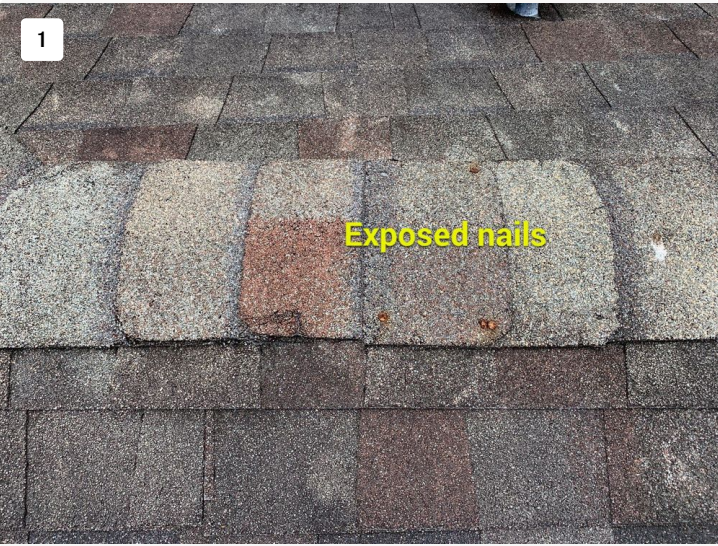
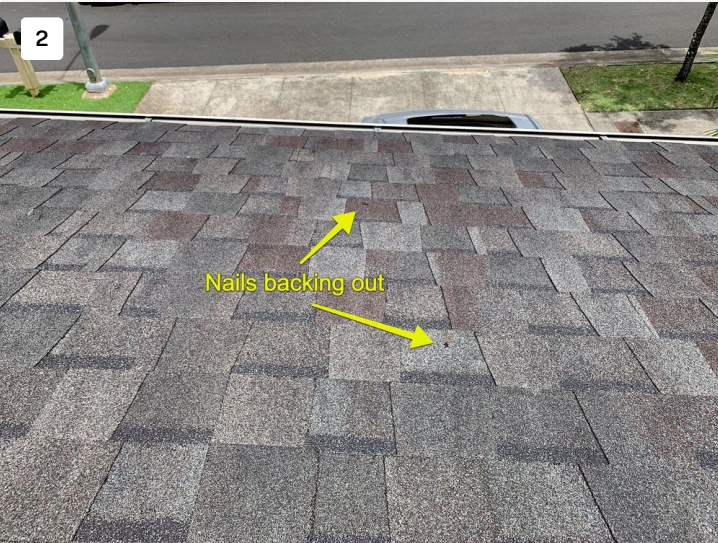
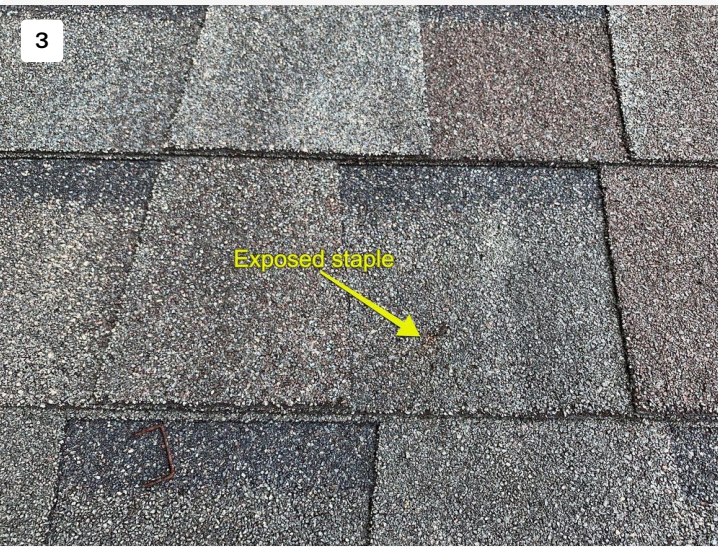
Roof Penetrations

All roof penetrations are susceptible to leaks. The plumbing vents, PV panel and solar water panel tie downs appear to be flashed correctly. Any exposed nails or screws will be covered with a clear sealant to protect it from rust. The plumbing vent collars are starting to dry out and crack. This is also a place where water can enter the home, and although it is usually a slow leak, over time it can cause structural damage and mold/mildew growth. As part of the tune-up, new vent collars will be installed over the existing gaskets. Also, any dried out roofing cement around any tie downs have been resealed.

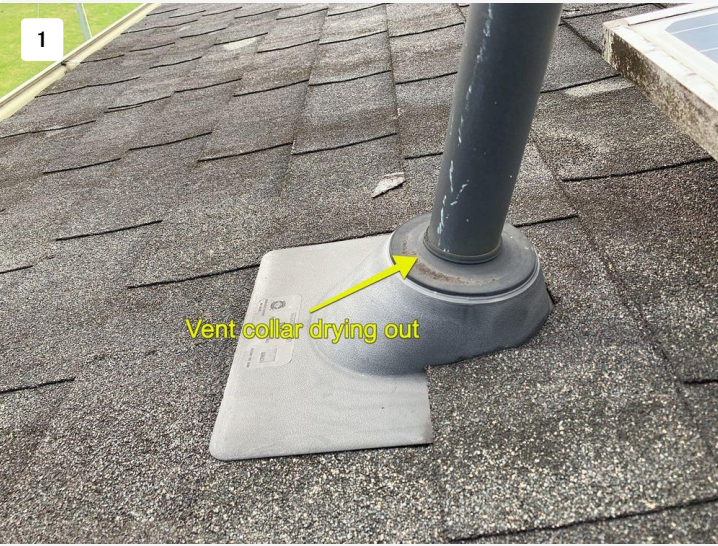
Algae growth

The black stains on the roof is *Gloeocapsa Magma*, a blue-green algae with a black outer shell. This algae feeds on the crushed limestone fillers in the shingle and actually accelerates the roofs aging process. It is recommended to have the roof treated periodically to minimize algae growth. Moss and lichen growth causes pitting on the roof as it's roots secure itself into the shingle. Advanced granule loss is usually seen in areas where moss and lichen are removed.
