DATE	PROJECT
June 10, 2025	Roof replacement - St. Paul Church in Baker Lake, Nunavut
SUBMITTED TO	ADDRESS
St. Patrick Parish	P.O. Box 99, 1039 - 14th Avenue, Sidney, Nebraska 69162
SUBMITTED BY	ADDRESS
Esk-Omi Missions	P.O. Box 159, St. Norbert, Manitoba, CANADA R3V 1L6

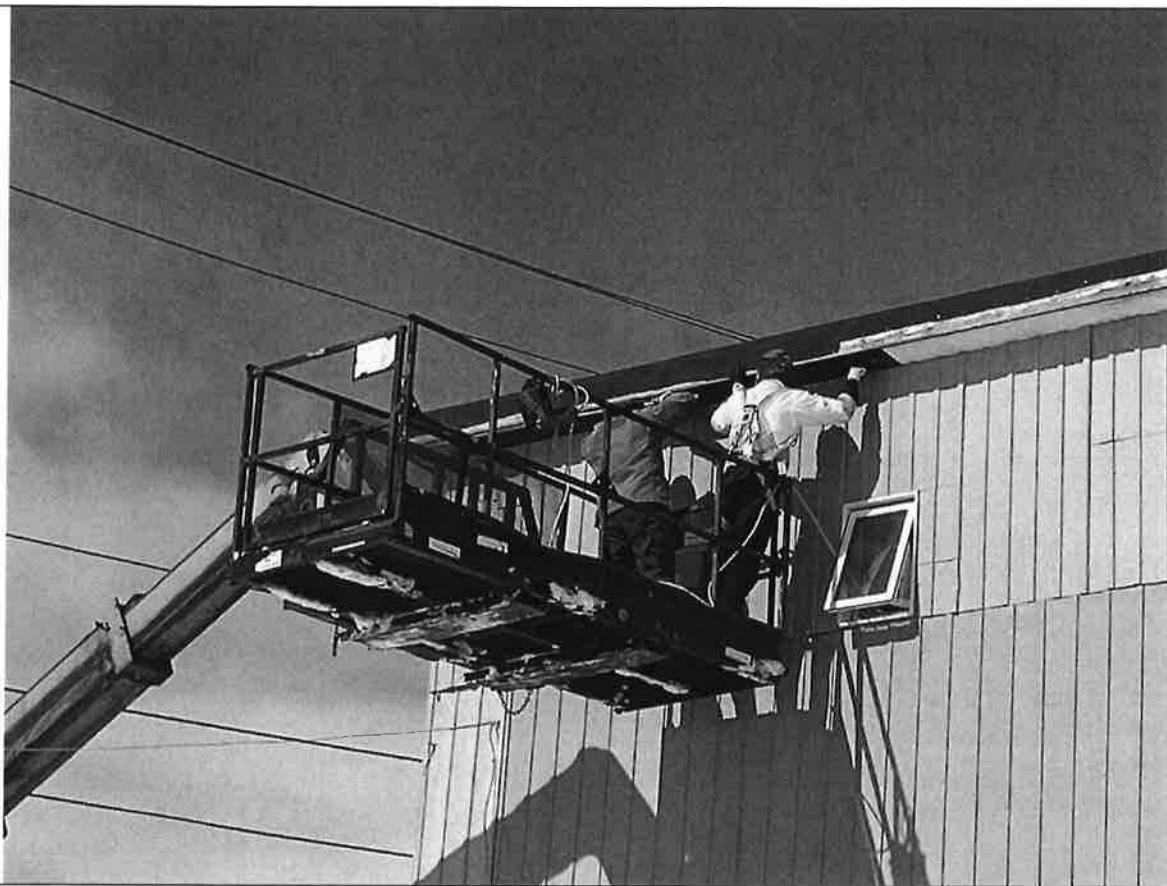
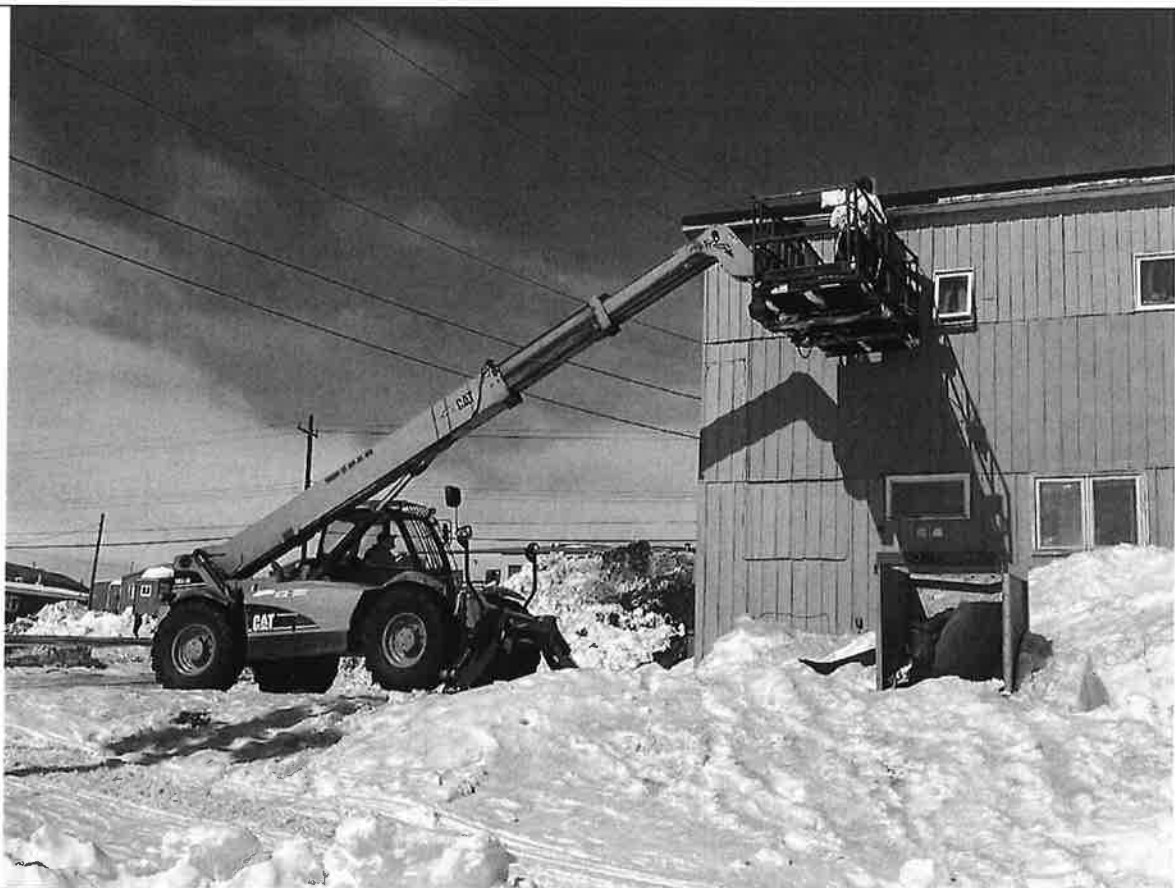
The structure's roof had deteriorated due to the adverse effects over time of the very harsh Arctic weather (extreme cold, high winds and moisture damage due to freeze/thaw cycles). Temperatures during the long winter can go as low as -50° C (-58° F) and wind speeds during winter storms can reach up to 115 kph (70 mph) or more. The roof, fascia and soffit had been repaired several times over the years in order to protect the church from the effects of the unforgiving climate. Unfortunately, this did not work and the entire roof had to be replaced and the fascia/soffit repaired to prevent any further damage to the structure and the church's ceiling.

1. removal of the old roofing material and underlayment;
2. repairs to the damaged parts of the original plywood sheathing;
3. installation of a 2nd layer of 3/4" plywood sheathing over the 1st layer to strengthen the roof;
4. installation of new ice/water shield underlayment;
5. installation of the corrugated steel roofing;
6. repairs to the damaged part of the fascia and soffit;
7. installation of new aluminum fascia and soffit covering;
8. replacement of damaged ceiling tiles in the church;
9. repainting of one of the walls in the church; and
10. repainting the bell tower.
