# Rock-a-Nore to Cliff End: The Story of Hastings' Vanishing Cliffs

A Hastings Kelp Project community report · Oct 21, 2026 · @Chris

This report tells the story of the cliffs between Rock-a-Nore in Hastings Old Town and Cliff End at Pett Level: how they formed, what people built on them, how much has been lost, and what may happen next. It is written for anyone who walks this coast, not just scientists.

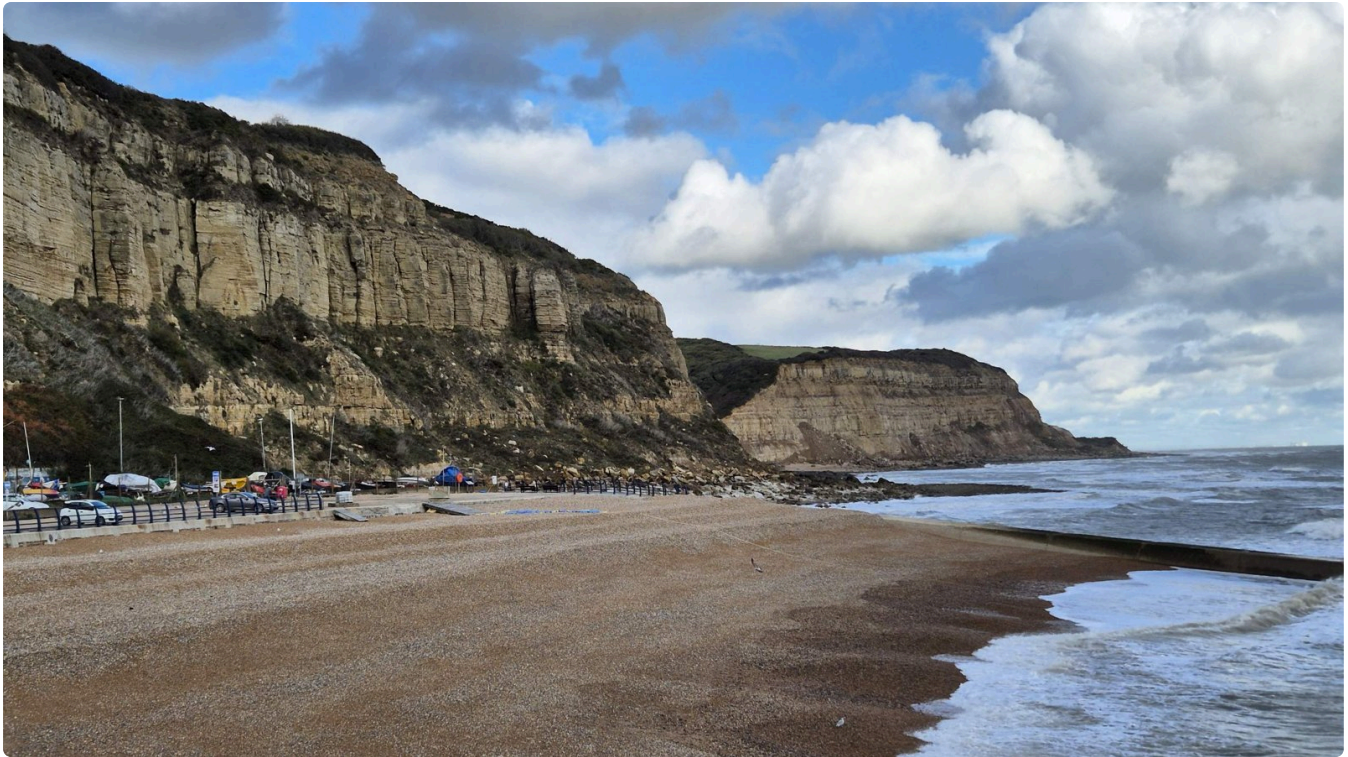
*Figure 1.1. The cliffs at Rock-a-Nore, looking east, October 2026. The tall pale face is Ashdown sandstone, cut by vertical cracks (joints); fallen blocks lie at its foot. The headland beyond leads to Ecclesbourne Glen. Photo: Hastings Kelp Project.*

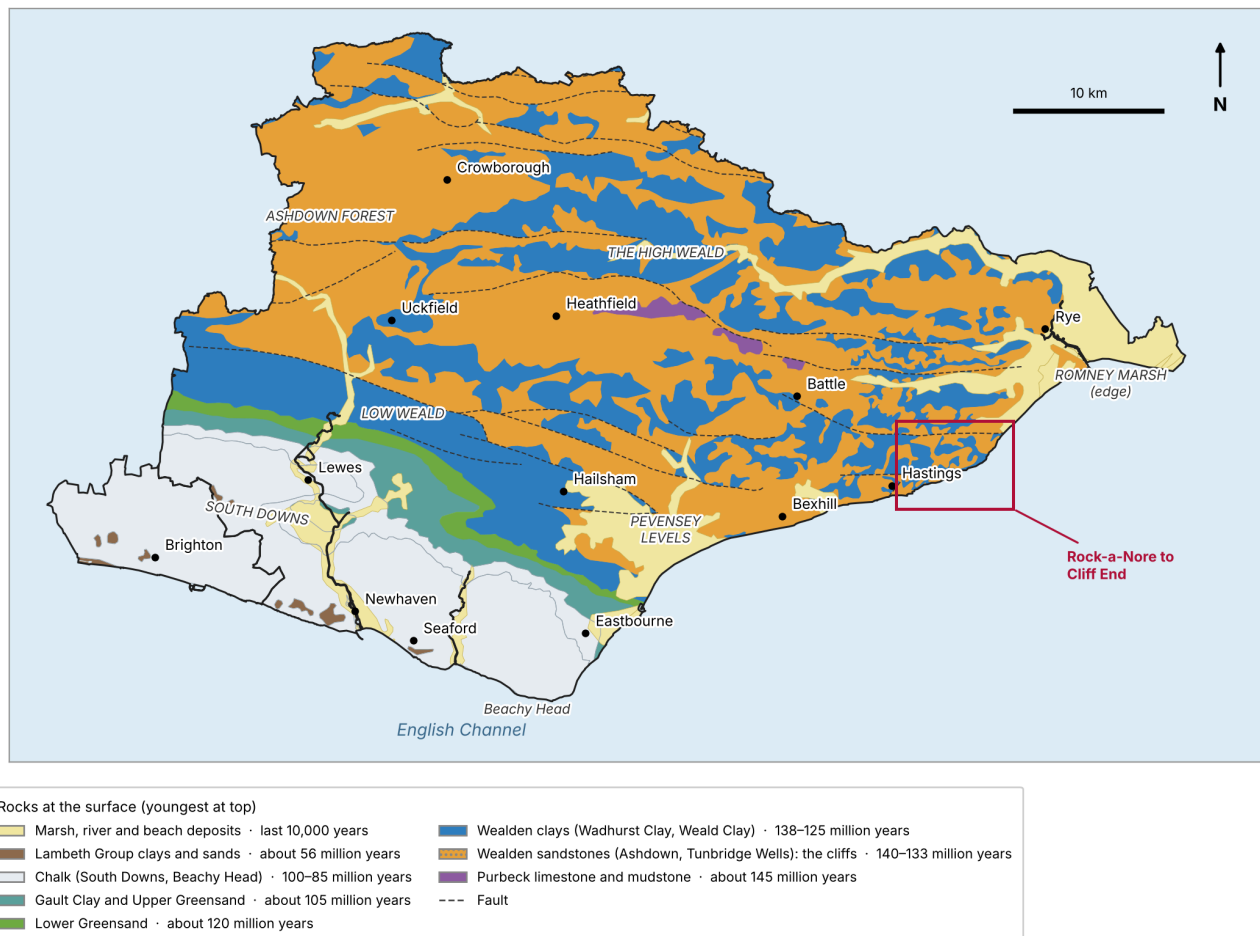
Old Wealden rocks in the middle, younger chalk to the south, recent mud in the low-lying levels. The Hastings cliffs are cut into the old Wealden sandstones and clays (orange and blue).

**Figure 2.1.** The rocks beneath East Sussex. The middle of the county (the High and Low Weald) is made of old Wealden sandstones (orange) and clays (blue), laid down by rivers and lakes 140 to 125 million years ago. Younger chalk forms the South Downs and Beachy Head, and recent mud and shingle fill the low-lying Pevensey Levels and the edge of Romney Marsh. The red box marks the cliffs covered in this report. Source: BGS Geology 625k © UKRI; county boundary © ONS, contains OS data © Crown copyright; both Open Government Licence.

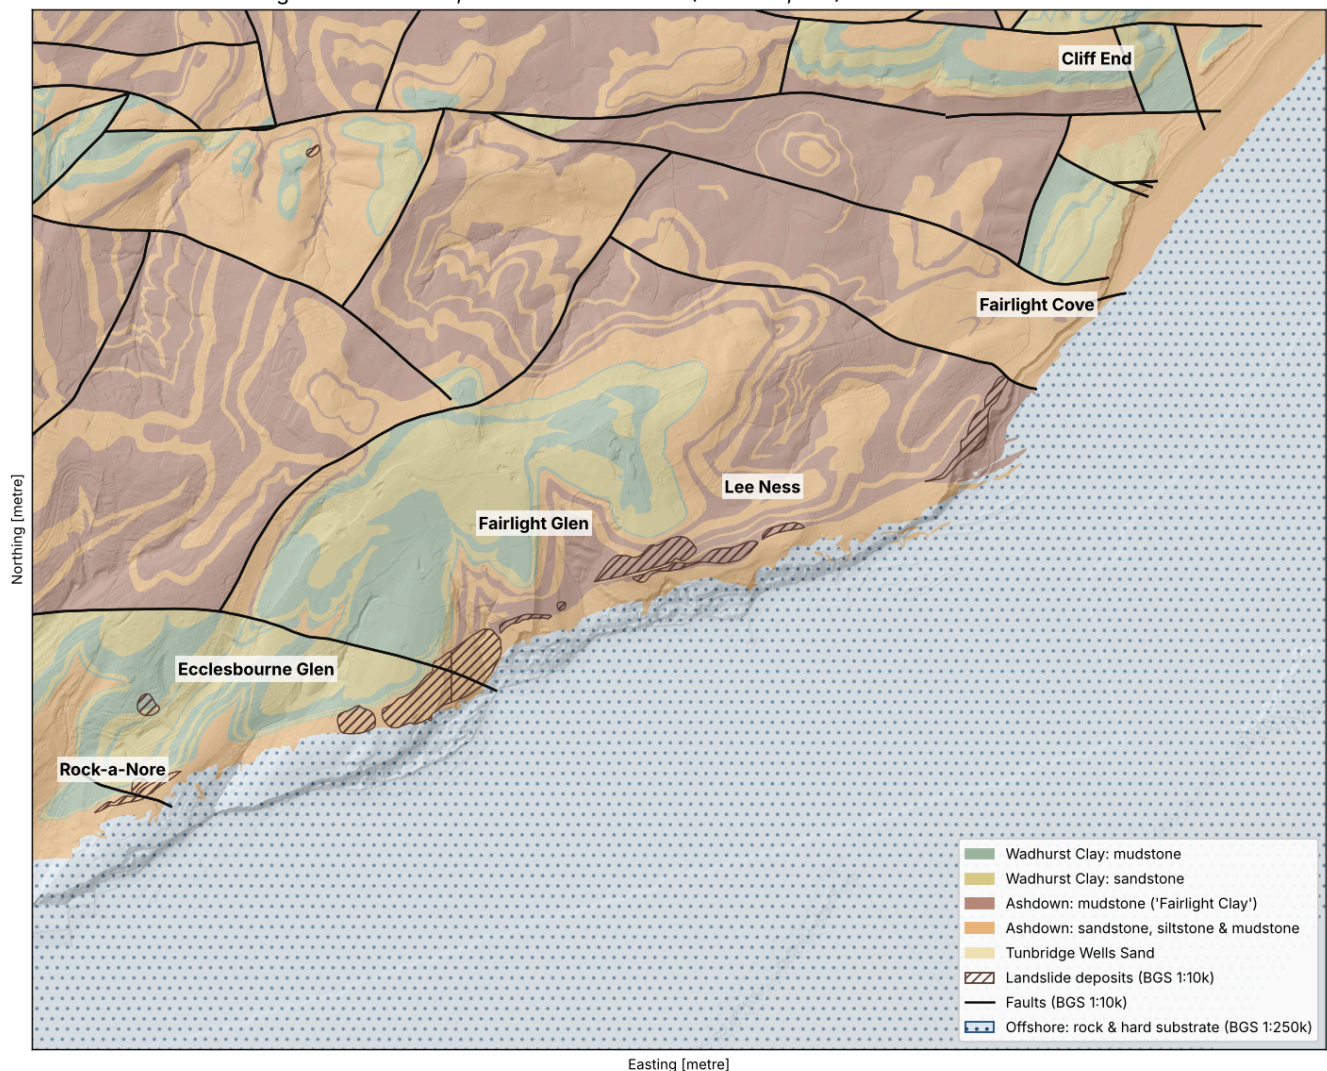
The rocks of the Hastings cliffs: bedrock, faults and landslides (BGS 1:10,000)

Figure 2.2. The rocks behind the cliffs. Brown areas are the soft Ashdown mudstones ("Fairlight Clay"), orange the stronger Ashdown sandstones and siltstones, green and yellow the Wadhurst Clay. Black lines are faults; hatched patches are mapped landslides. The dotted sea area is classed by the British Geological Survey as rock and hard seabed. Based upon Data provided by the British Geological Survey © UKRI. All rights reserved. LiDAR: Environment Agency, Open Government Licence.

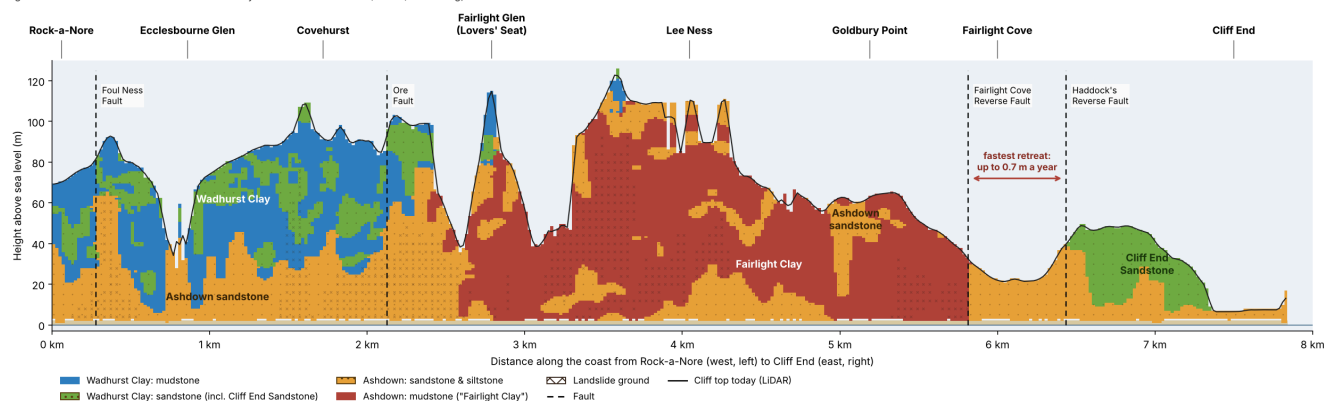
#### The Hastings cliffs side-on: which rocks make up the cliff face

Heights are stretched about 15 times to make the layers visible. Sandstones (dotted) are strong; mudstones are weak.

Simplified from the BGS 1:10,000 geology map where it crosses the cliff face, on Environment Agency LiDAR heights (2017-21). Not a true geological section.

*Figure 2.3. The cliffs side-on, from Rock-a-Nore (left) to Cliff End (right), showing which rocks make up the cliff face. At the western end, strong Ashdown sandstone (orange) sits beneath Wadhurst Clay (blue and green). In the middle, the soft "Fairlight Clay" (red) forms most of the cliff around Fairlight Glen and Lee Ness. Faults (dashed lines) break the layers; the fastest-retreating stretch lies between the two faults at Fairlight Cove. Heights are stretched about 15 times; simplified, not a true geological section. Based upon Data provided by the British Geological Survey © UKRI. All rights reserved. Heights: Environment Agency LiDAR, Open Government Licence.*

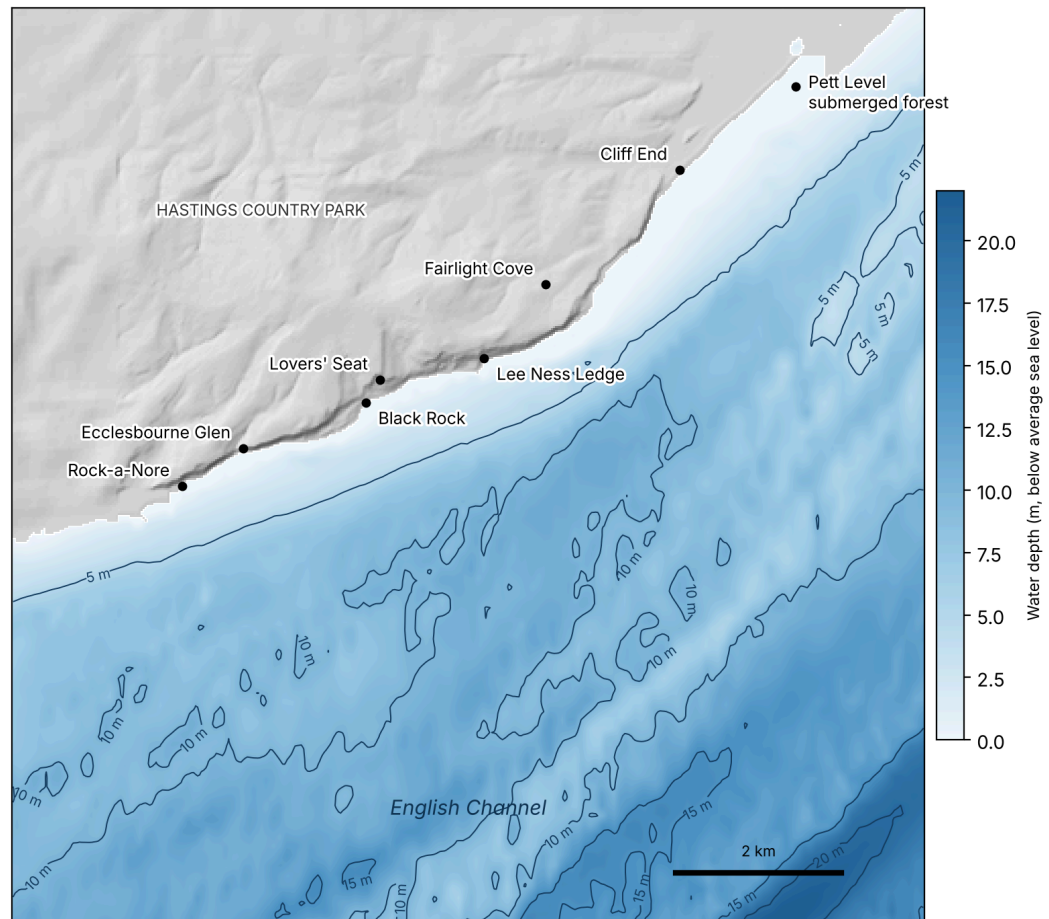
### The seabed off the Hastings cliffs

The sea stays under 5 m deep for over half a kilometre out, and under 10 m for one to two kilometres. The shallow rocky ledges close to the cliffs are where kelp could grow.

*Figure 3.1. Depth of the sea off the cliffs (darker blue = deeper), with 5, 10, 15 and 20 m depth contours. The shallow water close in is where kelp could grow; the long ridges further out run parallel to the coast. Depths: EMODnet Bathymetry (about 100 m grid), CC-BY. Land: Environment Agency LiDAR, Open Government Licence.*

Two things stand out:

- **Long ridges 2 to 5 km offshore** run roughly parallel to the coast. They may be the hard sandstone layers of the cliffs continuing under the sea, or banks of sand. Nobody has checked.
- **Rock ledges close inshore.** HKP volunteers walking the shore have seen large rock outcrops reaching 500 to 700 m out from the beach. The best existing depth maps are too coarse to show them at all. Further out, about 10 km south of Hastings, the Inner

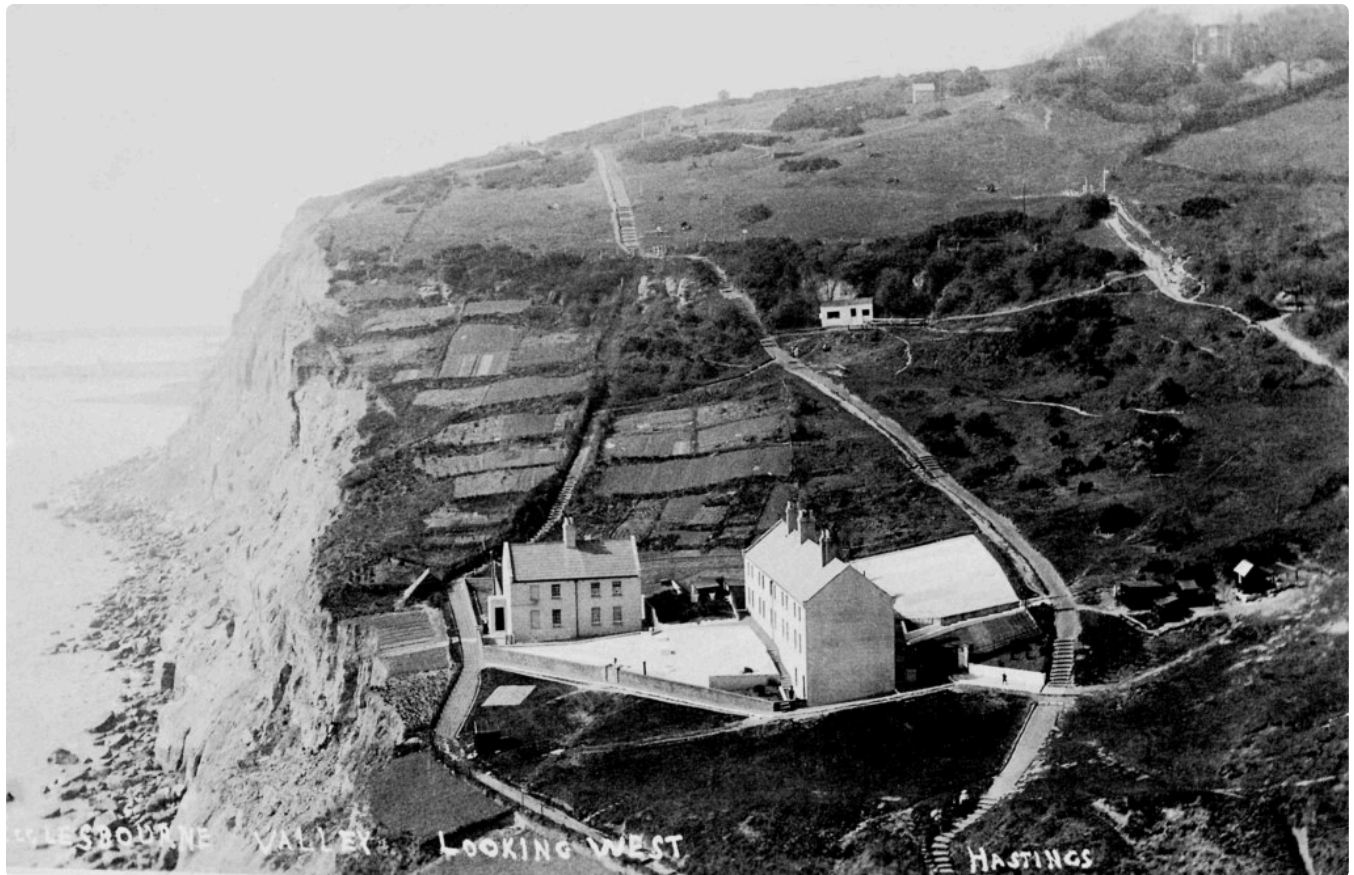
Figure 4.1. "Ecclesbourne Valley looking west, Hastings", a postcard from the early 1900s. The coastguard station and its yard stand right at the cliff edge, with allotment terraces on the slope and paths climbing to East Hill. Every building here has since gone. Photographer and publisher unknown; believed to be out of copyright (see Sources).

The coastguards left in 1908/09. By 1932 the cliff edge was about 15 ft (4.6 m) from the empty cottages. Landslips in January 1961 undermined them, and between 1962 and 1963 the buildings were pushed over the cliff onto the beach. The final bill to the Council was about £440 ([Hastings History](#)).

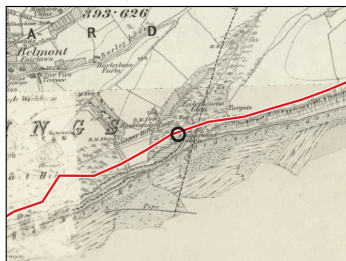
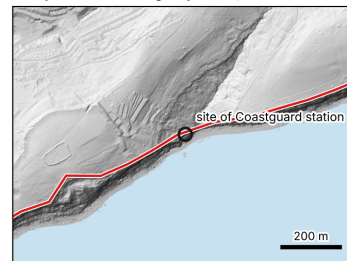
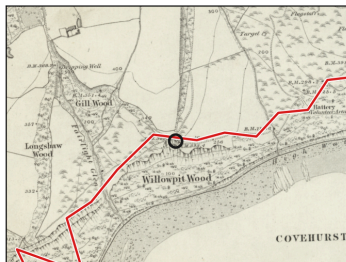
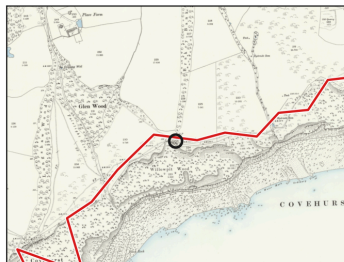
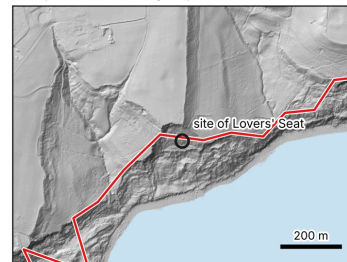
Red line = today's cliff top, or the back edge of a landslip, from LiDAR (approximate), drawn on every map. Circle = the landmark. Wherever the old map shows land on the seaward side of the red line, that land has since gone.

**Figure 4.9. Lost landmarks, then and now.** Top: the Ecclesbourne coastguard station on the 1870s six-inch map and on today's LiDAR. Bottom: Lovers' Seat in the 1870s, the 1890s–1900s and today. The red line is today's cliff top (or landslip edge). Old maps: Ordnance Survey, reproduced with the permission of the National Library of Scotland (CC-BY). LiDAR: Environment Agency, Open Government Licence.

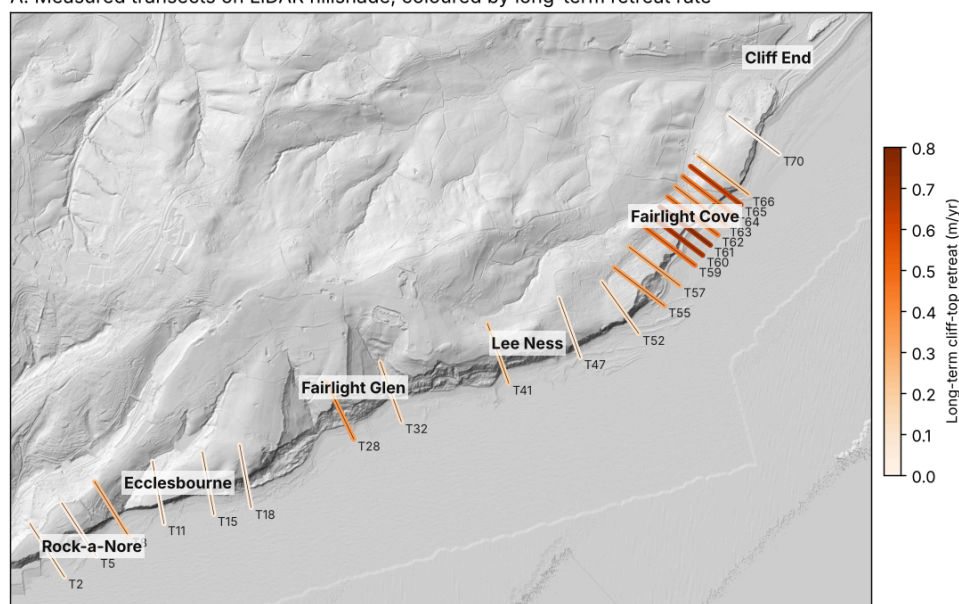
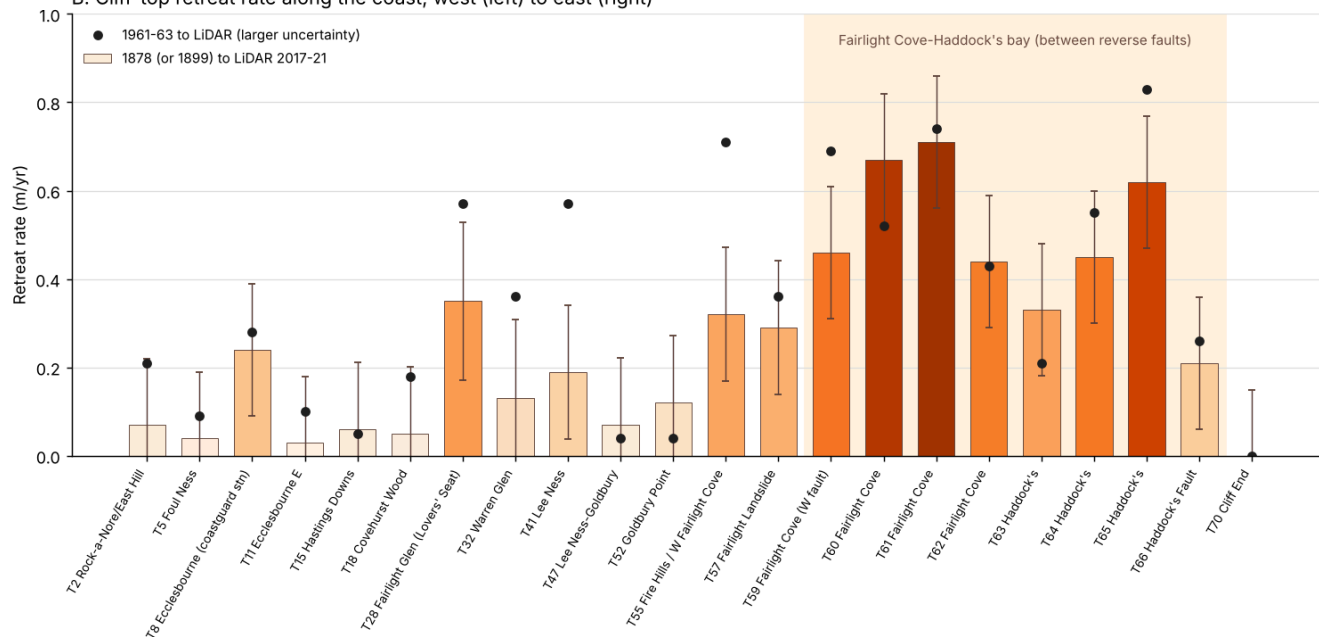
A. Measured transects on LiDAR hillshade, coloured by long-term retreat rate

B. Cliff-top retreat rate along the coast, west (left) to east (right)

Figure 5.1. Top: the 22 measured lines, coloured by how fast the cliff top has retreated. Bottom: the rate on each line, west to east. Bars = 1878 to today; dots = 1960s to today. Source: HKP measurements from old Ordnance Survey maps (1878–1963) and Environment Agency LiDAR (Open Government Licence).

| Section | Retreat since 1878 | Average rate |
| Rock-a-Nore, Foul Ness, Covehurst | 4 to 10 m | about 5 cm a year |
| Ecclesbourne (coastguard station) | about 34 m | about 24 cm a year |

| Section | Retreat since 1878 | Average rate |
|---|---|---|
| Fairlight Glen (Lovers' Seat) | about 42 m (since 1899) | about 35 cm a year |
| Fire Hills and Fairlight Landslide | 40 to 45 m | about 30 cm a year |
| Fairlight Cove to Haddock's | 60 to 100 m | 45 to 70 cm a year |
