## Event details

**Location of incident:** Gatwick Station

Waterproofing works undertaken on a flat roof area at height at Gatwick Station.

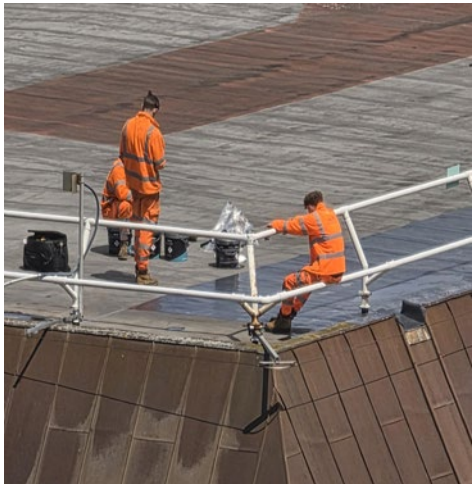
During the activity, an operative was observed sitting on the installed guardrail at the roof edge, placing the operative outside the designed protection zone and exposing them to a significant fall-from-height risk. The incident was photographed and escalated to the station manager, who notified Works Delivery of the incident.

- Operative sat on the edge protection guardrail at roof level, misusing the system and placing themselves in an unsafe position close to the edge.
- Operative sitting on the guardrail rather than maintaining a safe working position.
- Failure of supervision to challenge unsafe behaviour.

- Guardrails are for protection, not positioning or seating.  
Sitting, leaning, or working outside guardrails is strictly prohibited.
- Unsafe behaviours must be challenged immediately.
- Visible supervision plays a key role in reinforcing standards.

- Incident reported & recorded in accordance with company procedure
- Post incident D&A undertaken.
- Parties involved stood down from relevant duties
- Investigation initiated.
