## Event details

**Location of incident:** Wokingham Signal Box

### Event description:

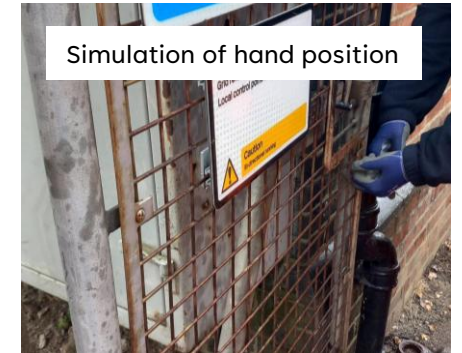
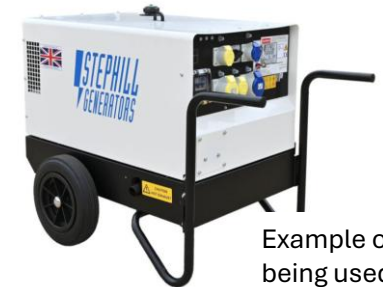
As part of site set-up (ahead of asbestos removal works), two operatives were manoeuvring a wheeled 5kVA generator through a railway access gate. The generator had been offloaded from a Luton van nearby. During the offloading process, one operative's left ring finger became trapped against the open access gate. The operative sustained an injury to their finger.

Simulation of hand position

- The operative was not wearing gloves at the time of the incident
- This was not identified or reinforced as part of the putting to work process

- Check risk assessments and WPP/TBS to confirm that the correct type of hand protection has been specified
- Review the hand protection that personnel are using to ensure that it aligns with the gloves specified
- For further information on glove specification, see the SRE Raising the Bar 'Glove Your Hands' campaign
- Have manual handling tasks been assessed and appropriate controls implemented?

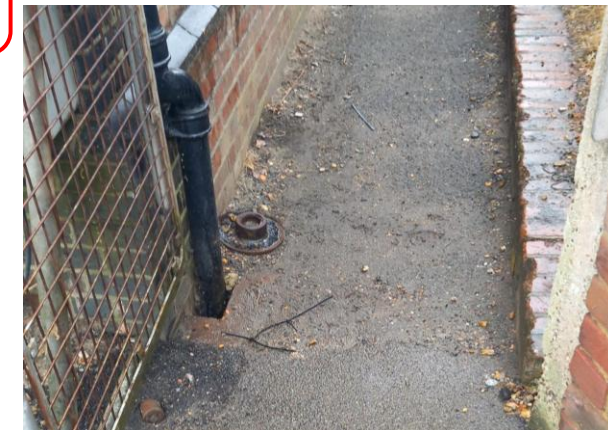
Example of generator being used
