# **TRAFFIC CONTROL DEVICES COMPLAINT REPORT**

**East Lake Woodlands Community  
Oldsmar, FL**

**East Lake Woodlands Community Association  
c/o Management & Associates  
COD No. C0076-J001**

**September 12, 2022**

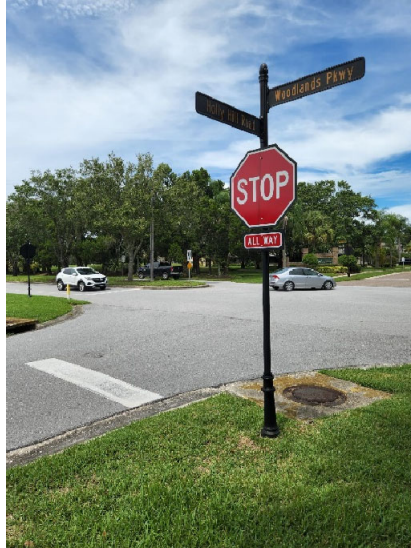
### Photo #1

Location: Holly Hill Road & Woodlands Parkway  
Description: Complaint Stop Sign & Stop Bar

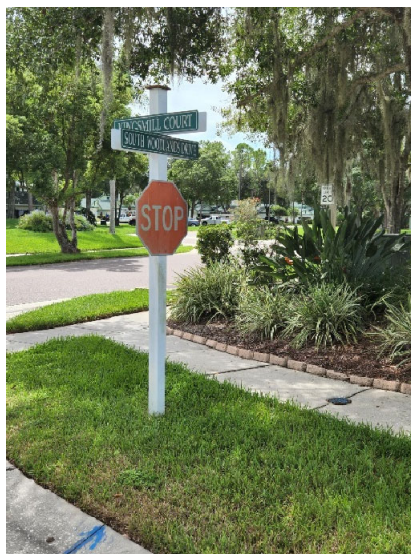
### Photo #2

Location: Kingsmill Court & South Woodlands Drive  
Description: Non-Compliant Stop Sign

dimensions. It is our recommendation that all non-standardized stop signs be replaced with standardized stop signs throughout the East Lake Woodlands Community Association rights-of-way.

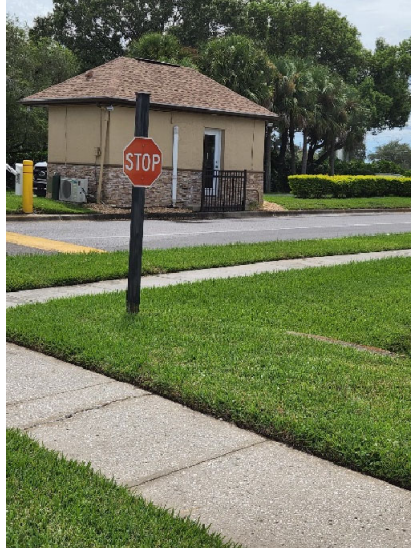
Photo #3

1. ERIC COURT
  - a. ID No. ELW-1
  - b. Deficiencies
    - i. Missing Stop Bar
    - ii. Stop Sign is non-compliant
    - iii. No Truncated Domes or Crosswalk striping

Location: Eric Court & East Lake Woodlands Parkway  
Description: Non-Complaint Stop Sign (material, height, & sign)

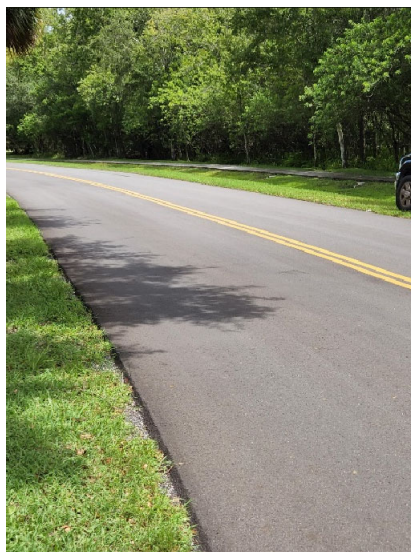
Photo #4

Location: East Lake Woodlands Parkway  
Description: Non-Complaint Double Yellow Striping

- Install six-inch double yellow reflective striping with reflective pavement markers (RPMs) down all centerlines.
- Install six-inch single white reflective striping along all outside edges of travel lanes
- Review “Roadway Analysis” for missing signage and miscellaneous striping.
- Check all signs for reflectivity.

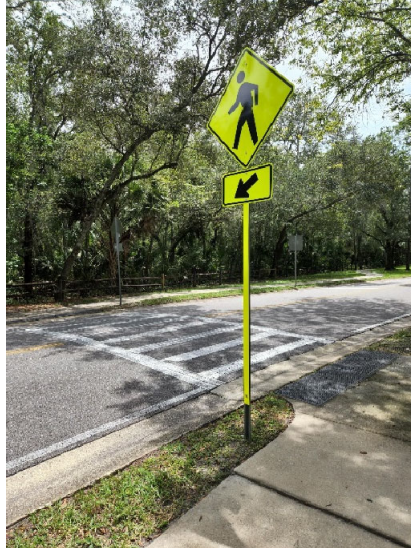
Photo #5

Location: Sunflower Drive  
Description: Complaint Pedestrian Crossing

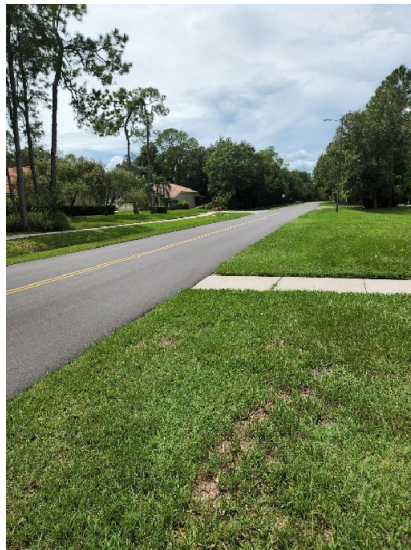
Photo #6

- b. Deficiencies
    - i. No Truncated Domes or Crosswalk striping
    - ii. Sidewalk abruptly ends at the EOP of E Lake Woodland Parkway southwest of the intersection. No crosswalk, signage, truncated domes, or sidewalk connection to the sidewalk on the opposite side of the ROW.

Location: East Lake Woodlands Parkway  
Description: Non-Complaint Pedestrian Crossing (no signage, truncated domes, crosswalk, or s/w connection)

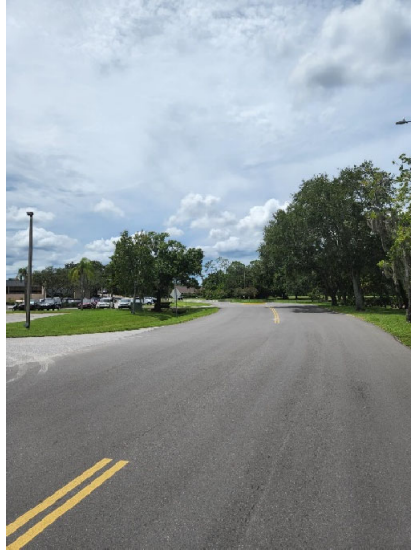
Photo #7

- 14. ROADWAY
  - a. Deficiencies
    - i. Missing “GOLF CART AHEAD” Sign between ELW-6 & ELW-7 SB
    - ii. Missing gore striping and R4-7 with reflective diamond on SB approach to median between ELW-5 & ELW-6.

Location: East Lake Woodlands Parkway (southbound approach to clubhouse)  
Description: Striping Non-Compliance (missing gore, centerline double yellow misaligned, poor placement of golf cart crossing approach sign)

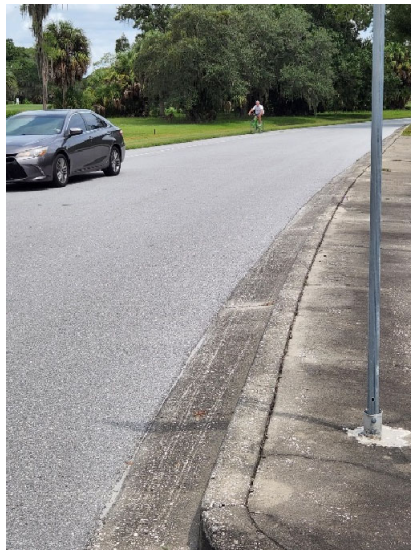
Photo #8

Location: Woodlake Wynde & Woodlands Parkway  
Description: Missing turn lane striping and signage

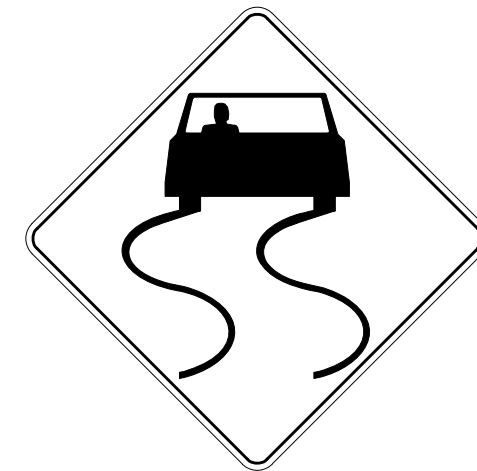
W8-5

Slippery When Wet signs shall be placed in advance of all movable and non-movable steel deck bridges.  
See Section 2.1 of the Traffic Engineering Manual (Topic Number 750-000-005).
