Preliminary Fencing Report

Exits 17 to 18 - Highway 107, Nova Scotia

December 2022

East Coast Aquatics Inc.

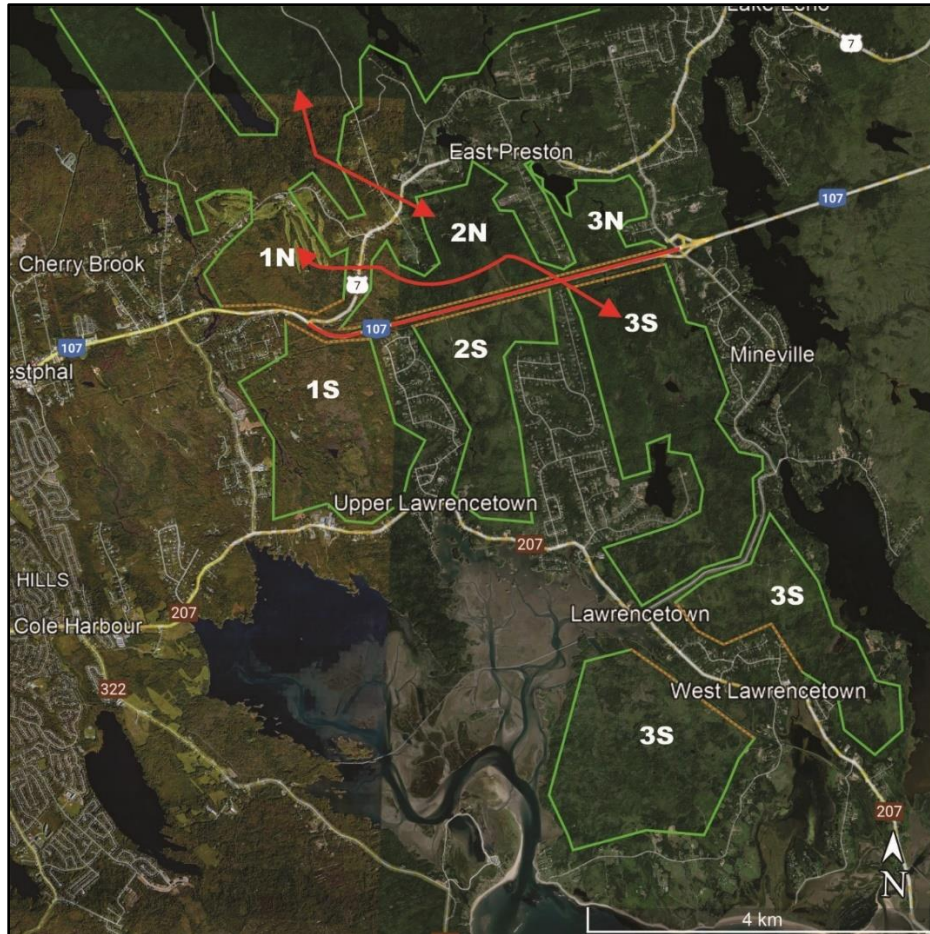
Figure 1: Preliminary assessment of large habitat areas north and south of the Highway 107 project site. 1N and 3S are the largest land areas and it is anticipated that large mammals would attempt to connect these areas during seasonal movements. The red arrows do not reflect actual crossing areas, only anticipated general movements connecting large habitats. Local scale movements could vary considerably.

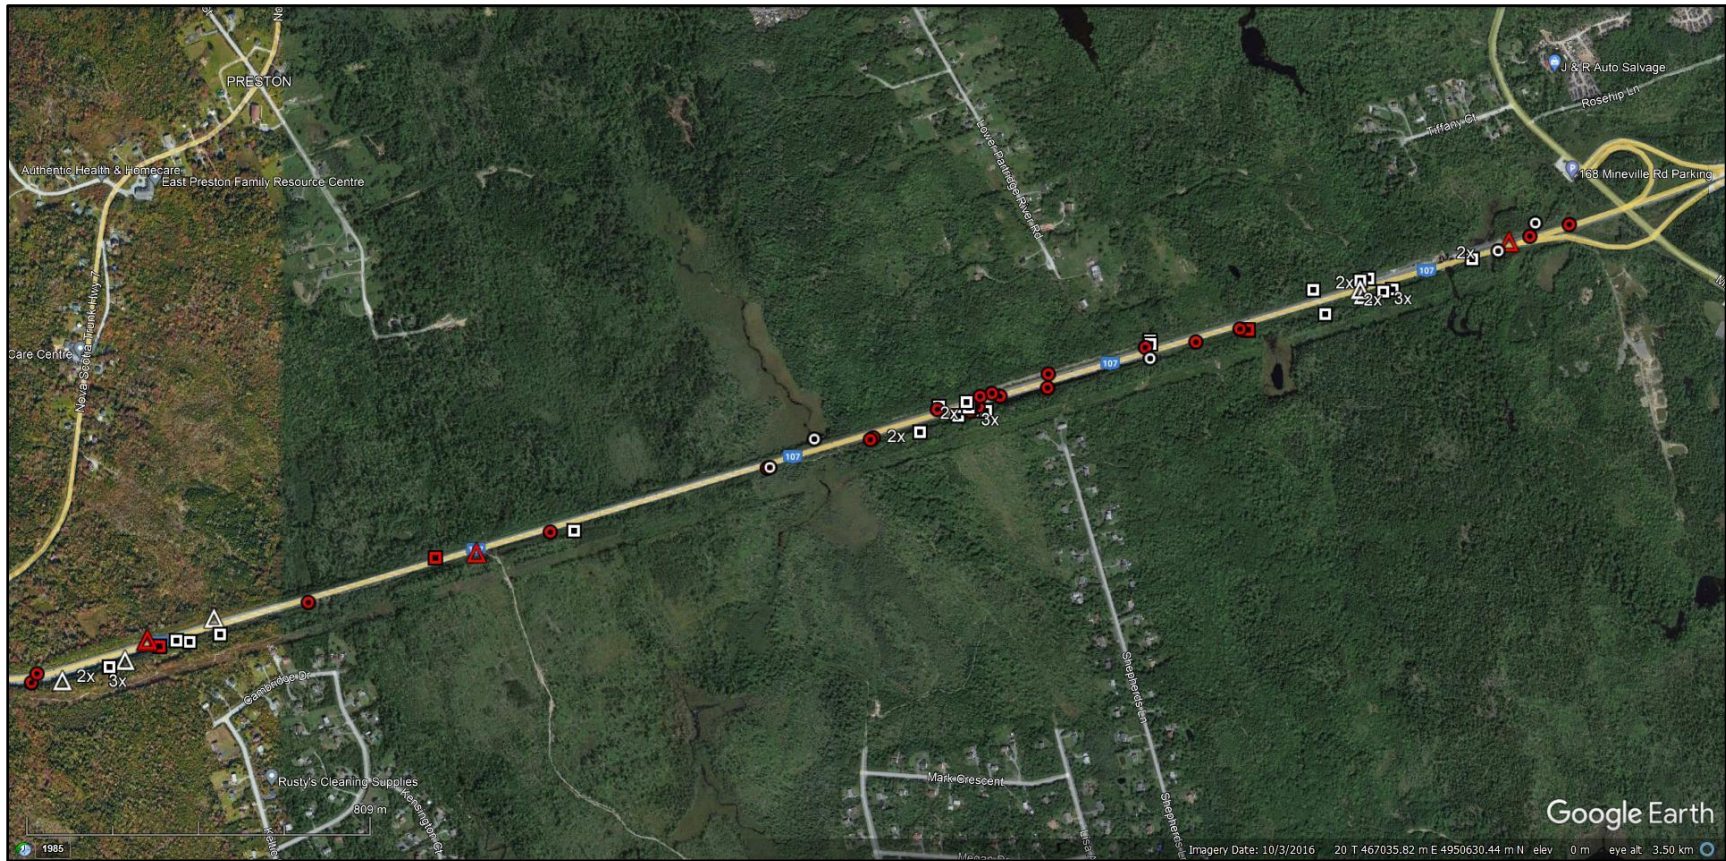
Figure 2: Observation (white symbols) and road kill (red symbols) location of wildlife in 2022 along the project corridor. Small mammals (circles) were the most numerous documented roadkill while medium-sized mammals (squares=coyotes) were both the most numerous observed and observed actively crossing the highway. Large mammals (triangles) are represented only by deer, although other large mammals may be present in the study area.

Table 1 summarizes all wildlife observation and road kill data collected in 2022 and depicted in Figure 2. It shows that small-sized wildlife were more frequently killed along the Highway 107 study area. Spatially, the greatest number of small animal kills occurred in and around an area of highway bordered by rock cut. This area is also at a crest in the highway and line of sight visibility may be poor for drivers. The rock cut would prevent easy escape from the highway corridor and the short line of sight would increase the risk of vehicle/wildlife collision. Medium sized mammals, represented only by coyote in the data set, were the most numerous observed along the corridor. Medium and large mammals are more likely to cause significant damage and pose greater risk to the driving public when encountered. Seven dead animals from these two size categories were located in 2022 despite a relatively limited number of roadkill survey dates (5). These carcasses were observed to be persistent in the highway corridor for a period of weeks to months.

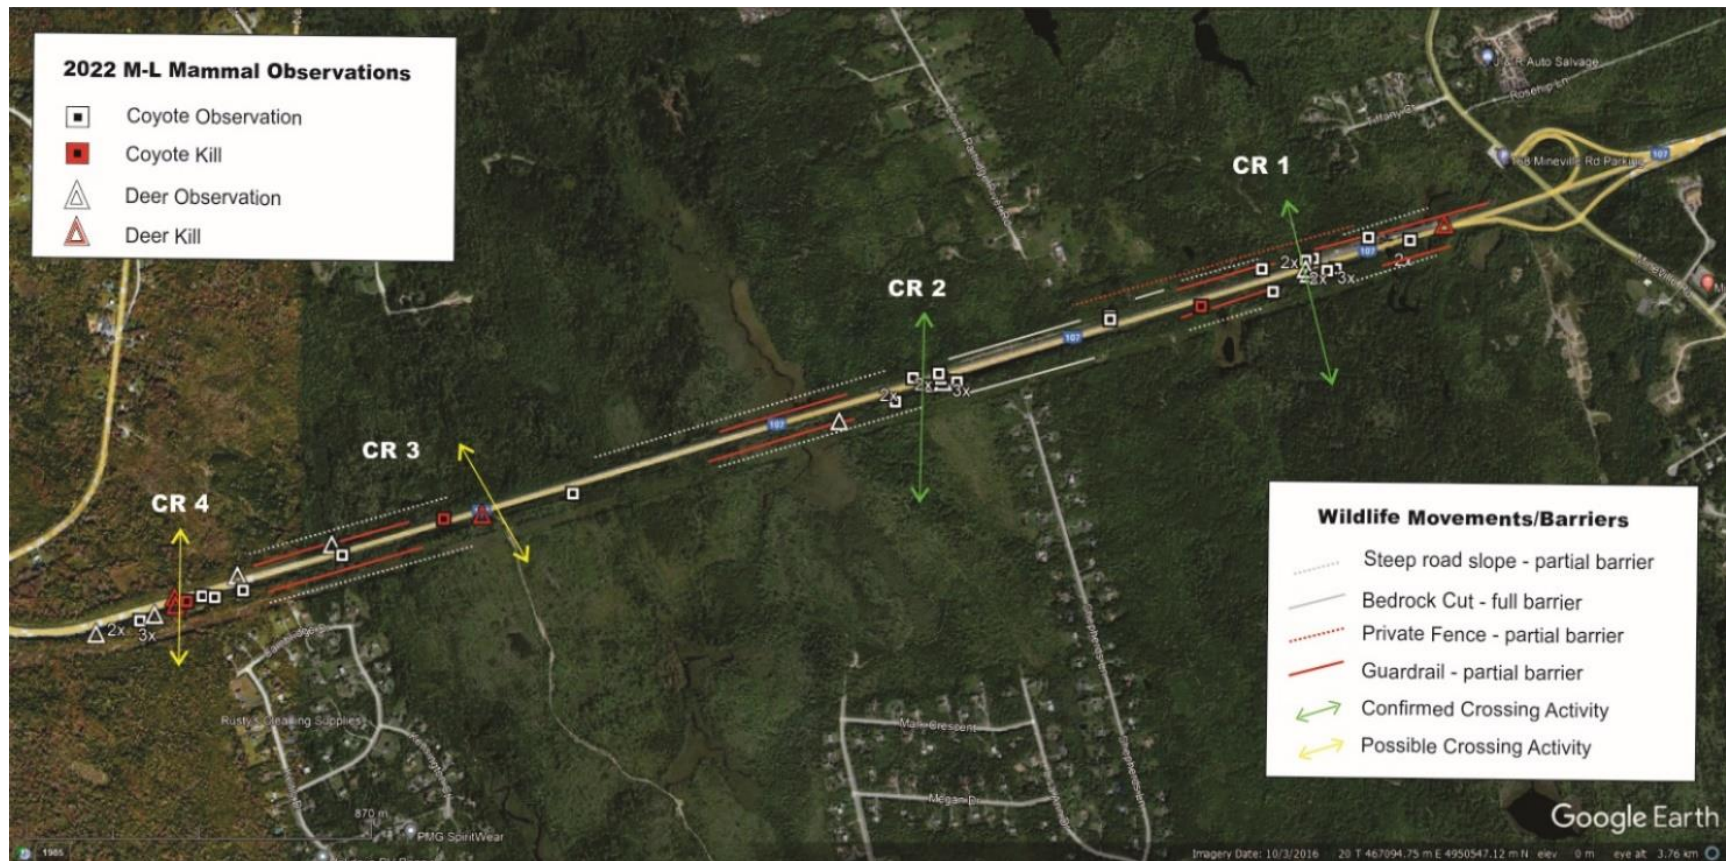
Figure 3: The locations of observed (white symbols) and road killed (red symbols) medium and large animals along the Highway 107 project corridor align with general gaps in the identified full and partial barriers to their movements. Confirmed crossings are where winter track surveys confirmed species and direction of movement on both sides of the highway. Possible crossing activity is inferred by a concentration in observations but no confirmed track movements across the highway. Road kills of medium (squares) and large-sized mammals (triangles) did not occur in the central portion of the survey area where topography and highway straightness generally provide a longer line of sight for drivers.

As indicated in Figure 3, large/medium sized mammals appear to currently be using two confirmed (CR1, CR2) areas and two additional possible (CR3, CR4) crossing locations along the project Highway 107 corridor to maintain connectivity between habitats north and south of the highway. The identification of these crossings is based on concentrations of data from the roadkill, winter track, and wildlife camera information collected to date. Confirmed crossings were locations where winter track surveys confirmed species and direction of movement at a single location on either side of the highway on a given date. Possible crossing activity is inferred by a concentration in observations in an area, but no confirmed track movements across the highway corridor on a given date.

As shown in Figures 3 and 4, when real (vertical bedrock cut) and perceived (guardrails, private fencing, steep embankments) barriers to wildlife movement are considered, all four locations of large/medium mammal crossings align with limited barriers connecting larger areas of habitat north and south of the highway. Also of note is that road kills of medium and large mammals did not occur in the central portion of the survey area. This is a section of highway where topography and highway straightness generally provide a long line of sight for drivers. There is a section where a road crest within the rock cut may limit line of sight, particularly for east bound drivers. However, it is expected that medium and large mammals do not enter the highway corridor through the rock cut, and area with no tracks, but instead stay atop the rock cut as evidenced by numerous tracks. Most medium/large mammal roadkill (5) were located near CR 3 and 4 where eastbound traffic rounds a corner over a crest of a hill and speed limits increase, factors that reduce line of sight and reaction time for drivers.

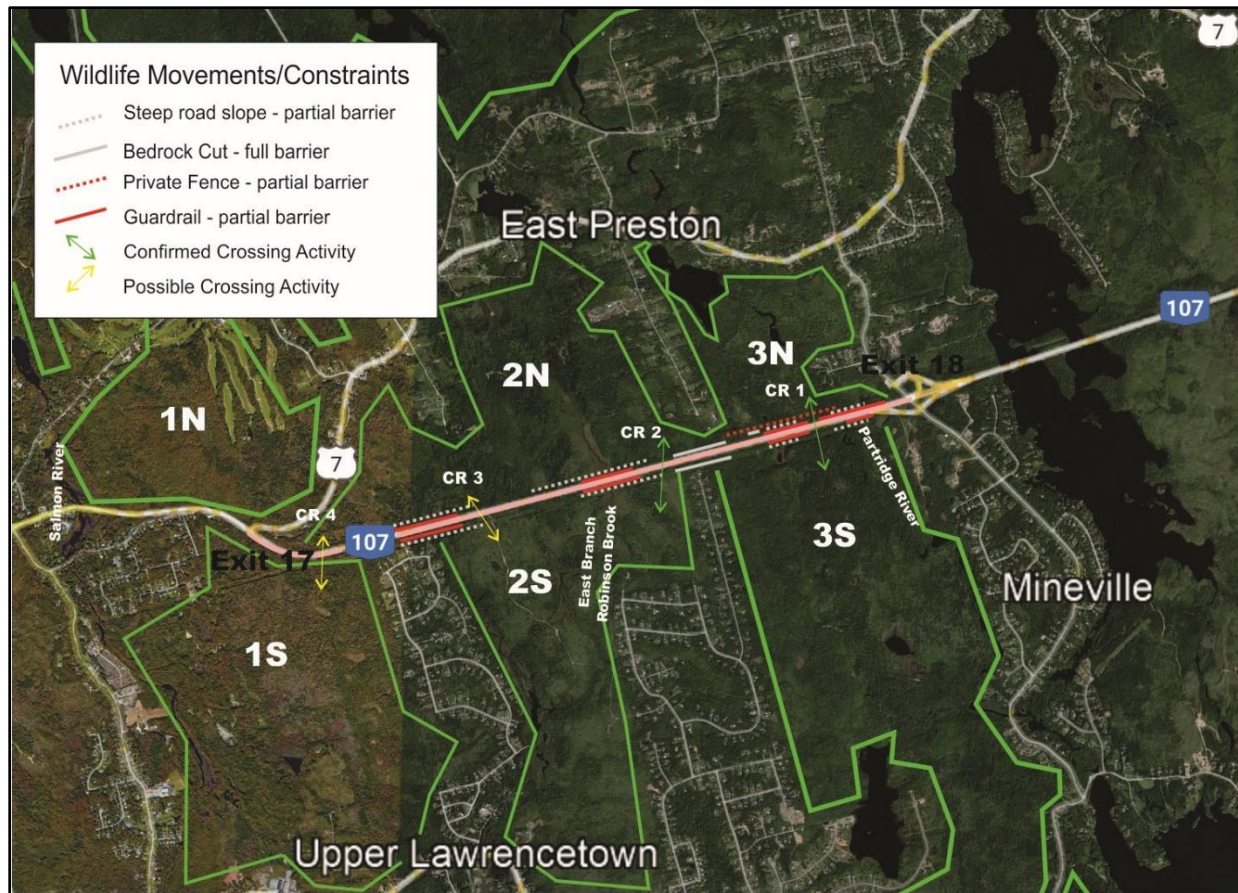
Figure 4: Current (2022) perceived full and partial barriers to wildlife movement across the Highway 107 study corridor are indicated. Current confirmed and potential wildlife movement corridors across the highway (CR#) generally occur where barrier gaps exist.

It is understood that extension of wildlife fencing westward to Exit 17 may occur. It is recommended that if future wildlife fencing should extend westward past Exit 17 to the Salmon River bridge (see Figure 4) to prevent an increased risk of vehicle/wildlife collisions at the fence end. Ending the fence closer to Exit 17 would have higher probability of creating a fence end effect, concentrating wildlife crossing attempts of highway at the western fence end regardless of the type of fence end treatments. Fencing layout must also ensure access to all existing culverts under Highway 107 such that they may be used by small/medium mammals for crossing under the highway.

Additionally, if fencing is to be extended to the area of Exit 17, a second large mammal crossing must be installed nearer Exit 17 prior to fencing in order to maintain wildlife habitat connectivity. The current wildlife crossing location CR4 (see Figure 4) would appear, based on assessment to date, to be the most appropriate location for a second large mammal crossing to be established. Elevated terrain on either side of the highway in that area could make it feasible to establish a small overpass structure that would connect significant natural habitats of large mammals north and south of the highway. An overpass (see Figure 18) has benefits of being accessible to all wildlife, daylight, and easy to naturalize. Overpasses tend to be highly successful in gaining wildlife use over time. Overpass drawbacks would include cost, engineering challenges, and potential use by OHV and humans to the detriment of wildlife use.

A final, but less desirable option for a second large mammal crossing, would be construction of a large mammal overpass at the rock cut of near CR2. This location would work well within topography, but would be less likely to provide good north south connectivity between habitat areas 1 and 2 located west of east branch of Robinson Brook (Figure 4) and is therefore less desirable than either location CR3 or CR4.

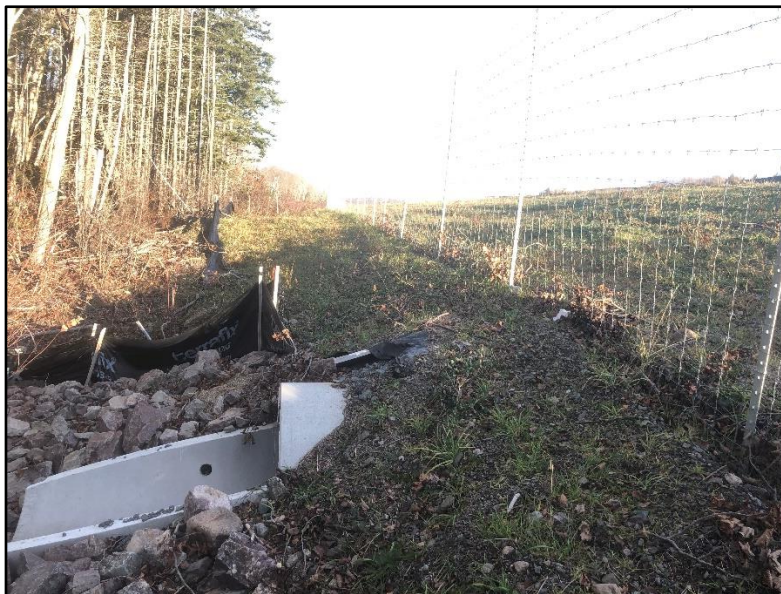
Figure 5: Wildlife fencing must be placed between the head of culverts and the highway to allow potential for small mammal use of the culvert as passage under the highway and to minimize fence maintenance requirements associated with water and debris.

Fourth, fencing across watercourses/drainages has an increased potential to allow wildlife penetration into the highway corridor and to create maintenance impacts. Avoiding placement of a fence across a watercourse eliminates the risk of flood/ice/debris jam damage to the fence. To allow for both unimpeded water drainage and to facilitate potential for small mammal use of culverted water crossings under the highway, wildlife fencing must cross over the top of a culvert between the culvert end and the edge of the highway as shown in Figure 5. If a water course is wide (>2m) or deep (>0.5m) a terrestrial area between the head of a culvert and the fencing of ~2m should be maintained such that wildlife can avoid the stream by moving over the head of the culvert. In some instances with older culvert installations, the proximity of the fencing to the highway to pass over the head of the culvert may require placement of a guardrail between the fence the highway. Although it is not an issue at the Highway 107 study site it is noted that the entrance to culverts that drain the median of a divided highway or off ramp area must not be fenced over the head of the culvert, but rather across the watercourse/drainage from the culvert. Allowing animals to freely access these culverts mean they can gain entry directly to the fenced highway corridor where a wildlife/vehicle collision becomes a high probability.

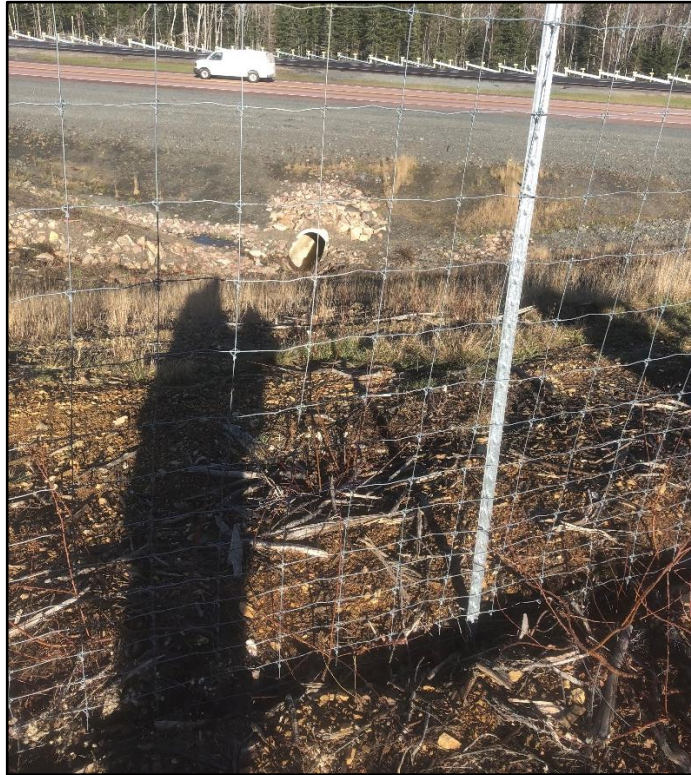
Figure 6: When fencing is not installed between the head of a culvert and the highway, as has occurred in this case, small/medium mammals can not access the culvert entrance as means of crossing under the highway.

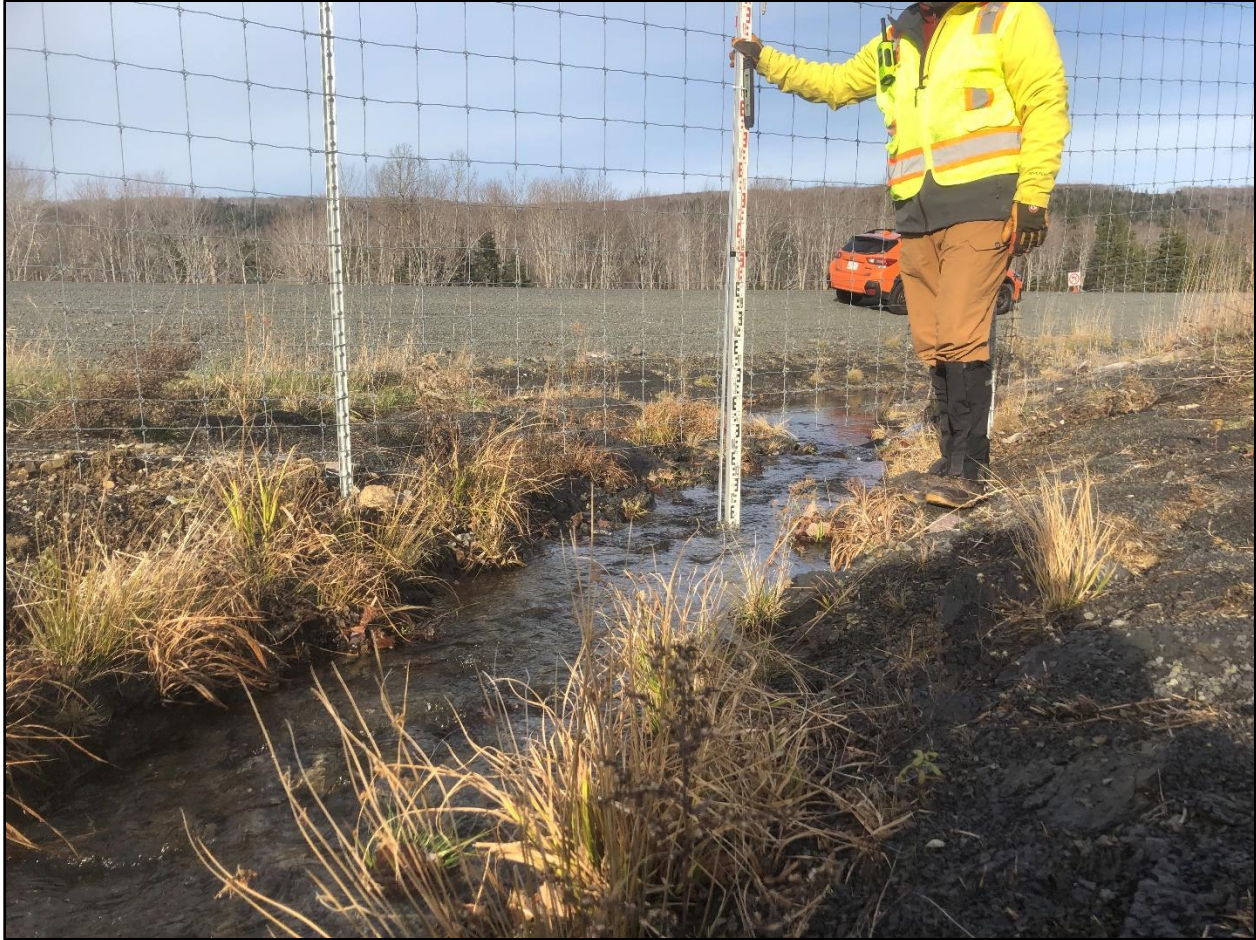
Figure 7: Gaps under a fence at drainages and dips in the terrain can easily allow even large mammals to gain access to the fenced highway corridor where the probability of wildlife/vehicle collision is high. An extension of the fence bottom is required to minimize the gap. A flexible apron could be wired to the bottom of the fence in this image to limit wildlife access while minimizing potential maintenance from stream debris. Ongoing monitoring is required to ensure proper function.

Fifth, gaps under a fence can easily allow small and large mammals access to the highway corridor. Gaps may exist from incorrect installation over dips in terrain, erosion under a fence, or some physical damage to a section of fence. Monitoring must be incorporated to ensure these conditions do not occur. Fencing is to be buried 0.1m+ at the bottom or pinned down as a wide skirt (NSDLF 2019) to discourage digging by wildlife and to maintain integrity from other disturbance to the fence. The skirt or any buried portion or portion used to eliminate a bottom gap may not take away from the overall effective 2.4m height of the fence nor from the 0.8m above ground small mesh panel requirement.

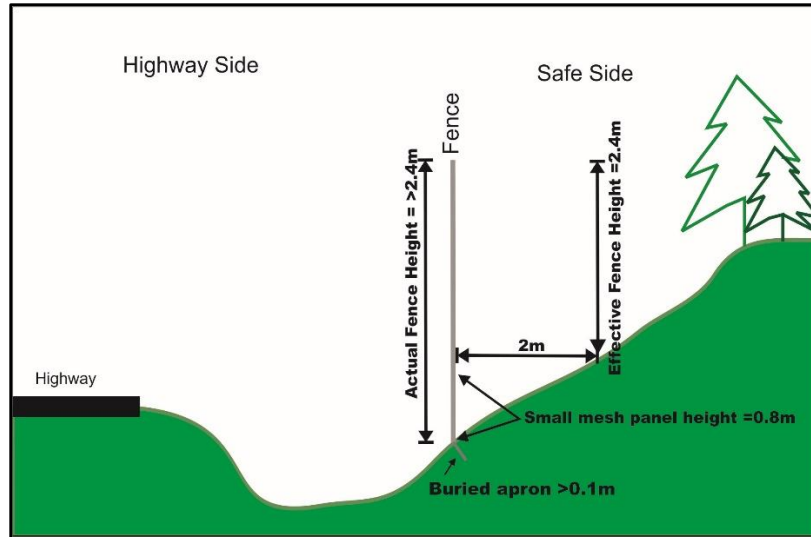
Figure 8: Effective fence height is measured from the ground 2m away the safe side of the fence and must be 2.4m. If the ground has a higher elevation on the safe side the actual fence height will need to be >2.4m to achieve an effective height of 2.4m.

Sixth, the wildlife fence must achieve an *effective height* of 2.4m as measured 2m from the safe side of the fence and based on chosen final alignment this objective will require an actual fence height well in excess of 2.4m. White tailed deer will rarely jump a 2.4m high fence. Two meters away from the fence is approximately where a deer would initiate a jump attempt over the fence. If the fence is placed on a slope where the safe side of the fence is higher than where the fence is installed the fence is effectively shortened as shown in Figures 8 and 9. This provides opportunity for deer to jump over a fence that is 2.4m of actual height. In such cases, additional height must be added to the fence to achieve the effective height of 2.4m. Avoiding placement of the fence on sloped areas, if possible, will eliminate the need to modify the actual fence height. At two meters upslope from the fence on a 2:1 slope 1m of effective height is lost and a 3.4m high fence would be required. At two meters upslope from the fence on a 3:1 side slope 0.70m of effective height is lost and a 3.1m high fence would be required. In both of these examples fence posts and fencing will need to be taller than 2.4m above ground in order to achieve an effective height of 2.4m. However, careful siting of the fence installation will avoid many challenges with achieving an effective 2.4m fence height.

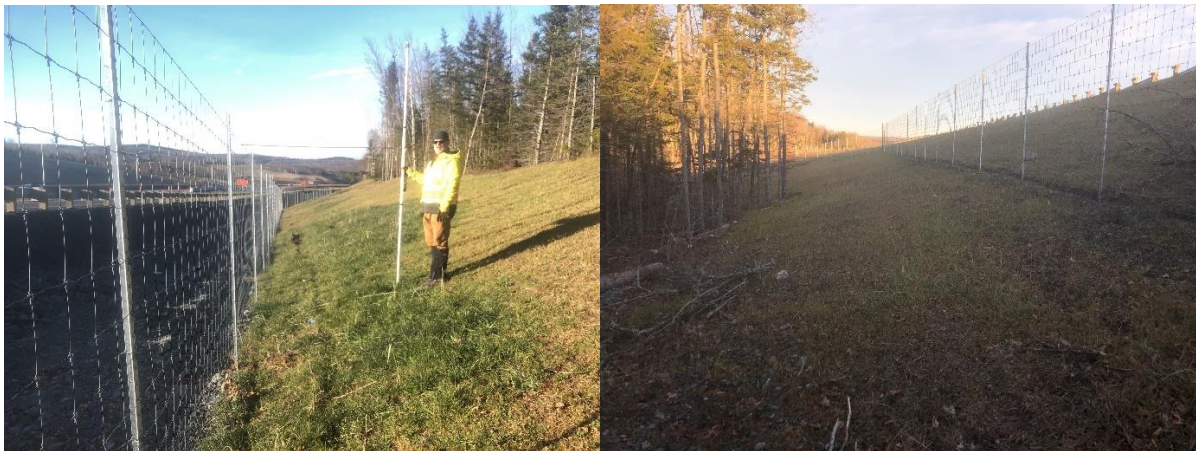
Figure 9: The effective height, as measured 2m away from the fence to accommodate for where a deer is likely to initiate a jump, is considerably less than the actual 2.4m height of fencing when the safe side of the fence is higher than the highway side (image left) while the effective height becomes greater than the actual fence height when the safe side is lower than the highway corridor (image right). Modifications to the fence in the left image will be required to prevent deer from jumping into the highway corridor.

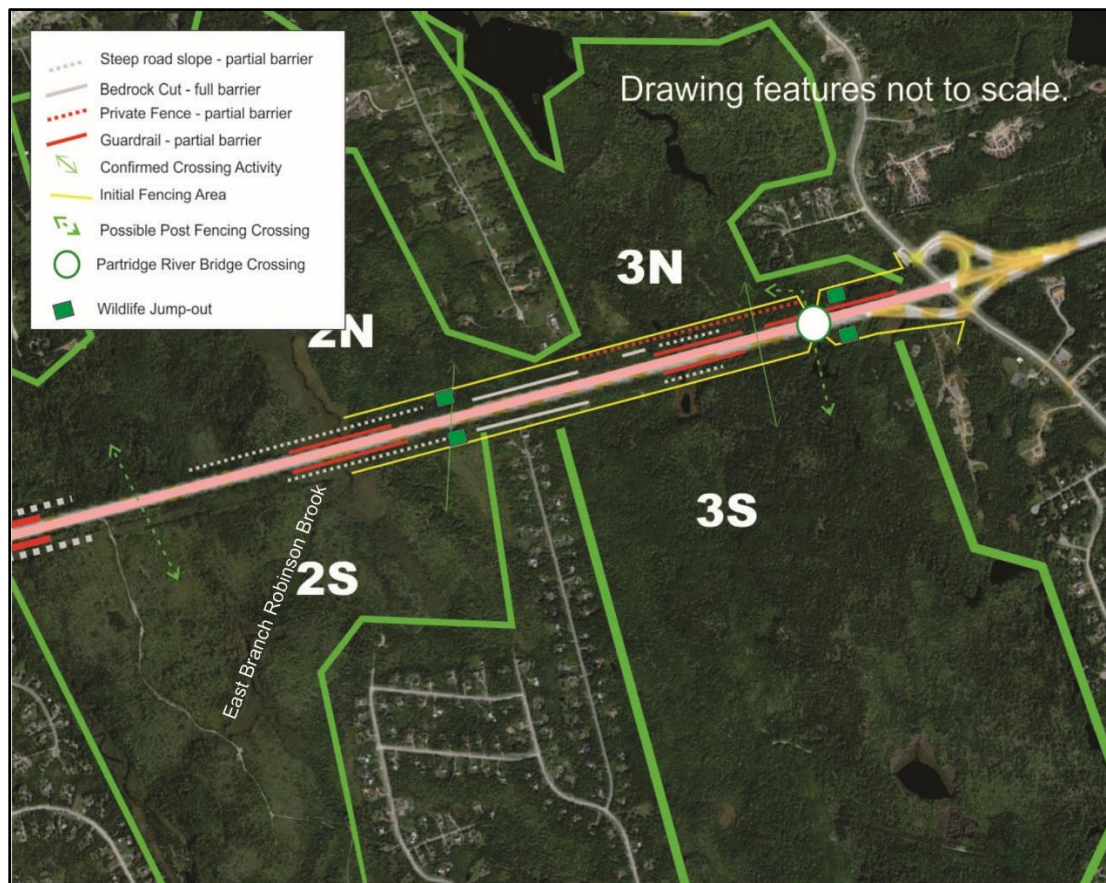
Figure 10: A plan to initiate partial fencing is shown for the east portion of the highway corridor. Fencing ends at potential barriers to animal movement, thereby minimizing fence end effects that could concentrate movement of animals across the highway and increase the risk of collision at the fence ends. Fence installation should follow the construction of a wildlife crossing structure (s) at Partridge River. Note wildlife features are not to scale but represent concept only.

Fencing could be installed from Exit 18 at Mineville westward to a large wetland area and ending at the east branch of Robinson Brook as shown in Figure 10. Fencing must be installed on both the north and south sides of the road at the same time to prevent capture of wildlife within the highway corridor. A concern with implementing a partial fencing plan over a relative short distance is the potential for “fence end effect” where wildlife follow the fence to the end and simply cross the highway at that location. This creates a concentration of wildlife crossing and increased potential for collision with the travelling public. The selection of the fencing segment’s fence end locations considered fence end effect and attempted to mitigate against its adverse effects. The placement also is intended to facilitate a transition period over which all wildlife learn to use alternative passageways at Partridge River, and for smaller nocturnal wildlife the existing culverts within the fenced area under the Highway 107.

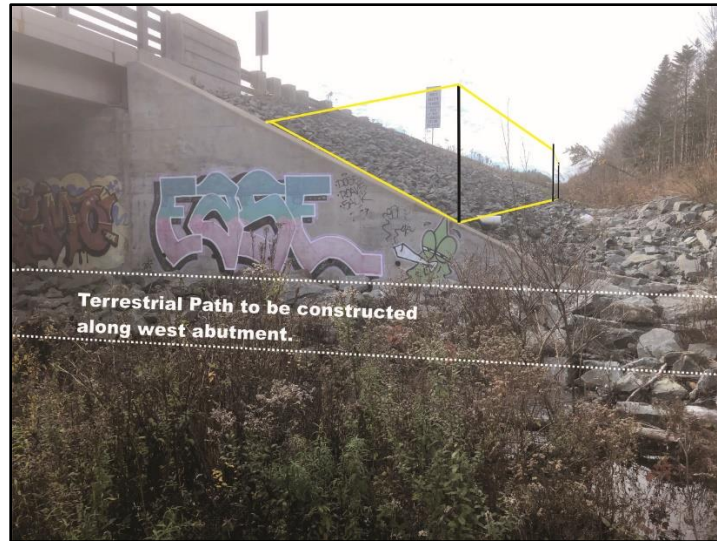
Figure 12: The terrestrial wildlife path location under the west abutment at Partridge River will allow fencing to attach direction to the abutment near the base of the slope. One option is as shown, keeping fence away from winter plow snow “throw zone” near the base of the road prism where effective fence height is easily achieved based on fence alignment.

At the east end, the fencing approaches Mineville Road and it should end at the guardrail along Mineville Road at the two locations (FE1 and FE2) indicated in Figure 15. The road, interchange, and some residential development should partially discourage animals approaching these fence ends. However, to further limit fence end effect at the eastern end, fence end wings ~50m in length should be installed away from the highway crossing and tied into the Mineville Road guardrail. These ends will help diffuse wildlife movement should they approach the end. This segment will also require that the fence be tied into the abutments of the Partridge River Bridge where two terrestrial wildlife crossings are to be retrofitted. Installers must ensure that access to these terrestrial crossings are not impacted by the fencing. An example of how this might be achieved on the east abutment, which has a small mammal terrestrial ledge elevated above the watercourse is shown in Figure 11 and on the west abutment in Figure 12.

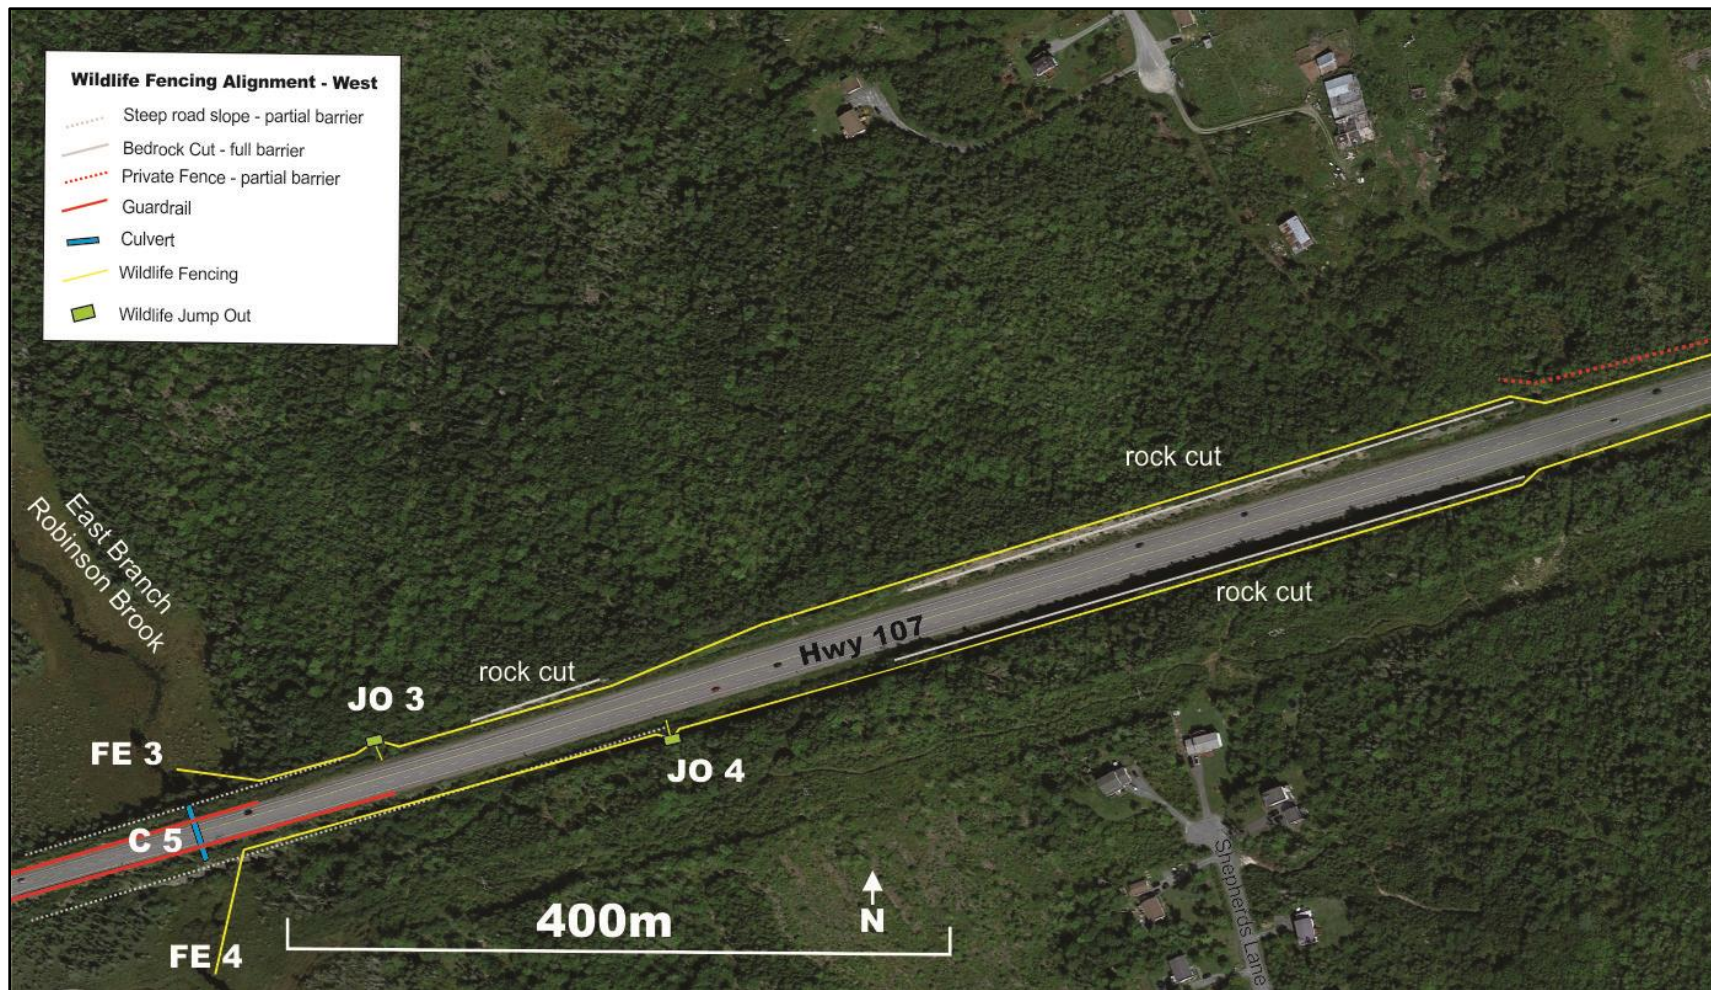
Figure 13: The general fence routing for the western fenced area ends (FE 3 and FE4) at the edge of Robinson Brook. Jump-outs (JO3 and JO4) are to be located near the bottom of the road prism but east of both the guard rail and the steepest segment of fill slope. Fencing can be run either atop the rock cuts north of Shepherds Lane as shown, or could optionally be tied into the wall of the rock cuts to omit the need for fencing through the rock cut as long as no gaps exist in the connection.

The west end (FE3 and FE4) of the proposed fence line must reach the very edge of the watercourse (east branch of Robinson Brook) at the locations shown within the large wetland Figure 13. FE 3 is located approximately 30m from the road edge and FE 4 approximately 70m. The placement of fence ends at these locations is also adjacent to a high and steep road fill prism that is topped with a guardrail. Should animals attempt to move to the west of these fence ends the fill slope, guardrail and watercourse all present obstacles that would serve to diffuse movement and limit the potential of concentrated wildlife

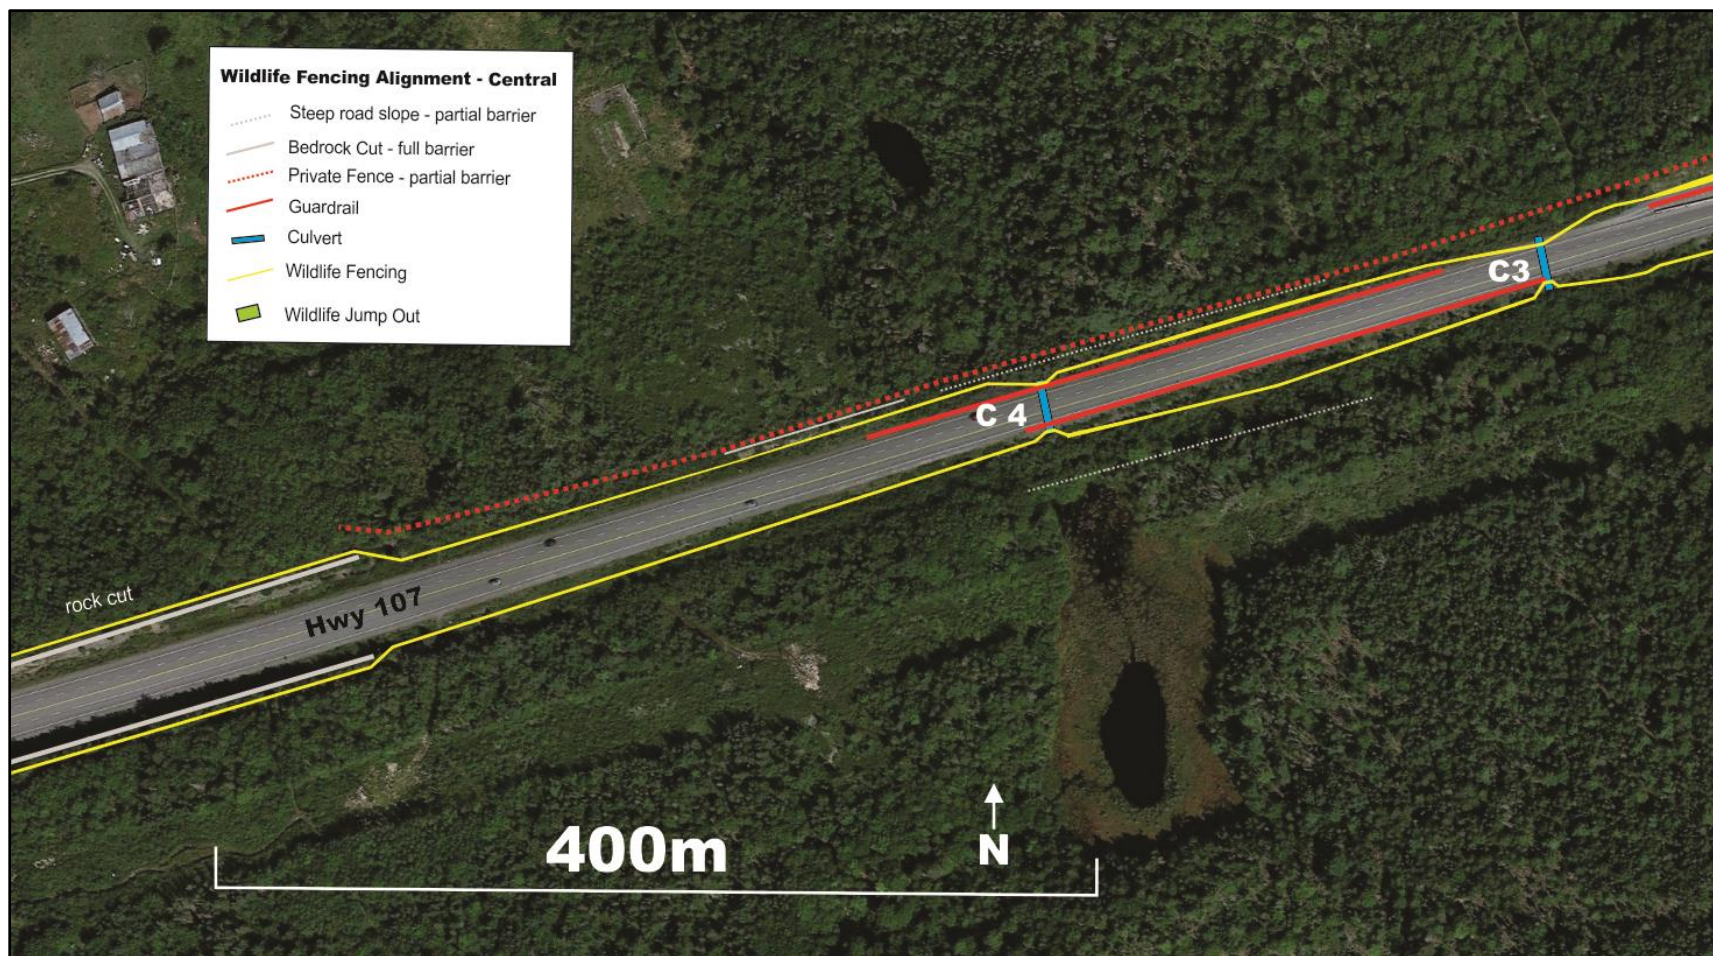
Figure 14: In the central portion of the proposed fenced area the fence will be aligned to meet installation requirements described in this document. These requirements include carrying the fence over the head of the culverts at locations C3 and C4 so that small/medium mammals might use the culverts to pass underneath Highway 107.

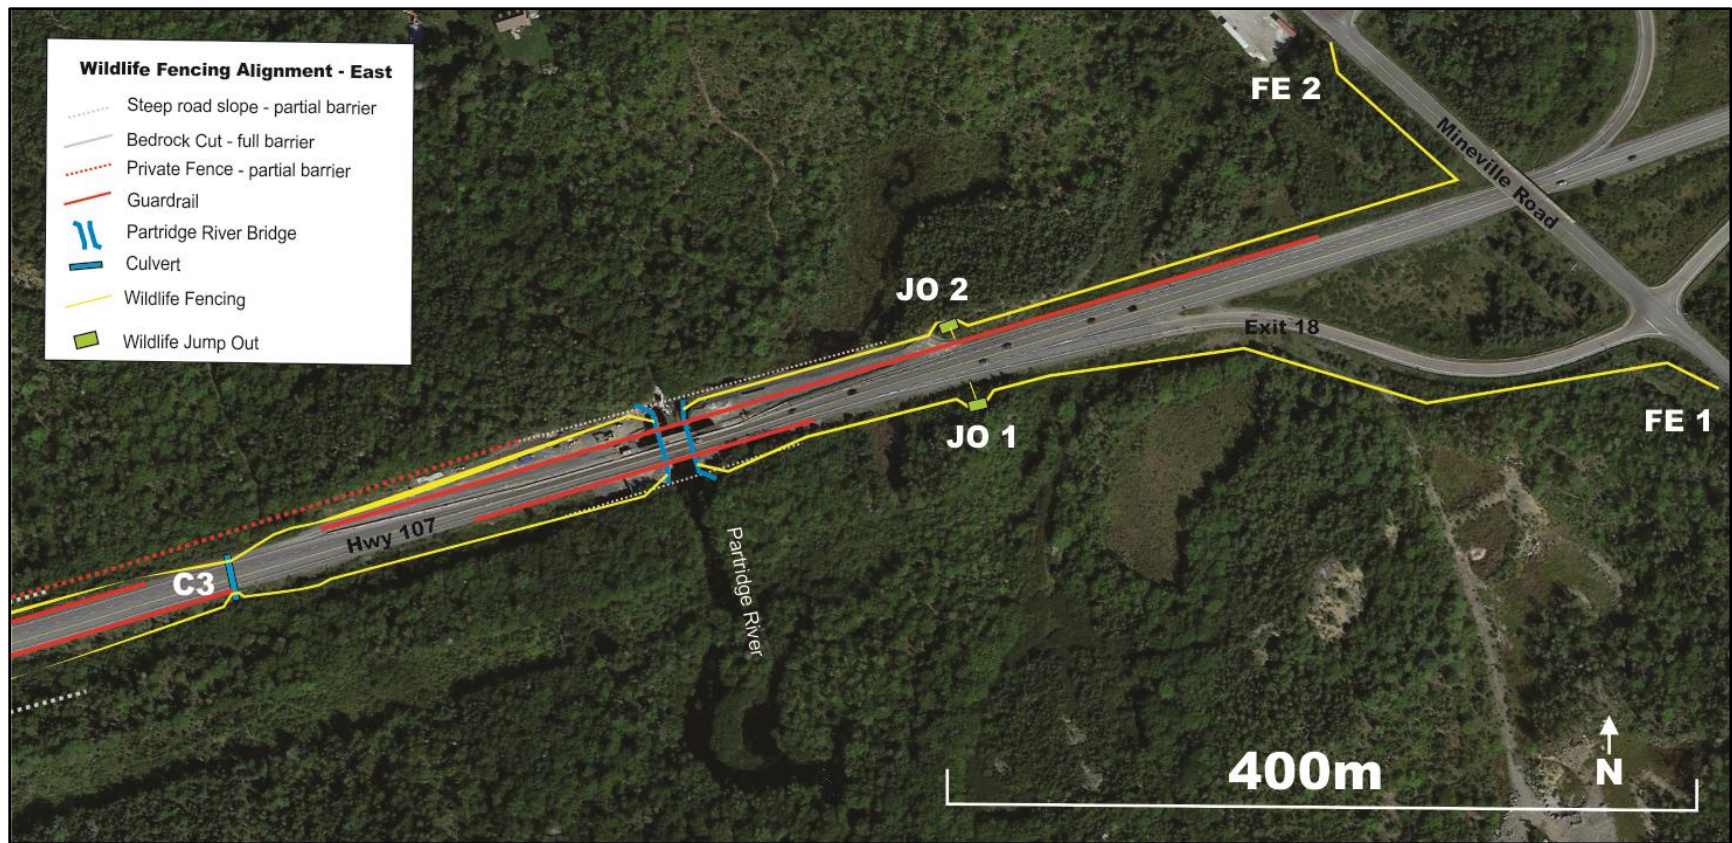
Figure 15: The west end of the proposed fencing ties into the bridge abutments at Partridge River and incorporates two Jump-outs and two fence ends. Terrestrial wildlife crossings are to be retrofitted under the Partridge River Bridge. Fence ends should end at the shoulder of the Mineville Road at the locations shown to limit the potential for fence end effect.

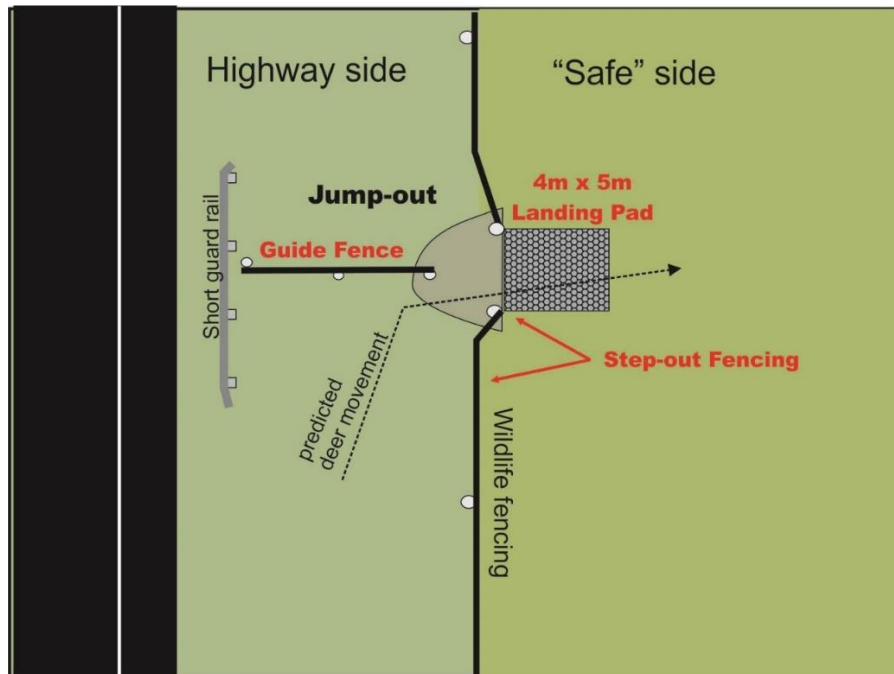
Figure 16: This schematic shows a typical Jump-out structure. A short section of guide fence run perpendicular to the highway helps direct wildlife toward the jump-out.

A jump-out must be 1.5-1.7m in height, have a retaining wall smooth surface that would be difficult for wildlife to climb, and have a landing pad area of at least 4m x 5m on the safe side of the jump-out. The landing pad is to be created by laying 20cm+ of washed pea gravel over a heavy landscape fabric. A section of guide fence run perpendicular to the highway from the edge of the road to within ~2m of the top of the jump-out is required to help direct approaching wildlife to the safe side of the jump-out. Similarly, a short step out section of fencing is required to improve use of the jump-out. These jump-out requirements are shown in Figures 16 and 17.

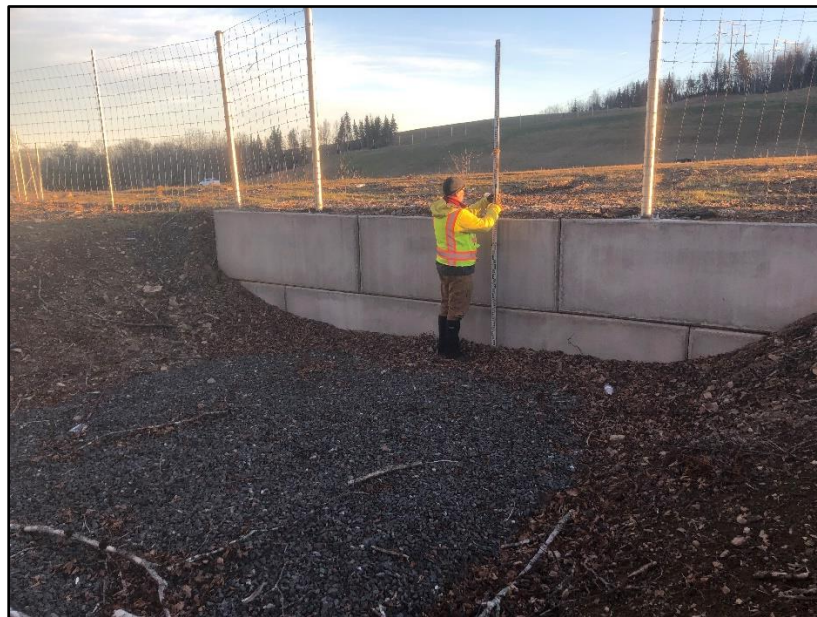
Figure 17: A jump-out should be 1.5-1.7m in height, have a smooth surface that would be difficult for wildlife to climb, and have a landing pad area of at least 4m x 5m created by laying 20cm+ of washed pea gravel over a heavy landscape fabric. A section of guide fence run perpendicular to the highway from the edge of the road to within 2m of the top of the jump out is missing from this structure that was still under construction at the time of capturing the photo.

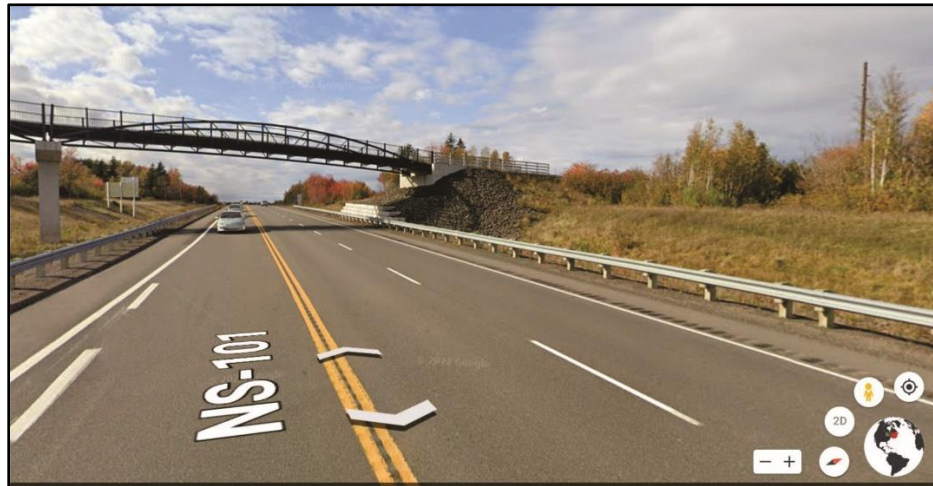
Figure 18: As shown in this Google Earth image, a structure similar to the light overpass crossing for OHV's west of Exit 26 on the Hwy 101 could form the basis of a wildlife overpass at CR4 on Highway 107. A natural substrate trial surface and side panels to obscure traffic movement would need to be incorporated into the final design.
