# JLT Sport Game Day Checklist

## Case Study

WILLIAMS V LA TROBE COUNCIL & ORS (2007)

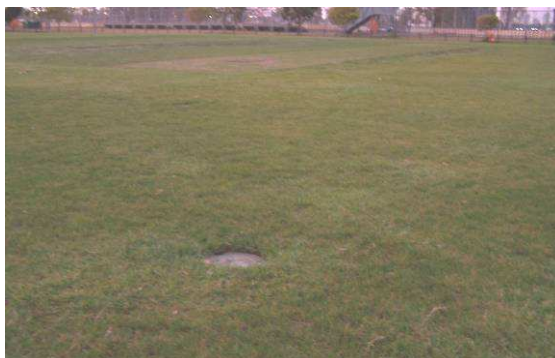
The picture above is an example of a sprinkler cover.  
This picture does not reflect the actual cover or conditions referred to in this case study.
