# Leckhampstead Section 19 Flood Investigation

## Technical Report

January 2024

Buckinghamshire  
Council

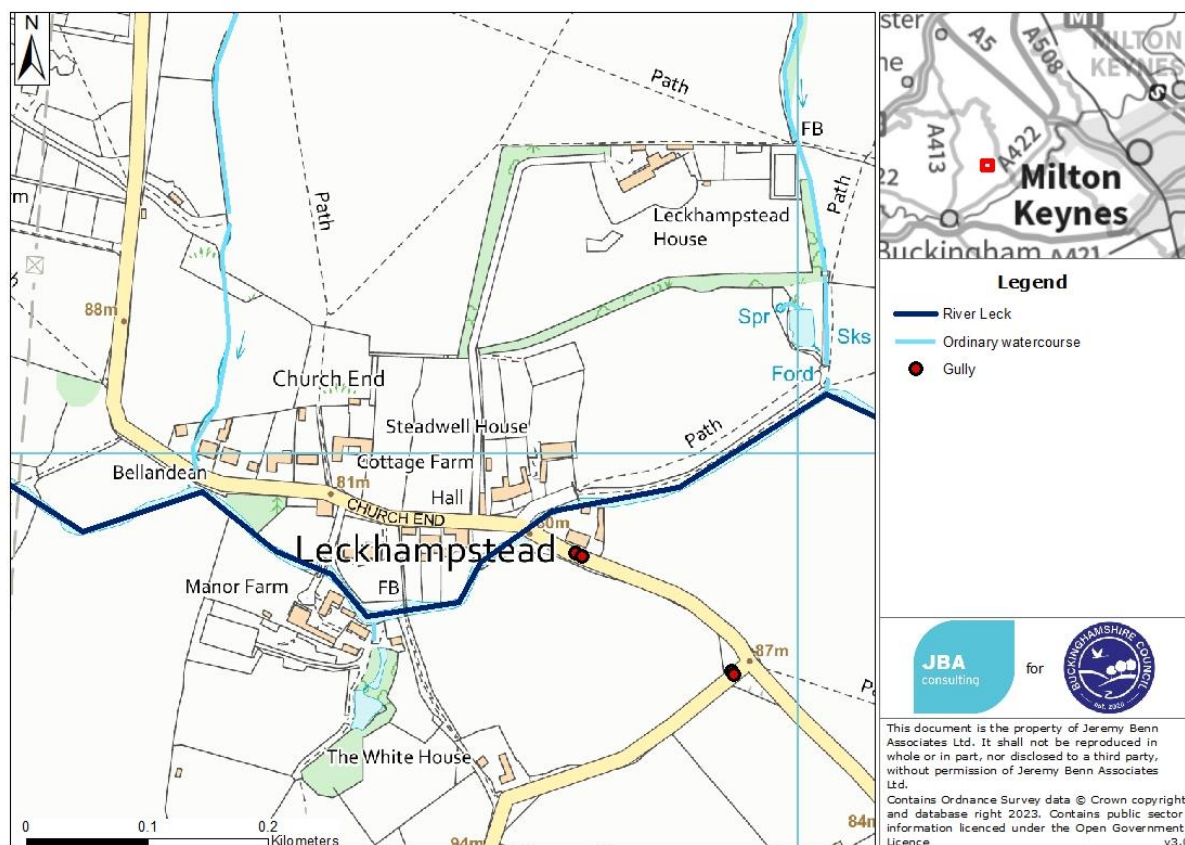
**Figure 3-2: Buckinghamshire Highways assets in Leckhampstead Church End**

Buckinghamshire Highways, who are responsible for highways and highway drainage across Buckinghamshire, have very few assets in the area of Leckhampstead. There are two gullies situated to the east of Church End, south of where the River Leck crosses underneath the road and slightly elevated from the bridge. Due to their location we

assume that they discharge into the river. Figure 3-2 shows the highways assets in the area of Church End<sup>4</sup>.

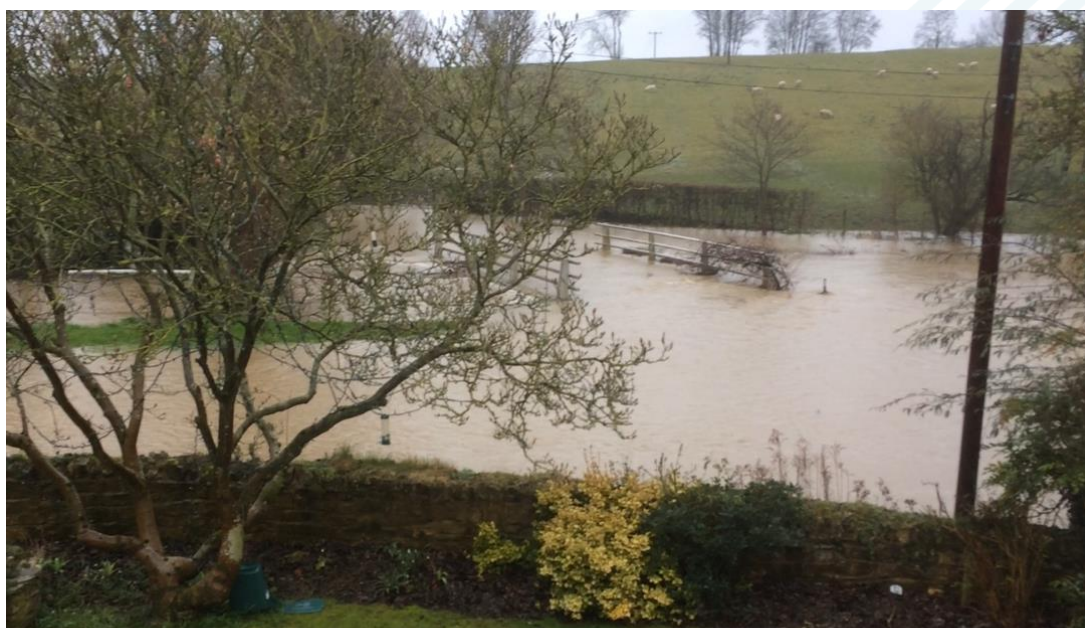
As well as through residents' gardens, the out-of-bank flow was channelled down Church End as described by residents as a 'secondary river'. At the upstream end of Church End (**1**) the water was described as being halfway up the fence, downstream the water running along the road was reportedly 75cm deep at the front of the properties (**5**), and was above the railing at the bridge(**6**), depicted in the resident photograph below.

**Figure 8-2 Floodwaters at Church End bridge (photo credit Tobin Jones)**

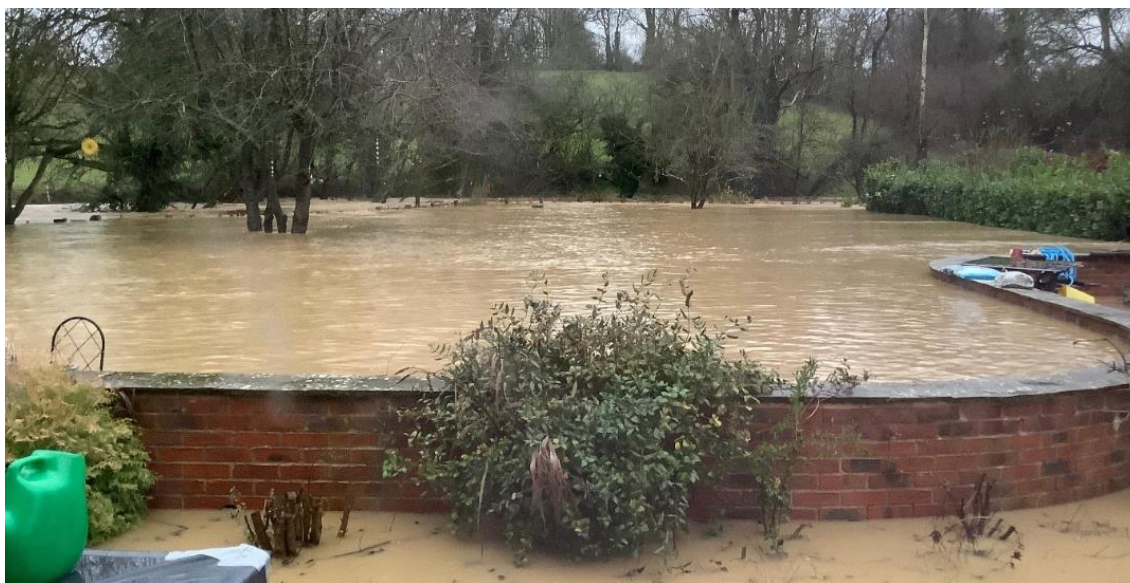
- Along Church End, overflow from the River Leck combined with surface water runoff from the fields to the north to create a secondary flow path which encroached on to the front of the adjacent properties (2).
- The rear gardens of Church End south conveyed the out of bank rising river levels to create a wide stretch of water, which in places reached the rear of the adjoining properties (3)(5) (Figure 8-3).

**Figure 8-3: Retaining wall at location 5, looking towards the River Leck. In normal conditions, the river is confined to the far end of the garden near the hedgerow. (photo credit Yvonne Gurney)**

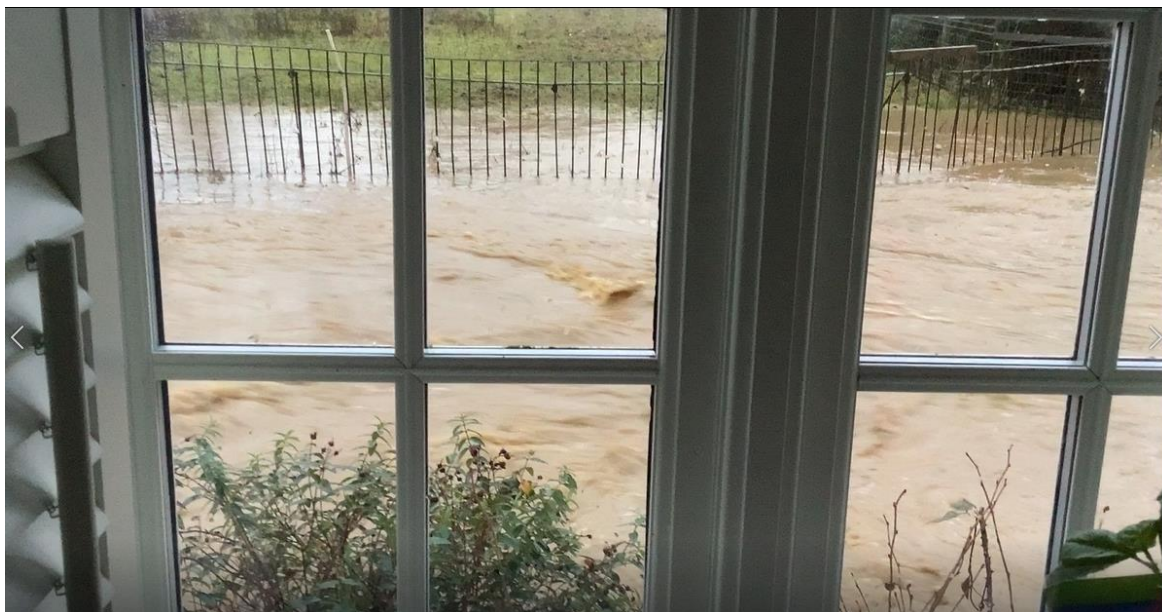
Roads in to and out of the village became impassable from 14:00 until late evening. This was due to the deep, fast flowing nature of the flood water on the main access route. The flooding meant that during the December 2020 event emergency services were unable to reach the village. Residents note that this is a regular occurrence, with access to the village cut off approximately four or five times per year due to water overtopping the bridge.

**Figure 8-4: Water flowing fast down Church End at 16:30 on 23 December 2020**  
(photo credit: Yvonne Gurney)
