## Sliplining Helps Restore Aging Sewer Lines

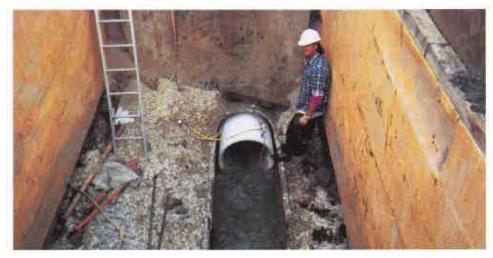
The old pipe is broken away in an entry pit so the liner can be slid into place.

Because work took place during Baton Rouge's dry season, no dewatering was necessary. With trench protection in place, workers entered the pit and removed the top of the old pipe using sledgehammers and jackhammers. Cleaning buckets were pulled through the
