Town of Winchester

Aquatic Plant Point Intercept Report: Rainbow and Tamarack Lake

July and August 2024

Prepared By: North Lakeland Discovery Center

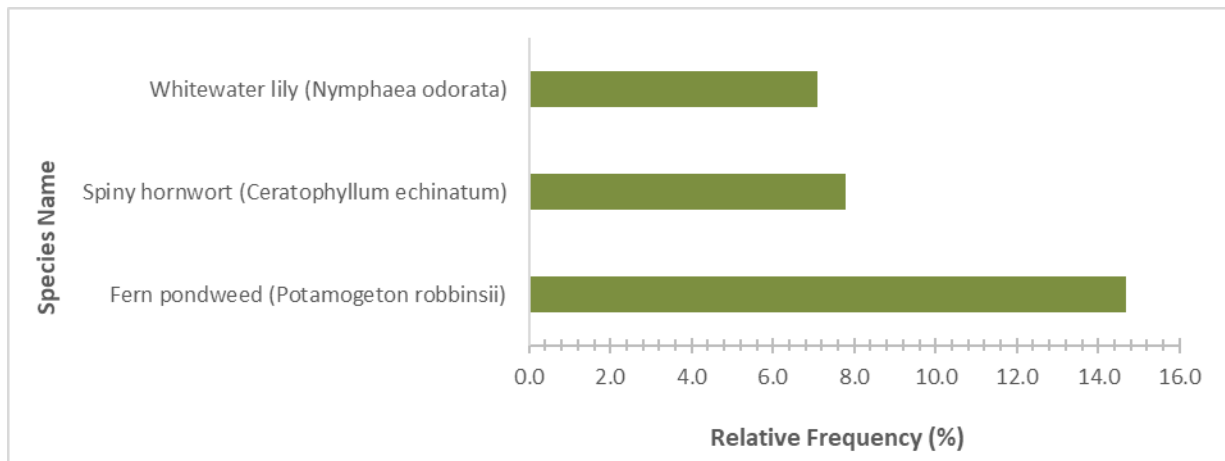
Figure 1: Rainbow Lake 2024 relative frequency (%) of occurrence of aquatic plant species collected in rake during the 2024 point-intercept survey.

The three most relatively frequent plants on Rainbow Lake are fern pondweed (*Potamogeton robbinsii*), spiny hornwort (*Ceratophyllum echinatum*), and white water lily (*Nymphaea odorata*). Fern Pondweed had a relative frequency of 45.27% and its distribution is shown on Map 2.. Spiny Hornwort had a relative frequency of 23.88% and its distribution is shown on Map 3. White water lily had a relative frequency of 21.89% and its distribution is shown on Map 4.

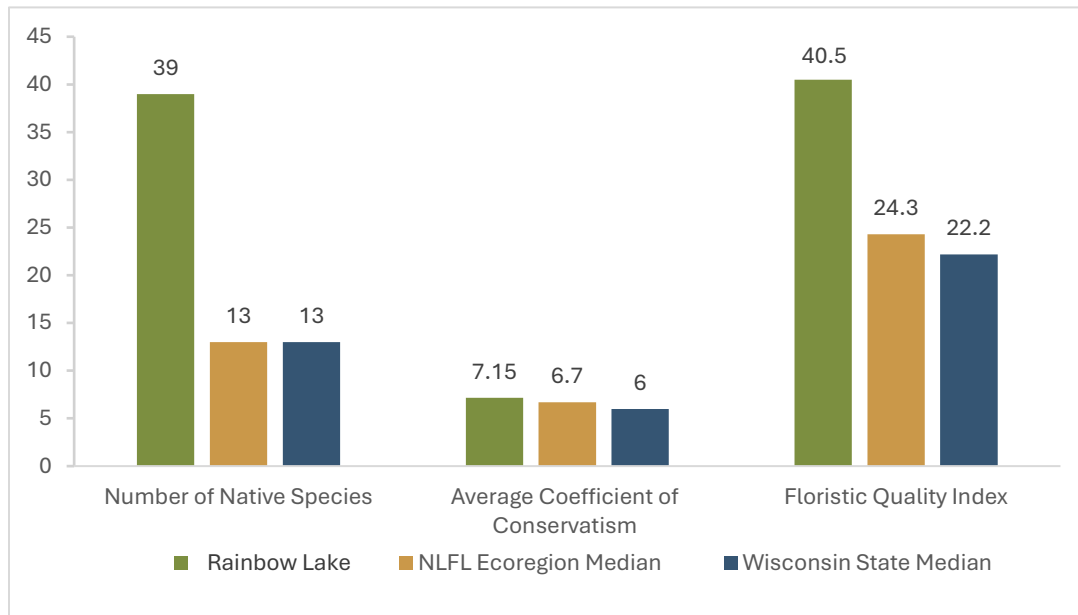
Figure 2: Floristic Quality Assessment of Rainbow Lake using data from 2024-point intercept survey. Analysis follows Nichols (1999).

Analysis of the data collected from the plant point-intercept survey conducted on Rainbow Lake indicates that it contains a relatively healthy plant community, and no aquatic invasive species were detected. Rainbow Lake's floristic quality index value of 40.5 is higher than the state and regional means. Rainbow Lake also has a conservatism value of 7.15 out of 10. These values indicate a high florist integrity and a lower sensitivity to changes in the proportion and distribution of vegetation. Tamarack Lake's floristic quality index value of 35.4 is higher than the state and regional means. Tamarack Lake also has a conservatism value of 7.5 out of 10. These values indicate a higher florist integrity and a lower sensitivity to changes in the proportion and distribution of vegetation. It is important to note that the FQI can be impacted by both the size and the heterogeneity of the lake (Bernthal 2003).

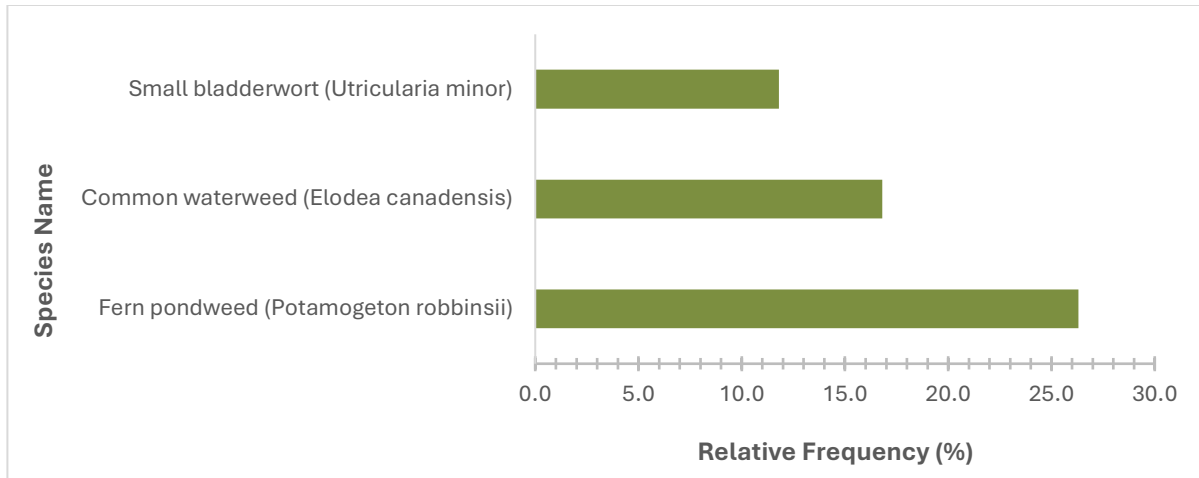
Figure 3: Tamarack Lake 2024 relative frequency (%) of occurrence of aquatic plant species collected in rake during the 2024 point-intercept survey.

The three most relatively frequent plants on Tamarack were fern pondweed (*Potamogeton robbinsii*), common waterweed (*Elodea canadensis*), and small bladderwort (*Utricularia minor*).

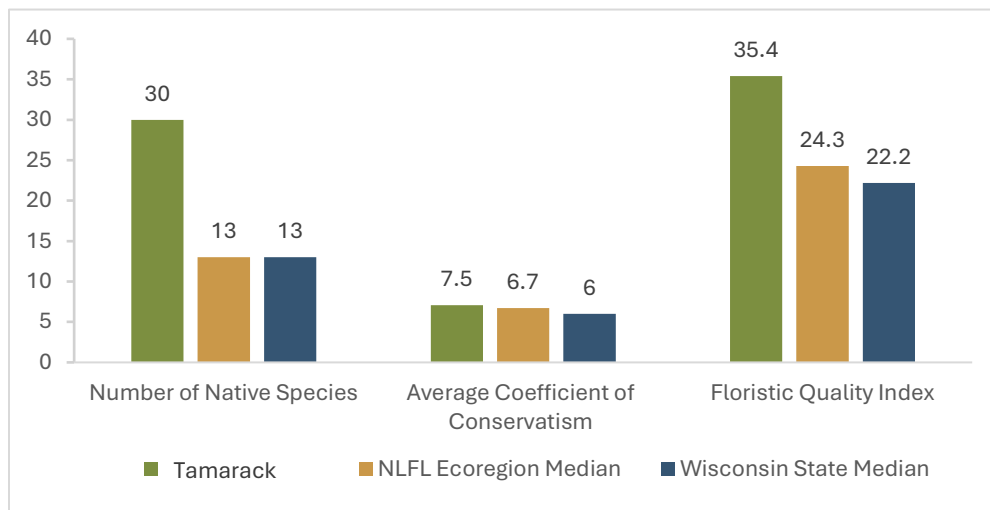
Figure 4: Floristic Quality Assessment of Tamarack Lake using data from 2024-point intercept survey. Analysis follows Nichols (1999).
