Broken Head Quarry

Enforceable Undertaking Progress Report

Report #21 – September 2024

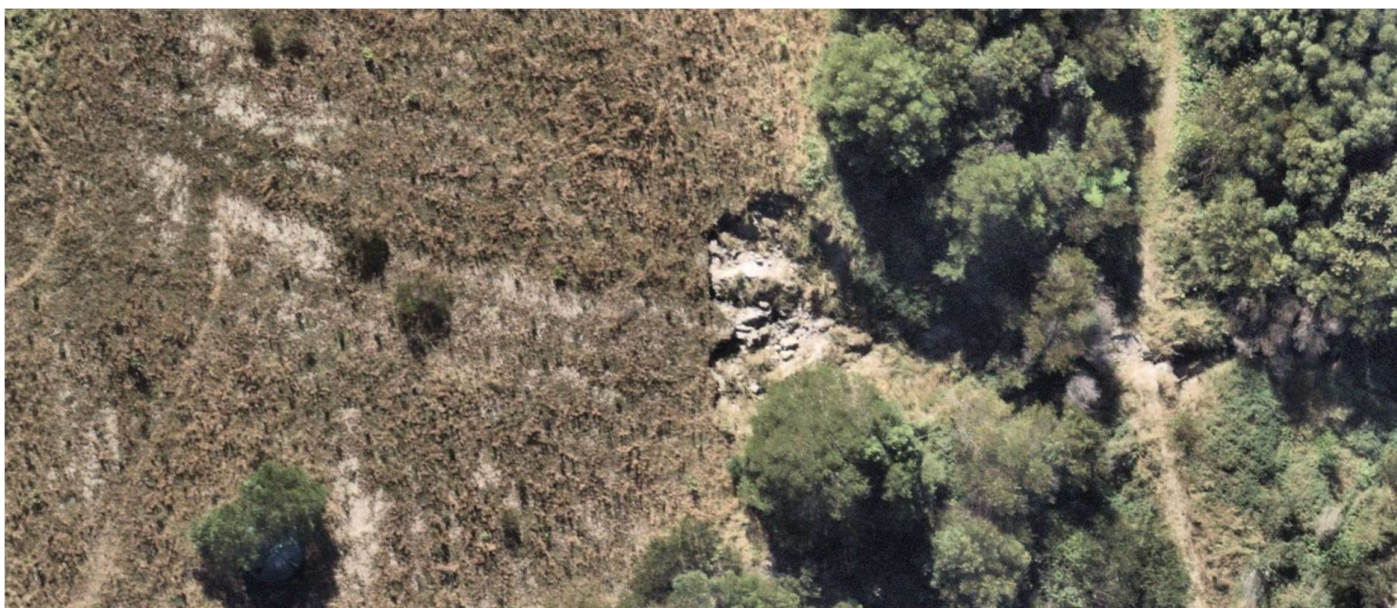
Figure 3 – Landslip Area (source – Nearmaps 14 May 2024)

In addition to photo 4 of the GeoLINK September 23 Report, the below aerial photo shows the landslip area in better detail:

On a close inspection with my earthworks contractor the beginning of the year, the landslip issue was worse than the area affected by the actual landslip, as follows:

- it was clear that the battered slope above the road was unstable along the road alignment north of the landslide area, with a series of small slips and cracks appearing and toppling vegetation. To avoid a recurrence of the landslide, in addition to repair of the landslide area to create a more stable batter and drainage watercourse, the entire upper slope above the road north of the landslide location required to be reshaped consistent with the reshaping on the landslide area.

- repair, reshaping and fill of the original landslide area, with a batter gradient of 1:3;
- repair of road and installation of a culvert under to manage the water in the new drain, cut, form and rockfill road edge drain leading to new drainage pit feeding new culvert;

- trapezoid drain, geofab lined and rock filled to manage runoff that caused the original landslide, down to a new drainage pit feeding new culvert;
- repair, reshaping and fill of the batters adjacent to the original landslide area to replicate the batter gradient and direct surface water to the head of the new drain;

- removal of landslide debris, repair, reshaping and reducing batter gradients downside of road, including to improve geotechnical stability of road;
- trapezoid drain, geofab lined and rock filled to manage runoff from culvert to existing northwest detention basin;

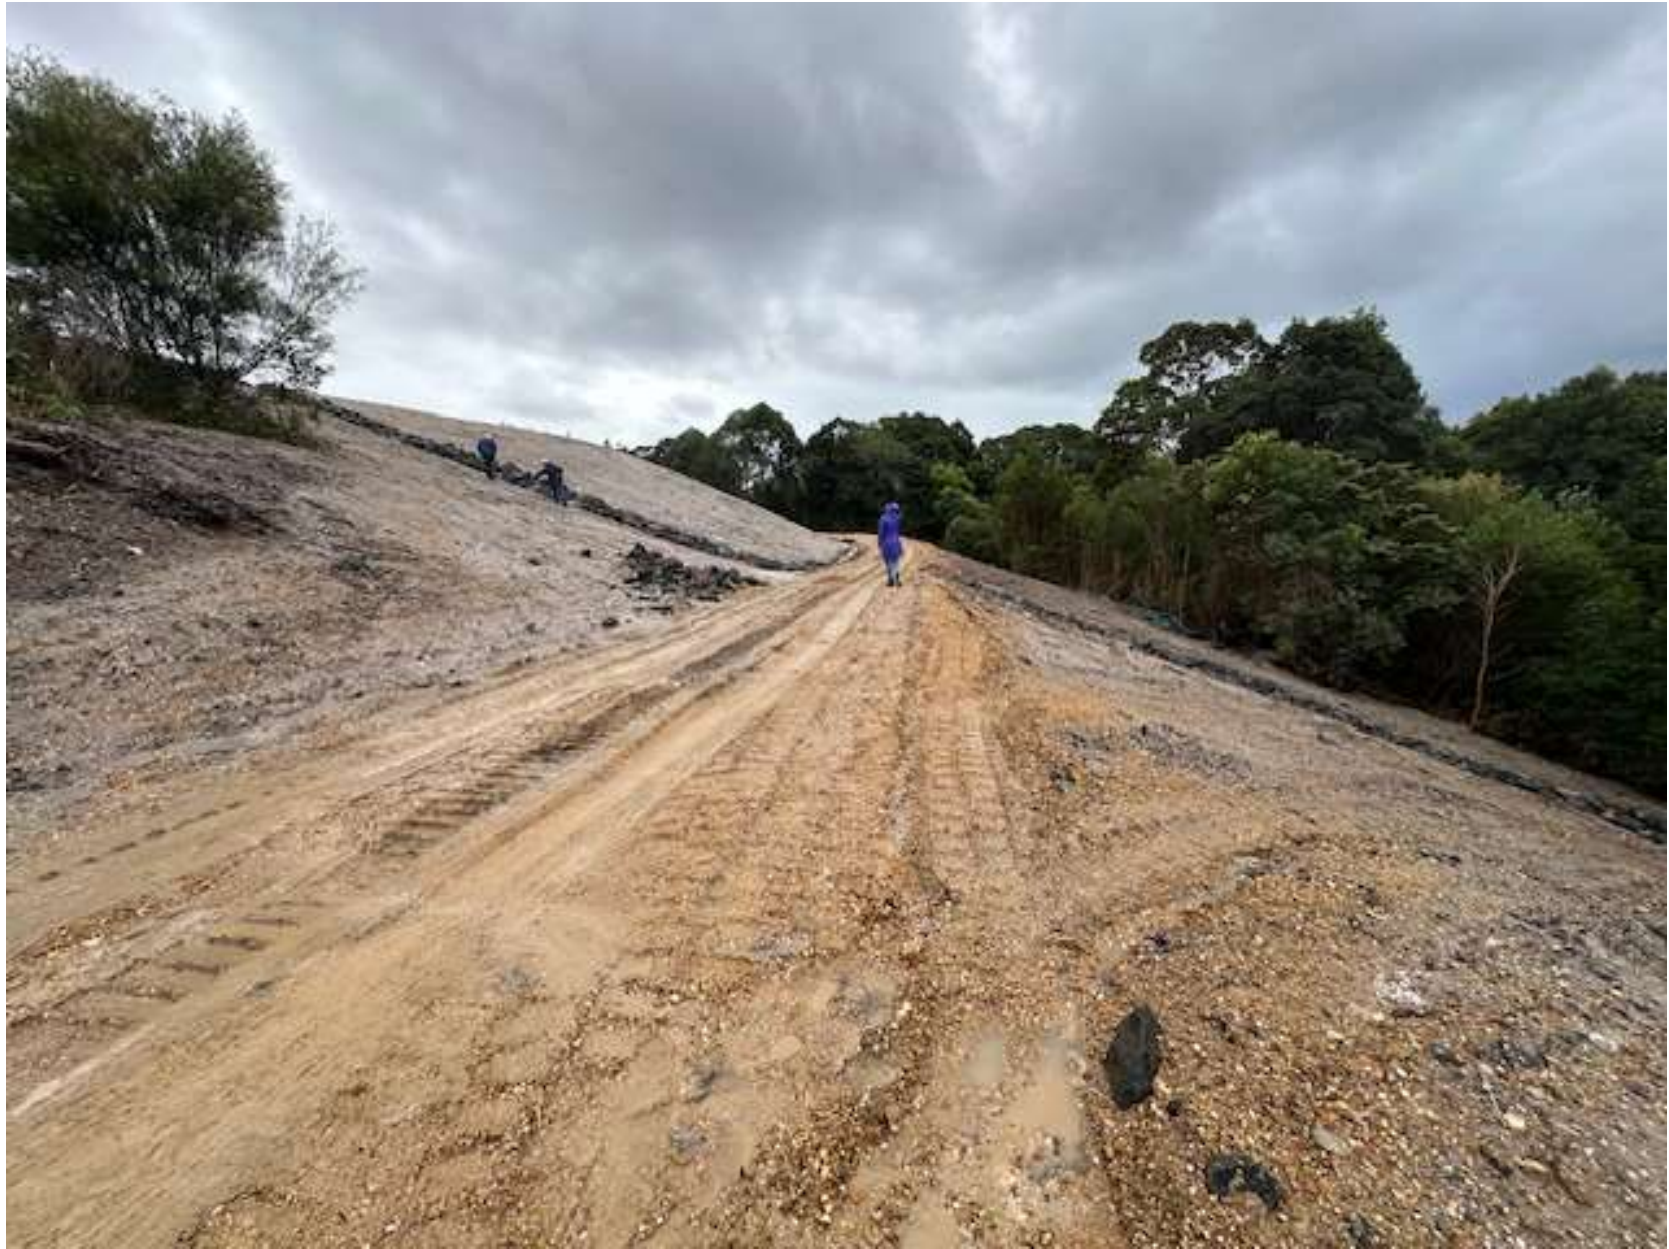
Picture 1 – original landslip location

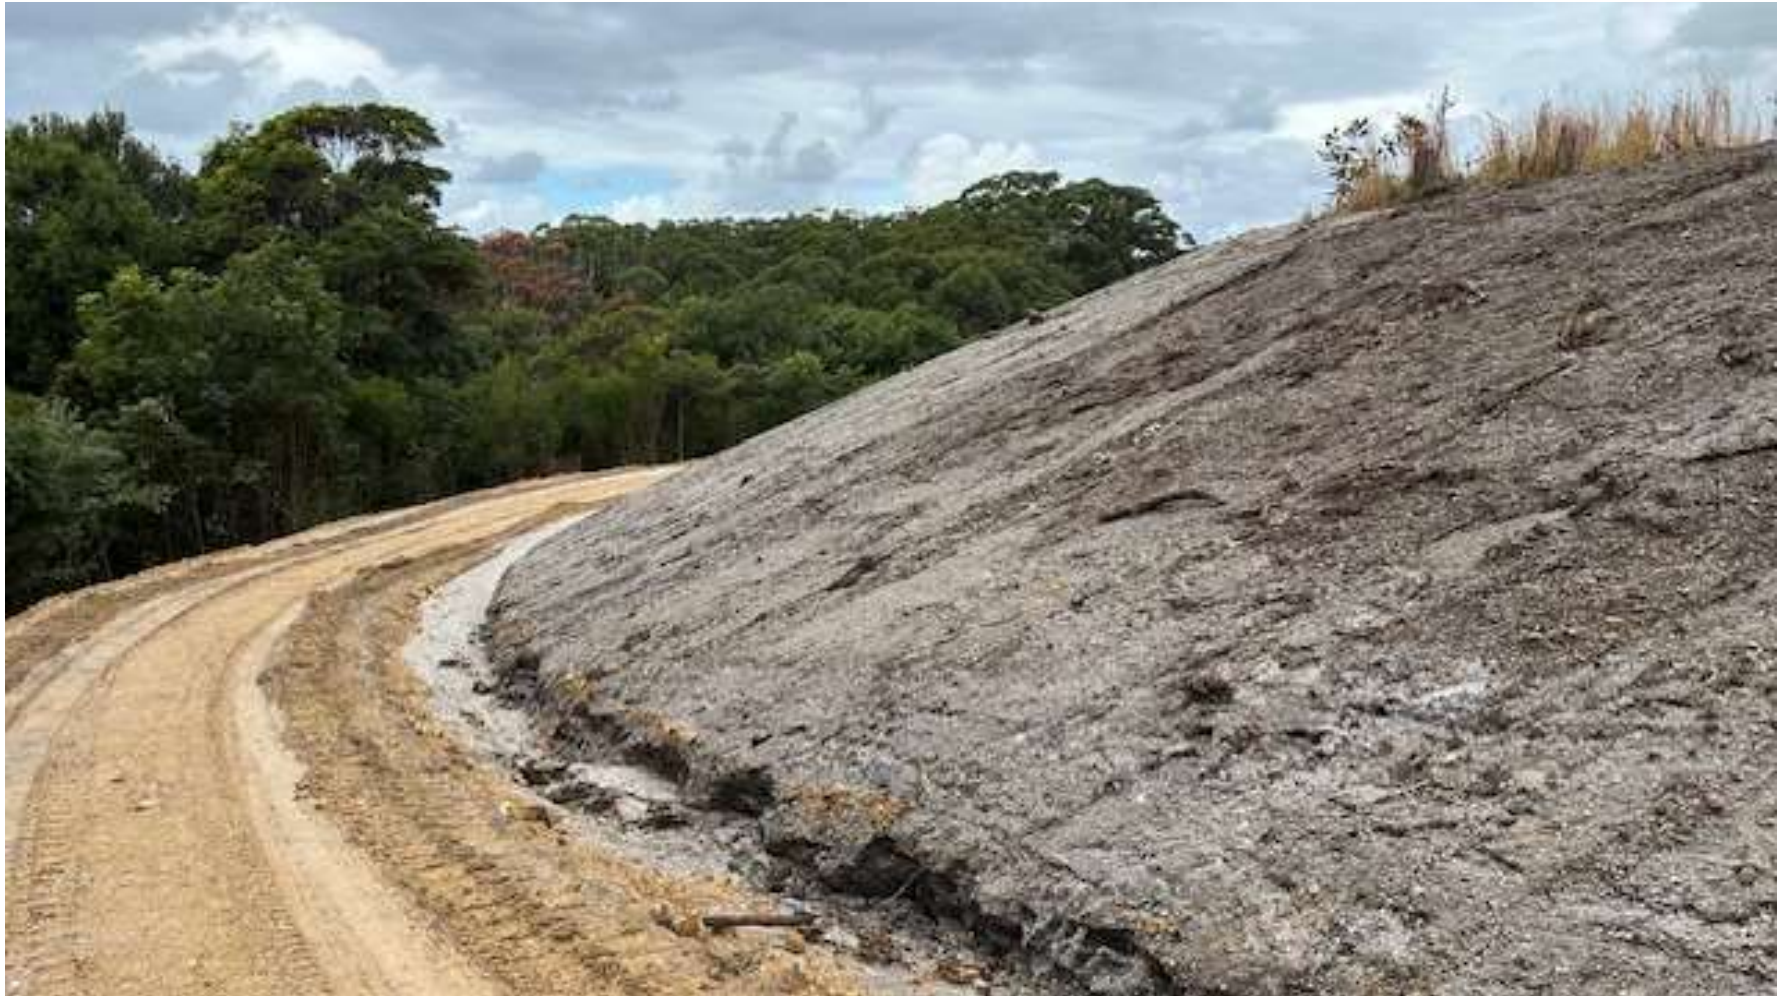
Picture 2 – extended batter remediation uphill of landslip, road edge drain

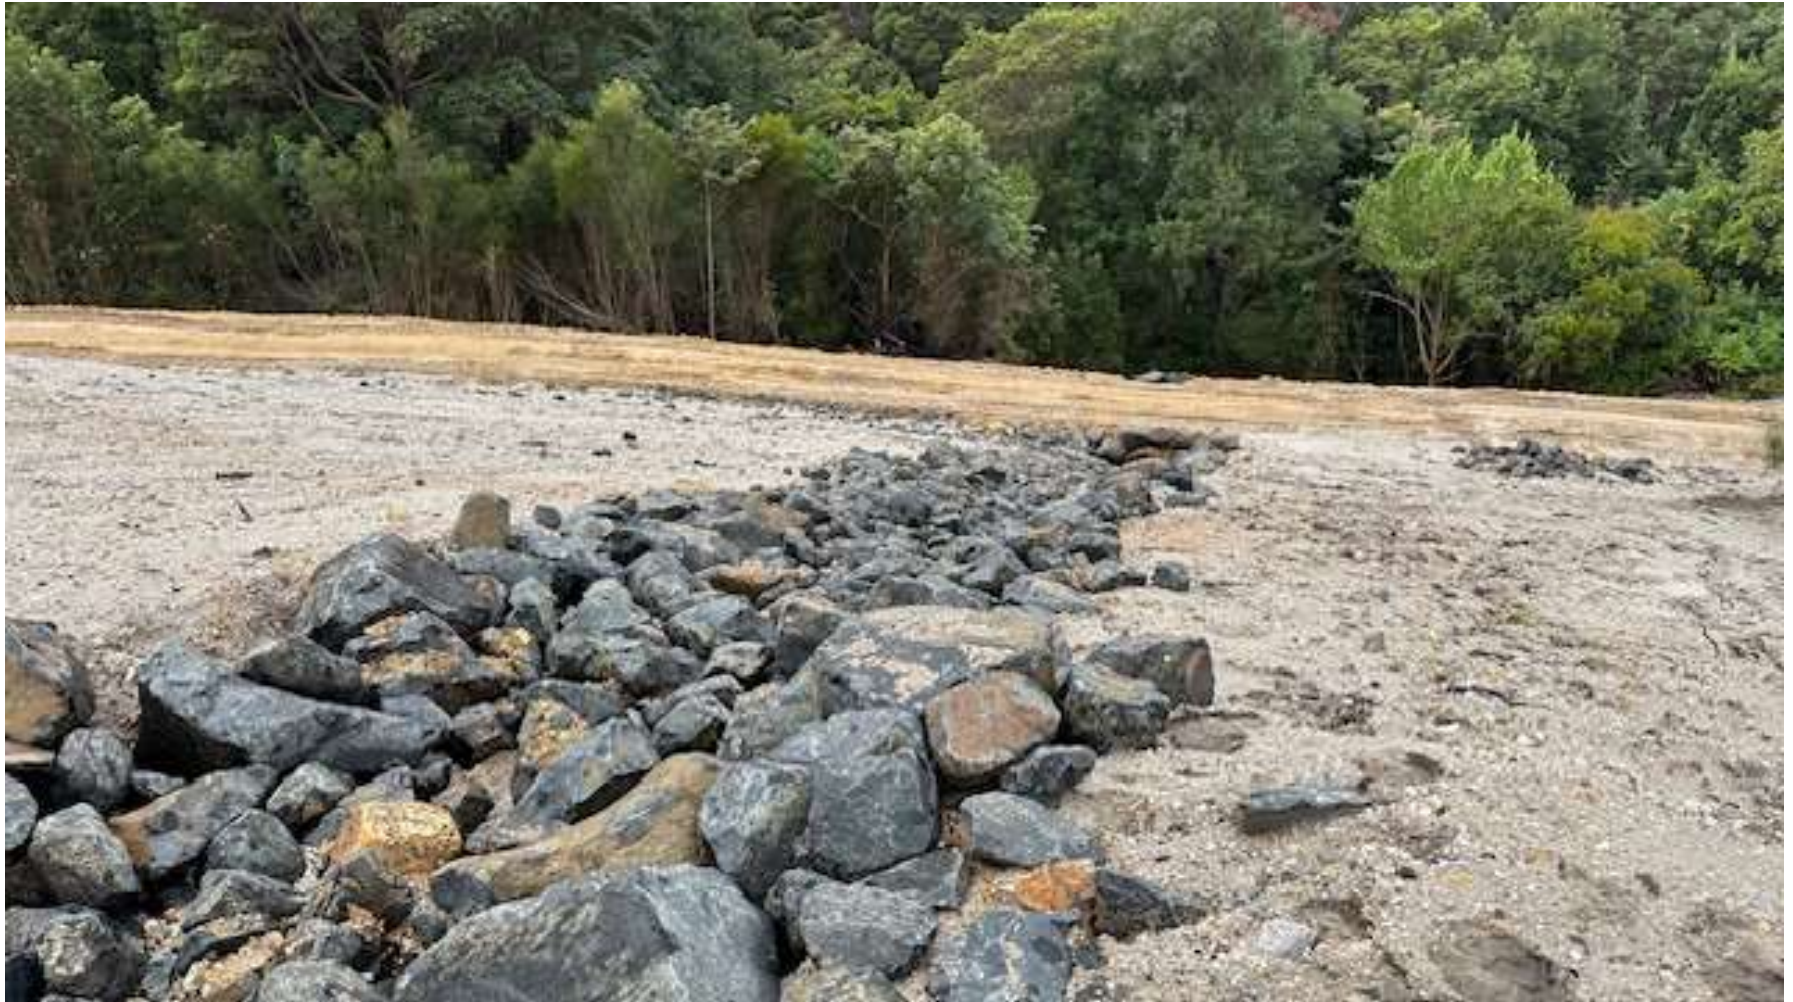
Picture 3 – new drain to road

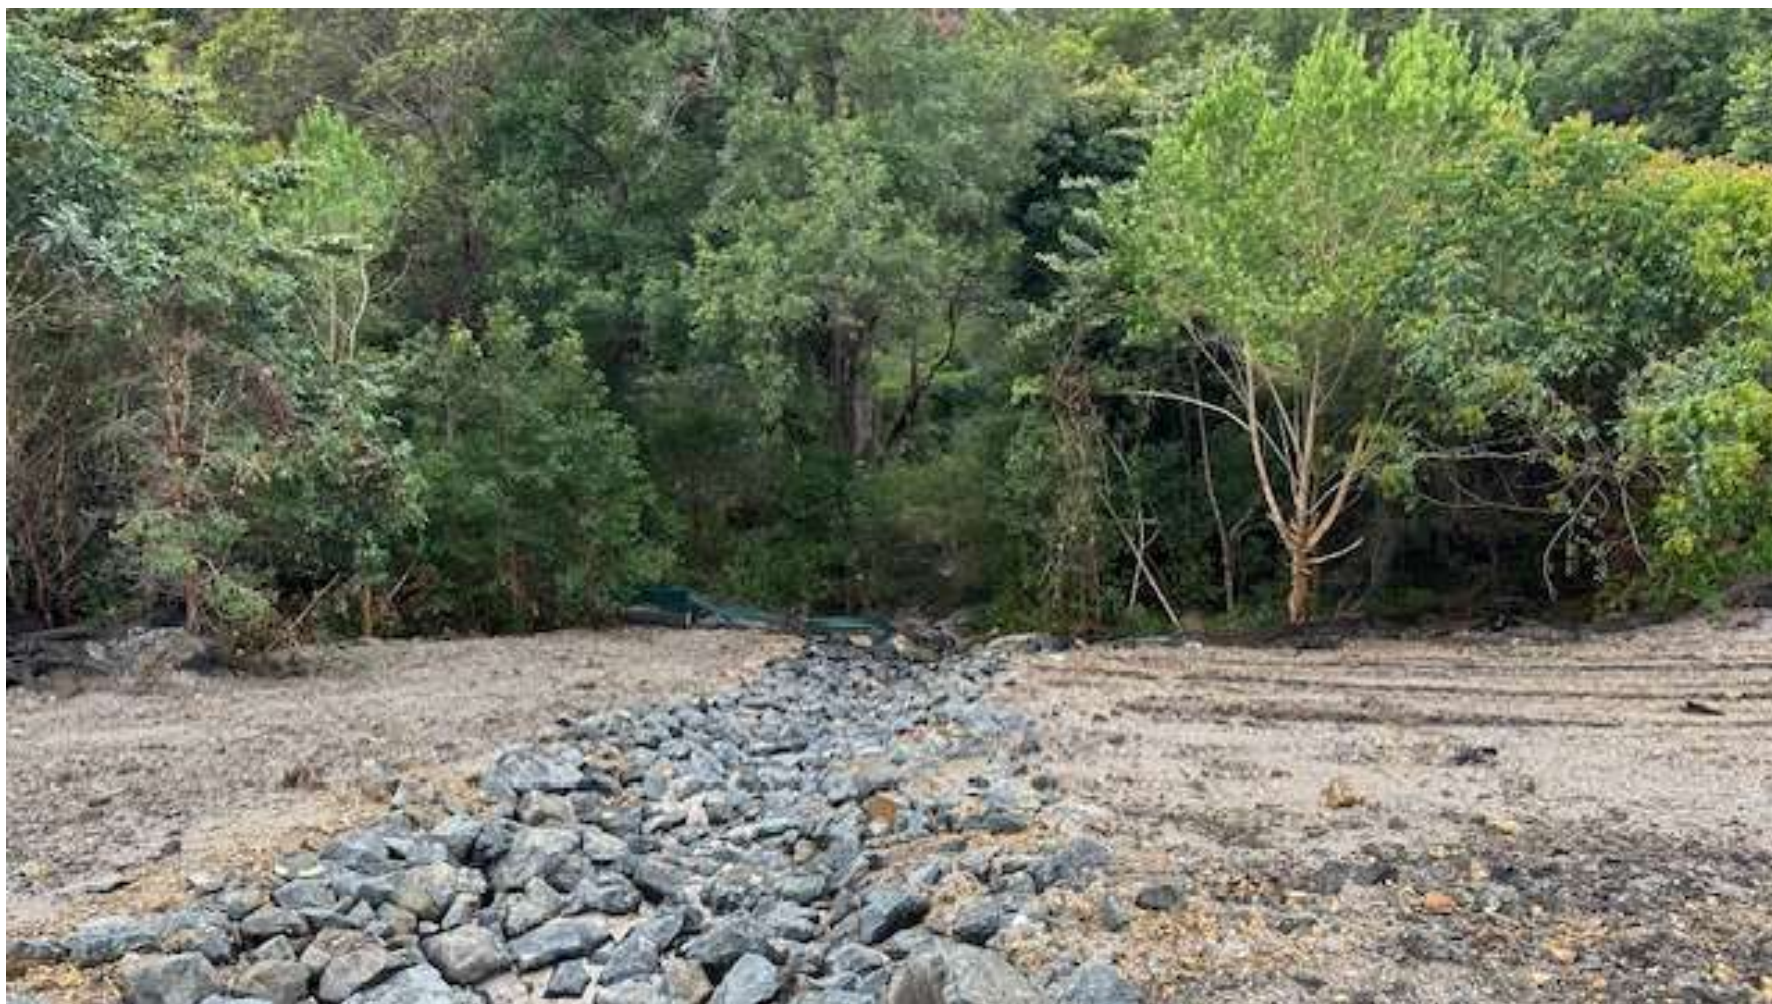
Picture 4 – new drain from culvert to detention basin

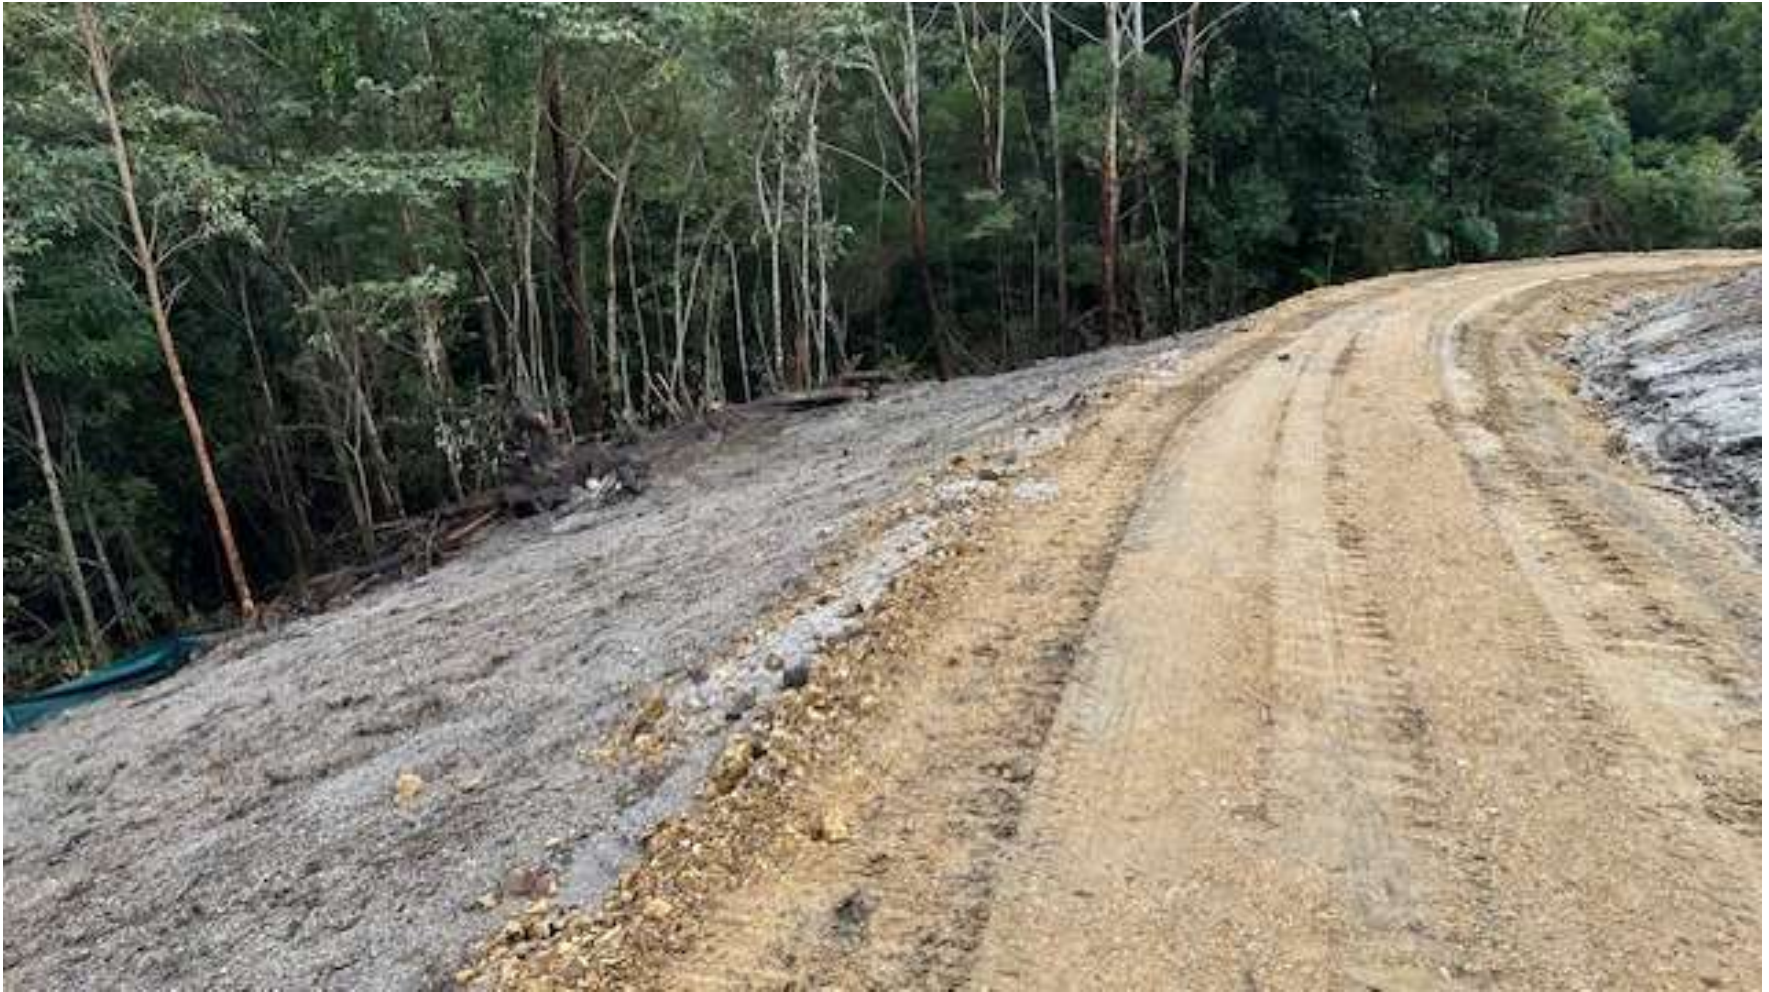
Picture 5 – reformed batter below road

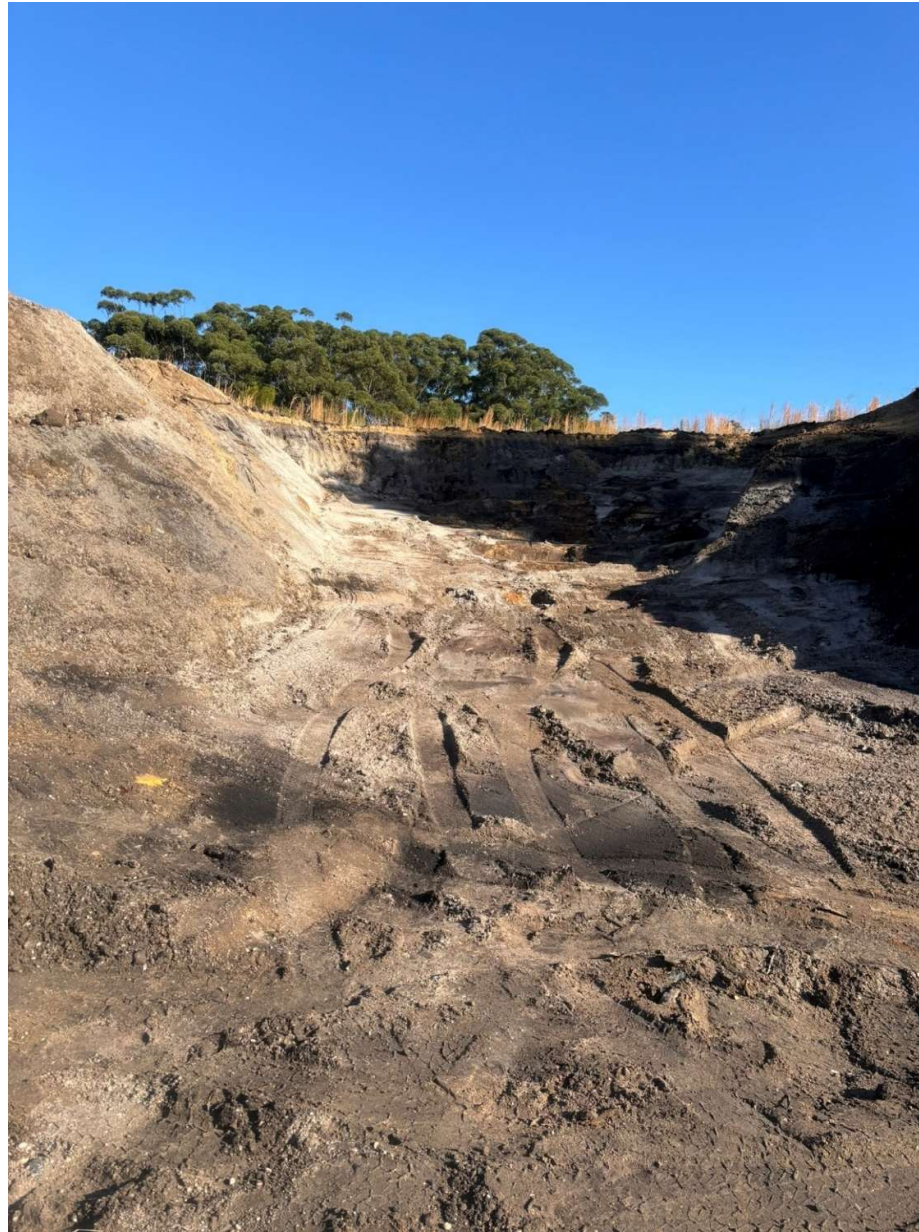
Picture 6 – original landslide location after vegetation clearance prior to reforming batter

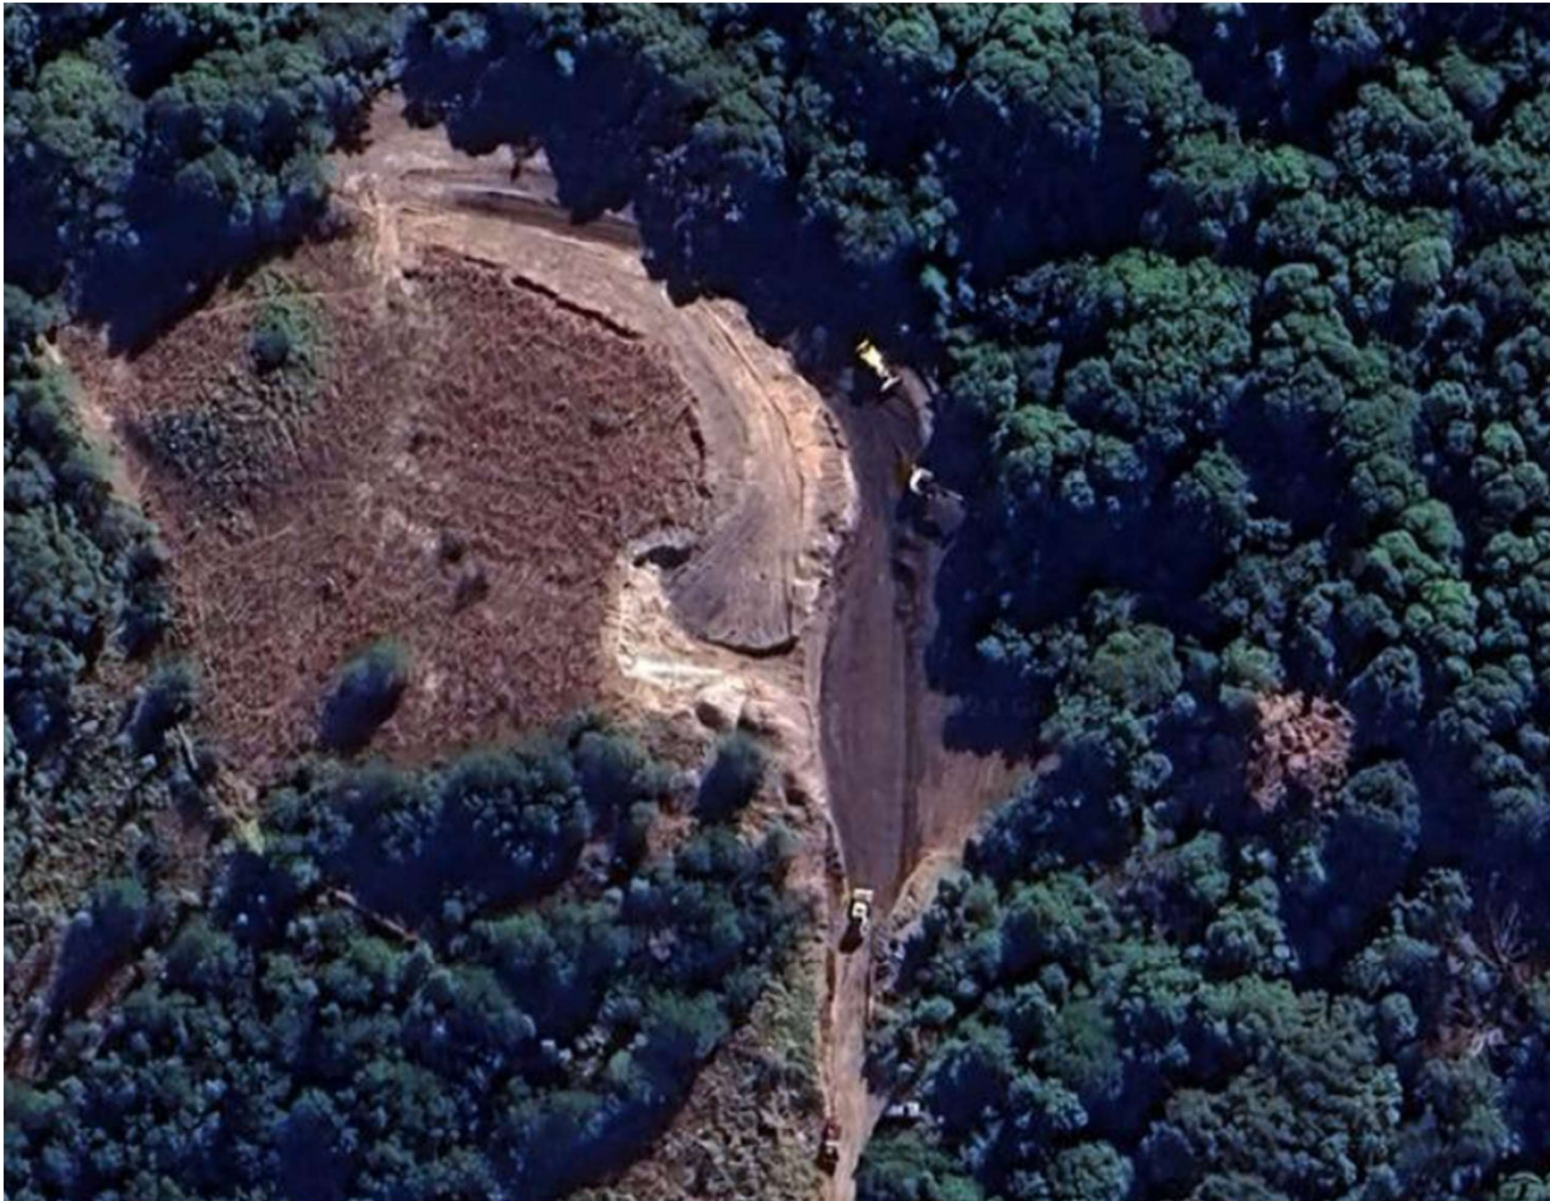
Figure 4 –Landslip Area works in progress (source – Google Maps June 2024)

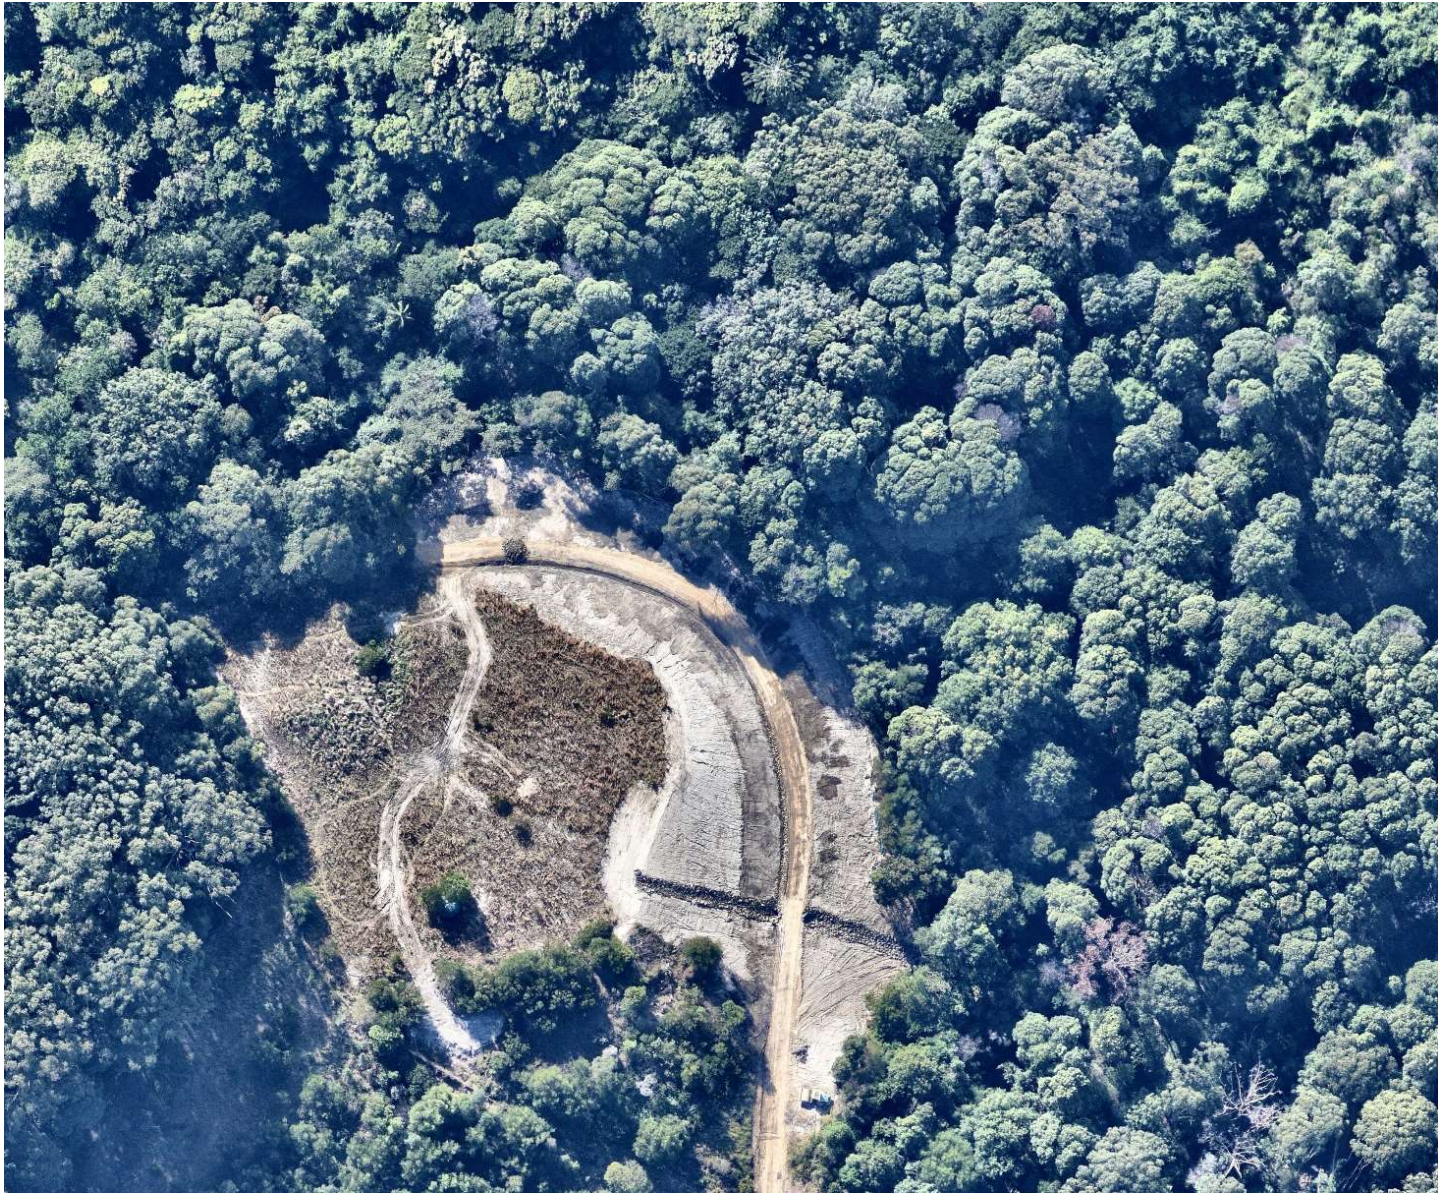
Figure 5 – Reformed Landslip Area (source – Nearmaps 15 July 2024)

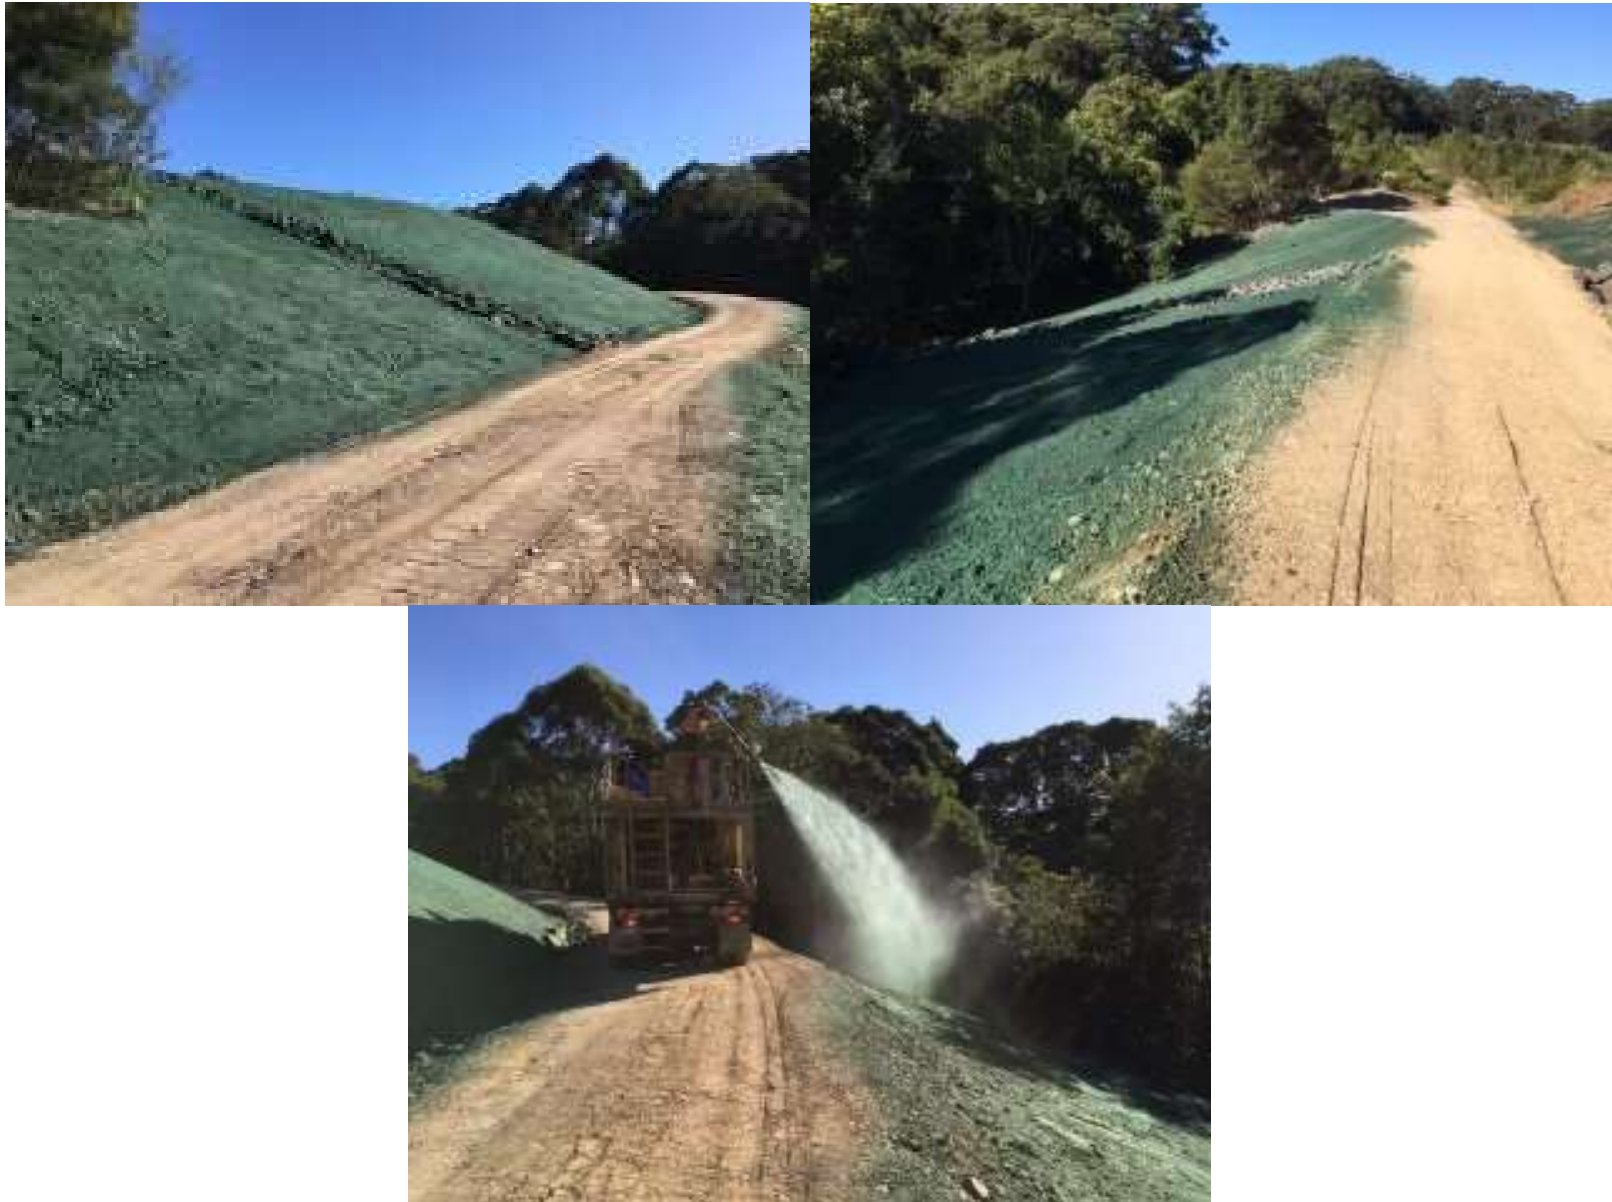
Pictures 7, 8 & 9 – Hydromulched batters 15 July 2024

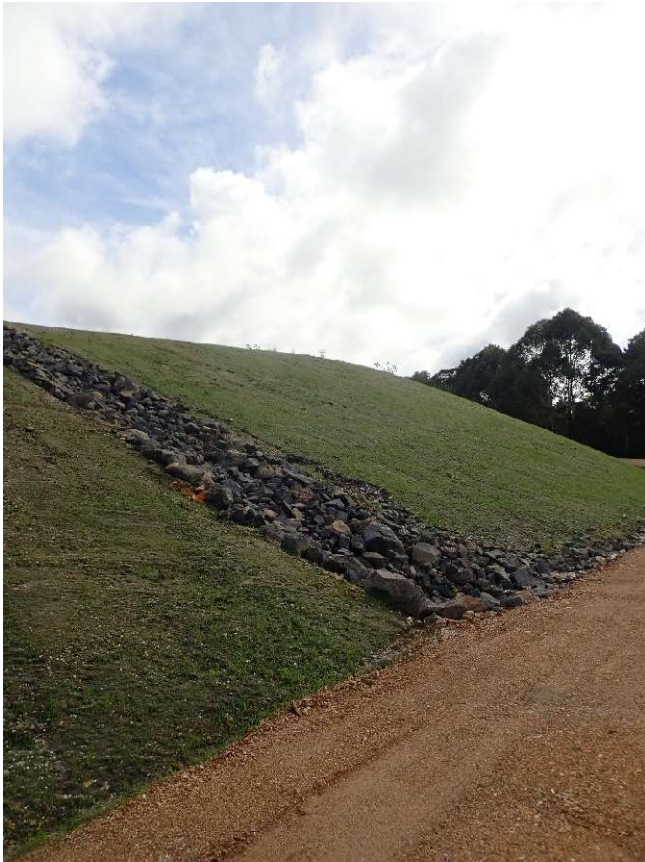
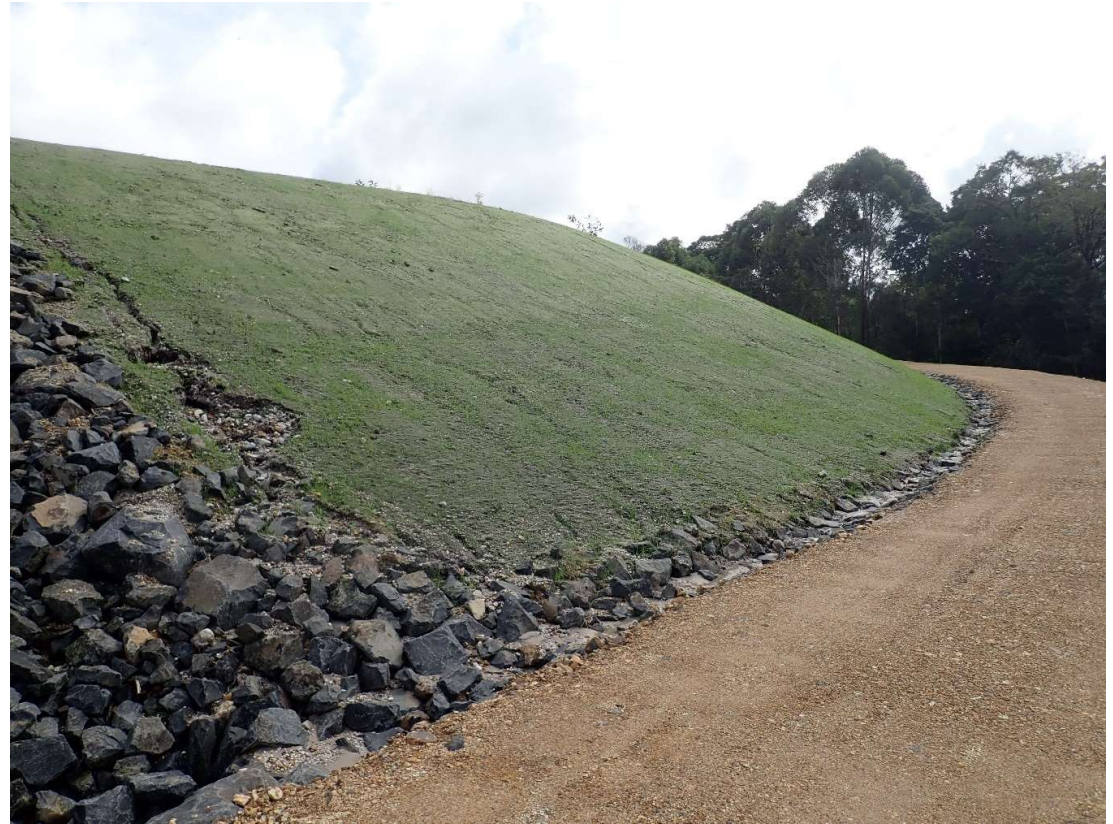
Pictures 11 & 12 – Grass established 16 August 2024

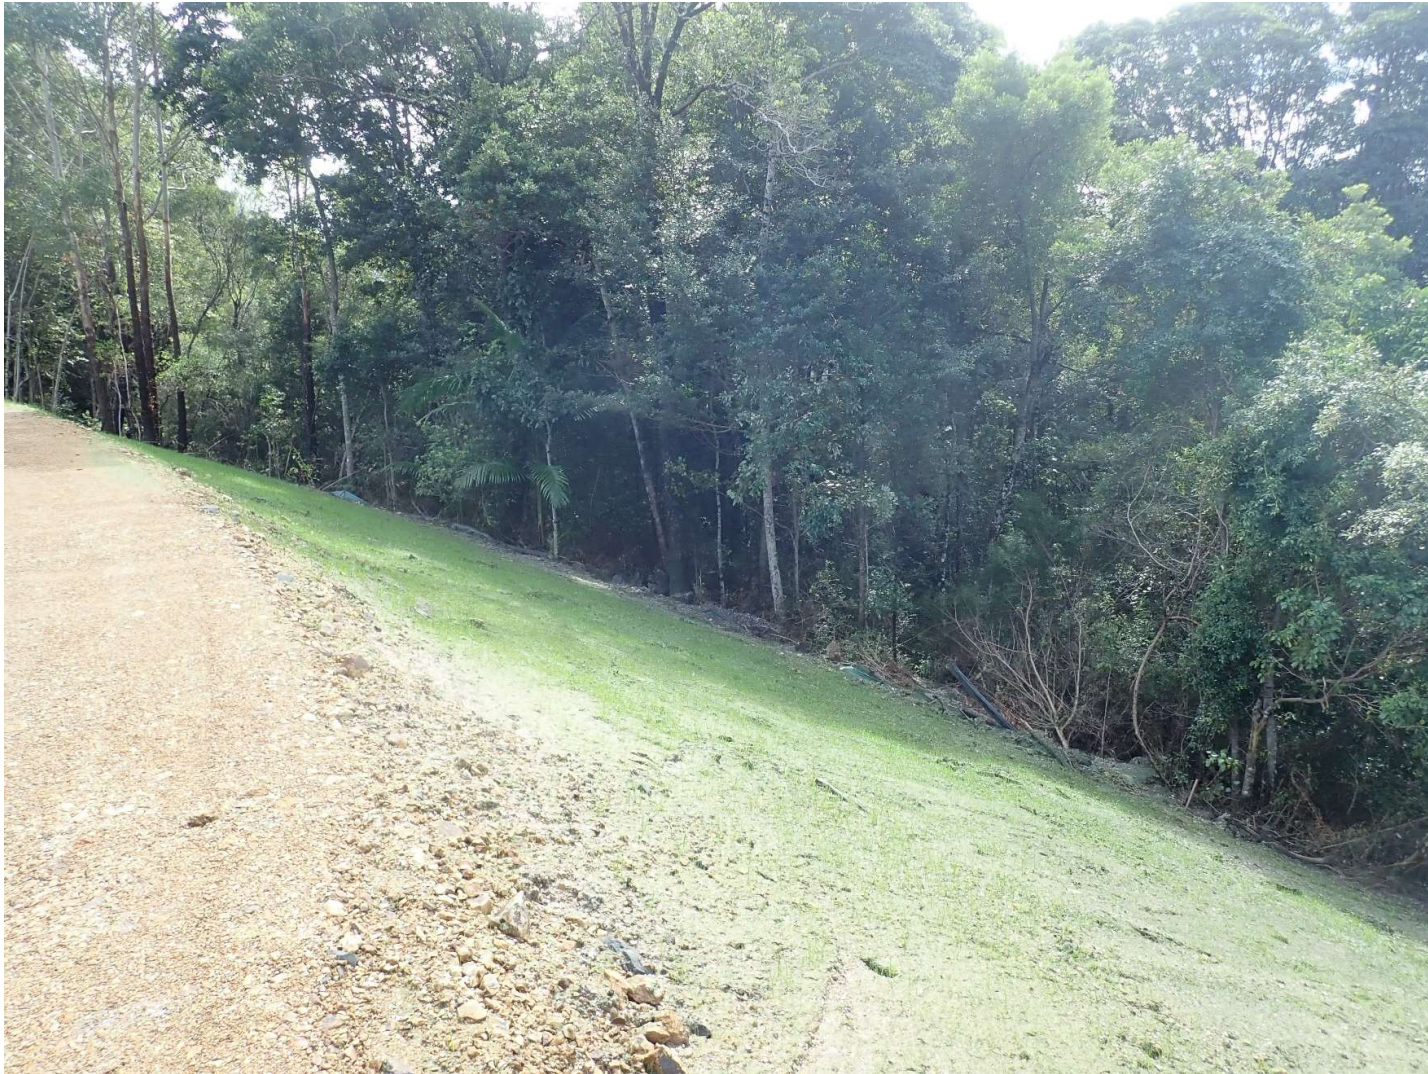
Picture 13 – Grass established 16 August 2024

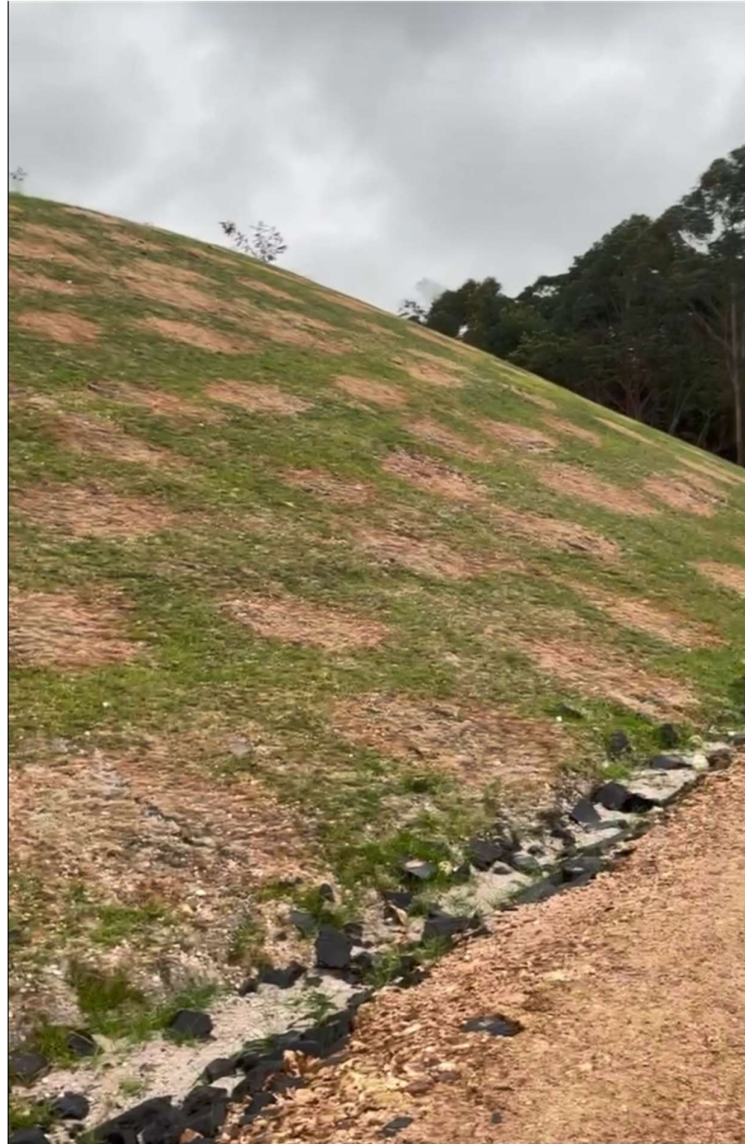
Picture 14 – Grass sprayed with weed killer in preparation for planting 12 September 2024

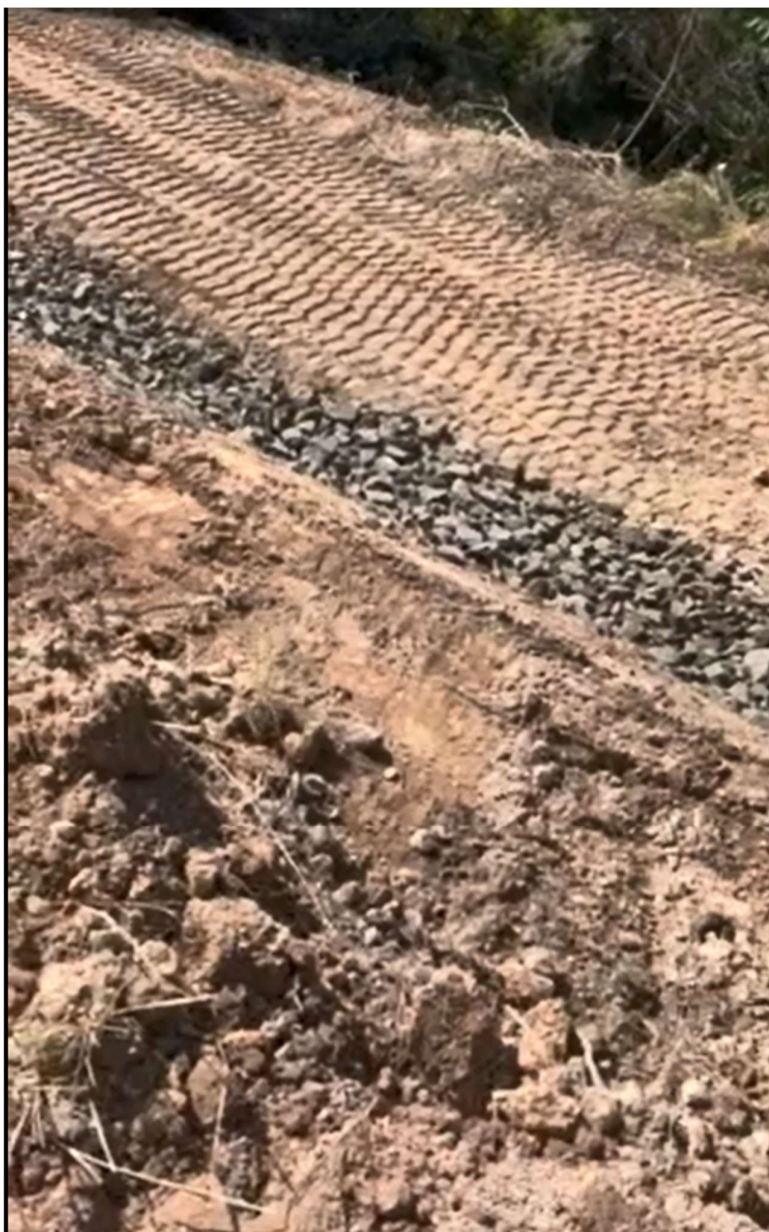
Picture 15 – Reformed road and new drain

These works have been undertaken by altering the former road to a rock lined drain, completed on 18 September 2024. The works involved:

- removing encroaching vegetation;
- reforming the road;
- creating a drainage pathway on the edge of the reformed road;
- creating additional drains from the road above to improve drainage of that road and use the new drainage pathway to manage that runoff.
