Broken Head Quarry

Enforceable Undertaking Progress Report

Report #21 – September 2024

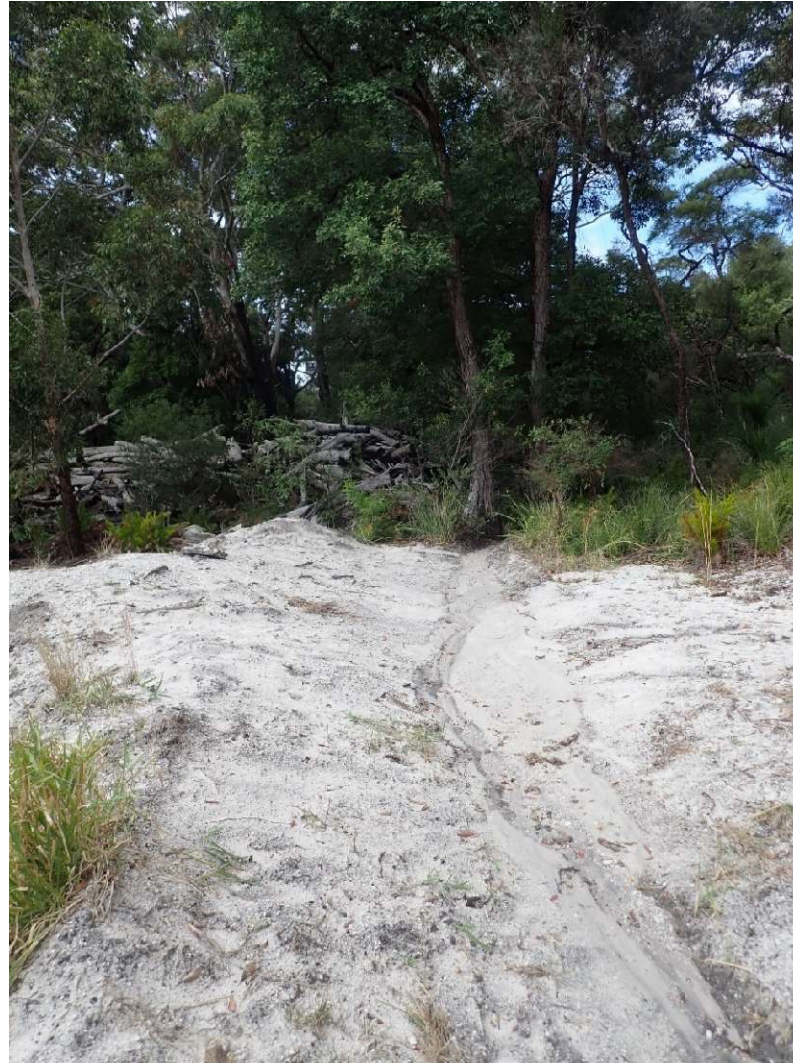
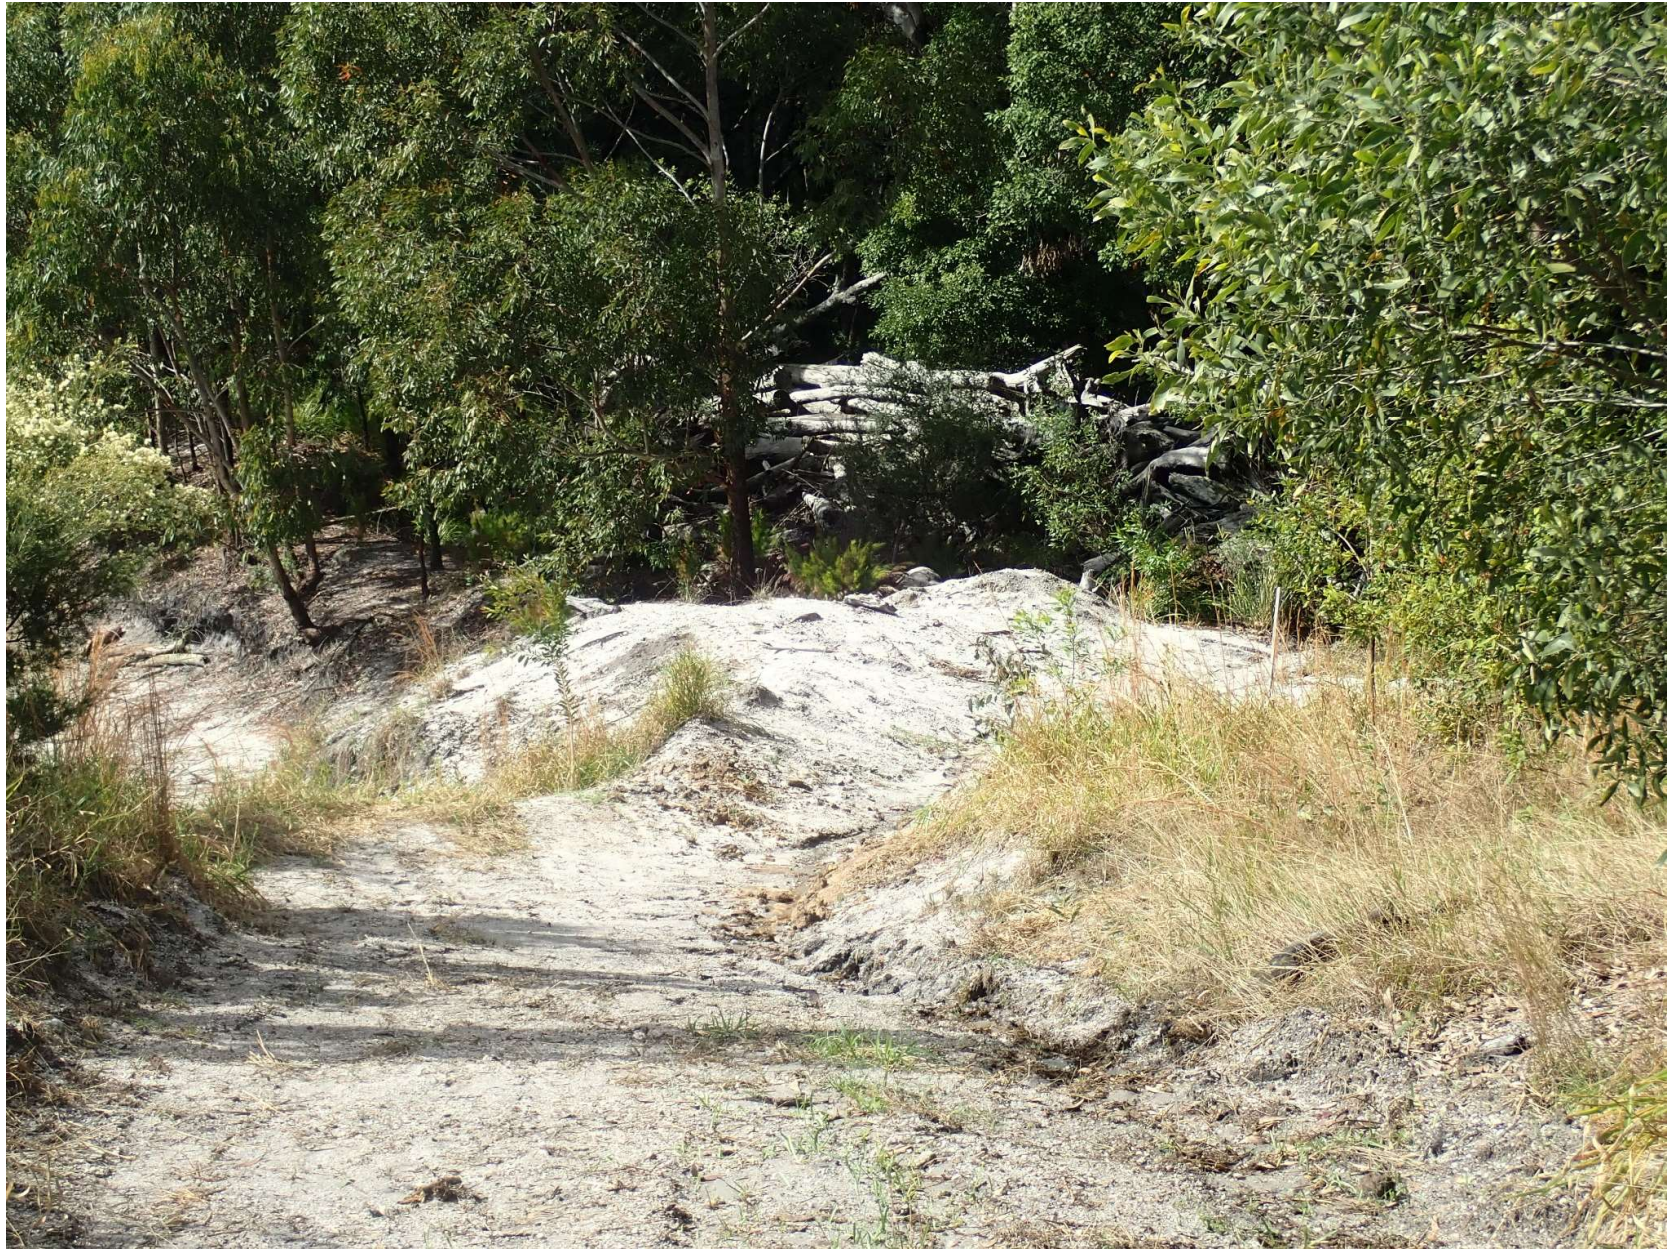
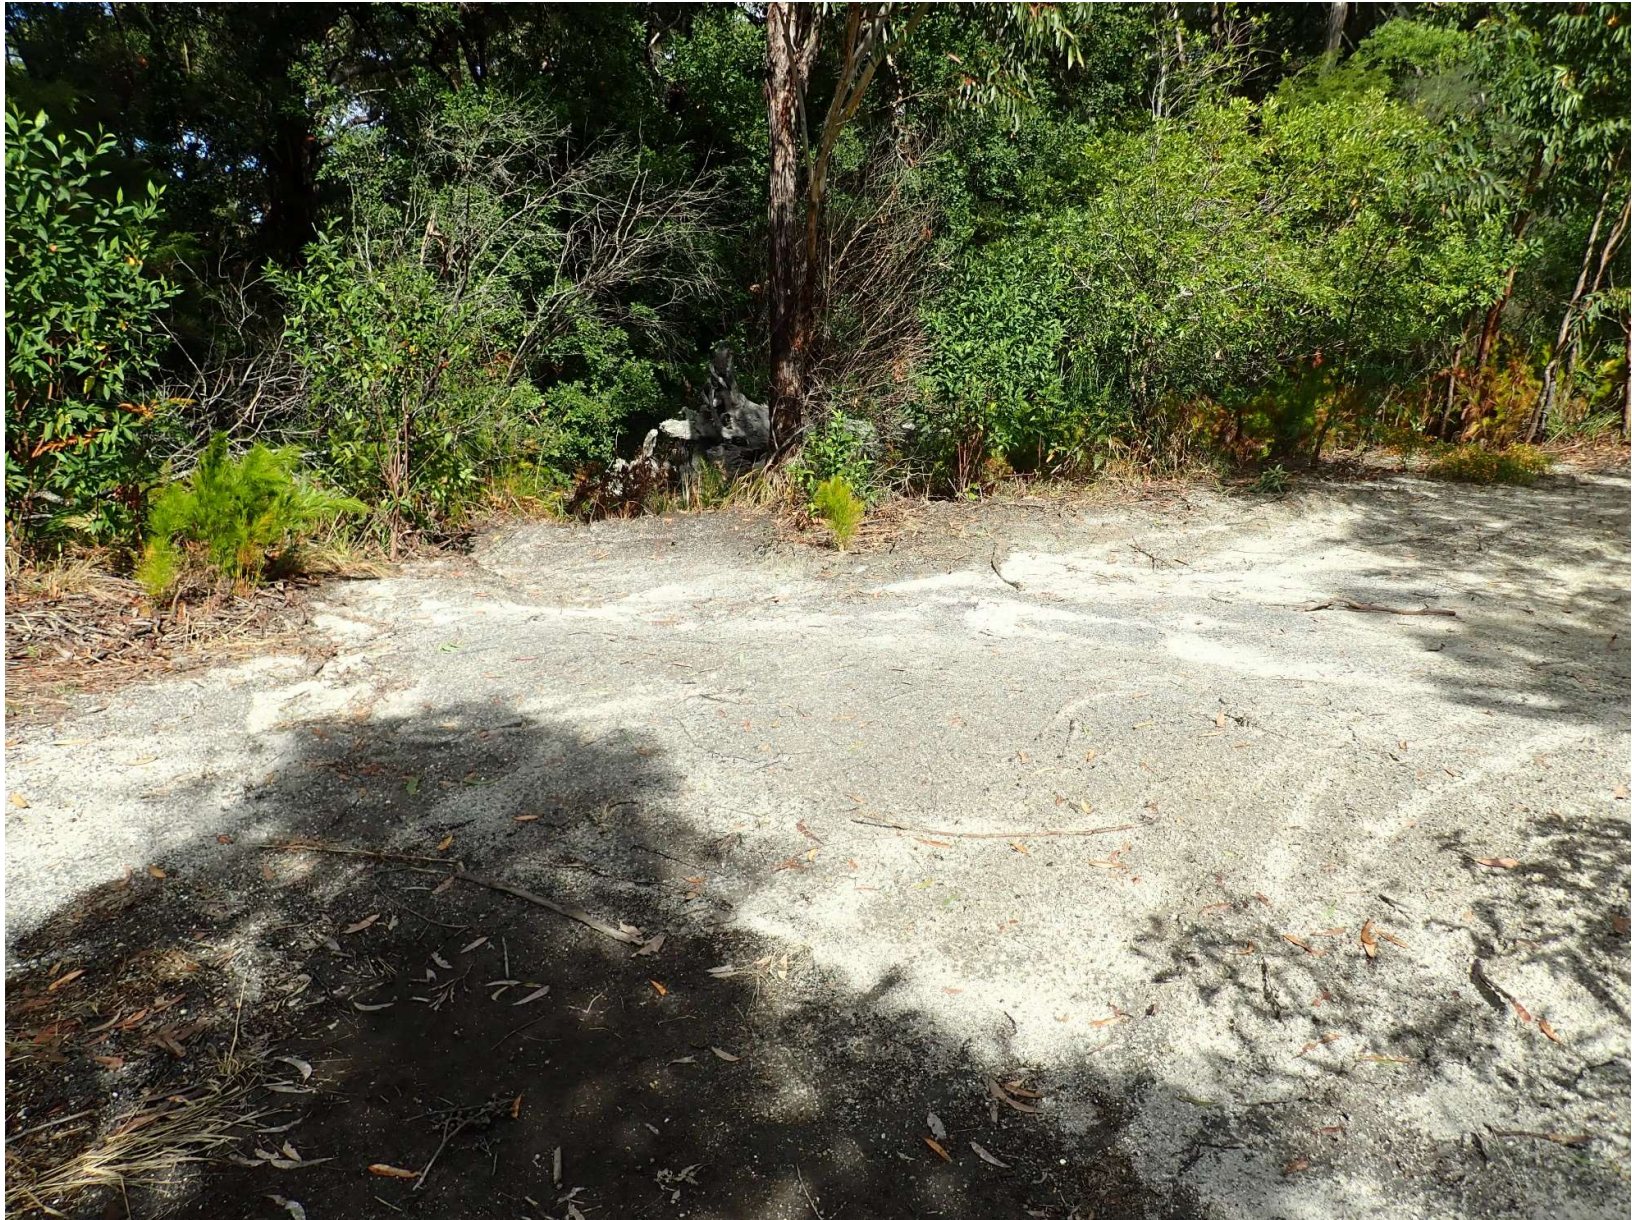
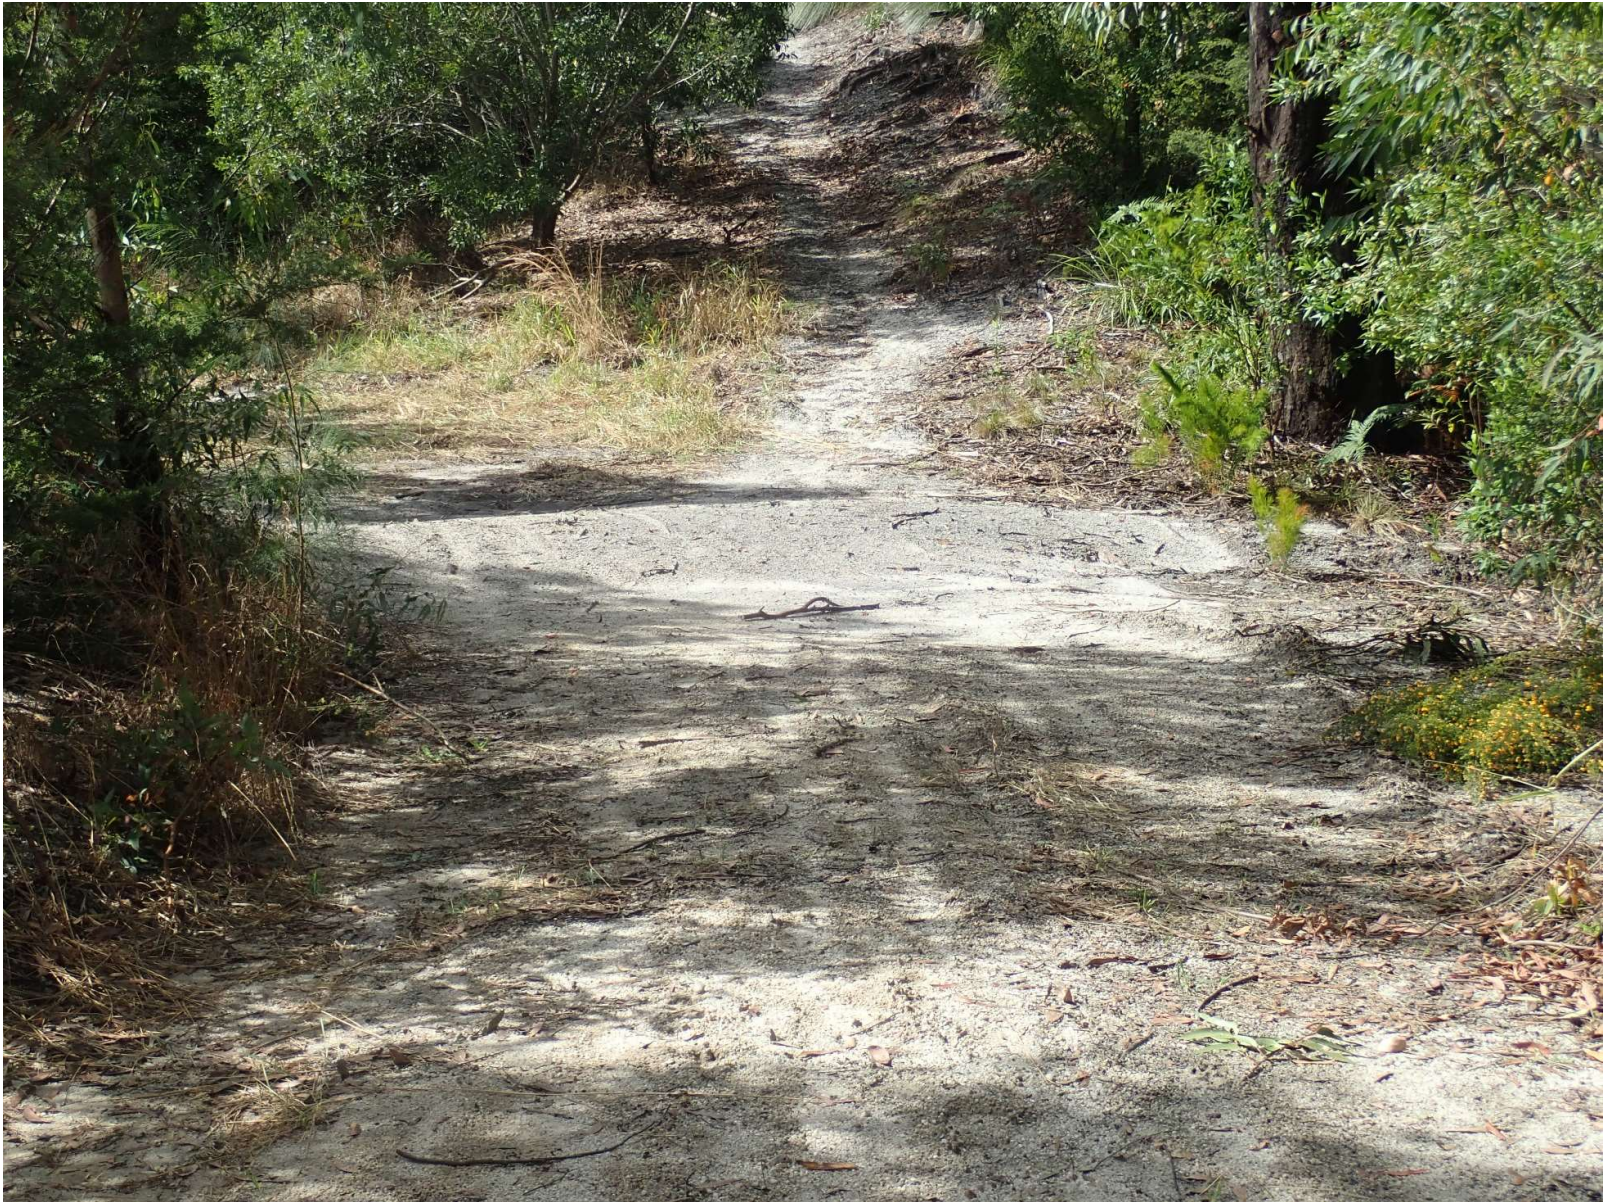
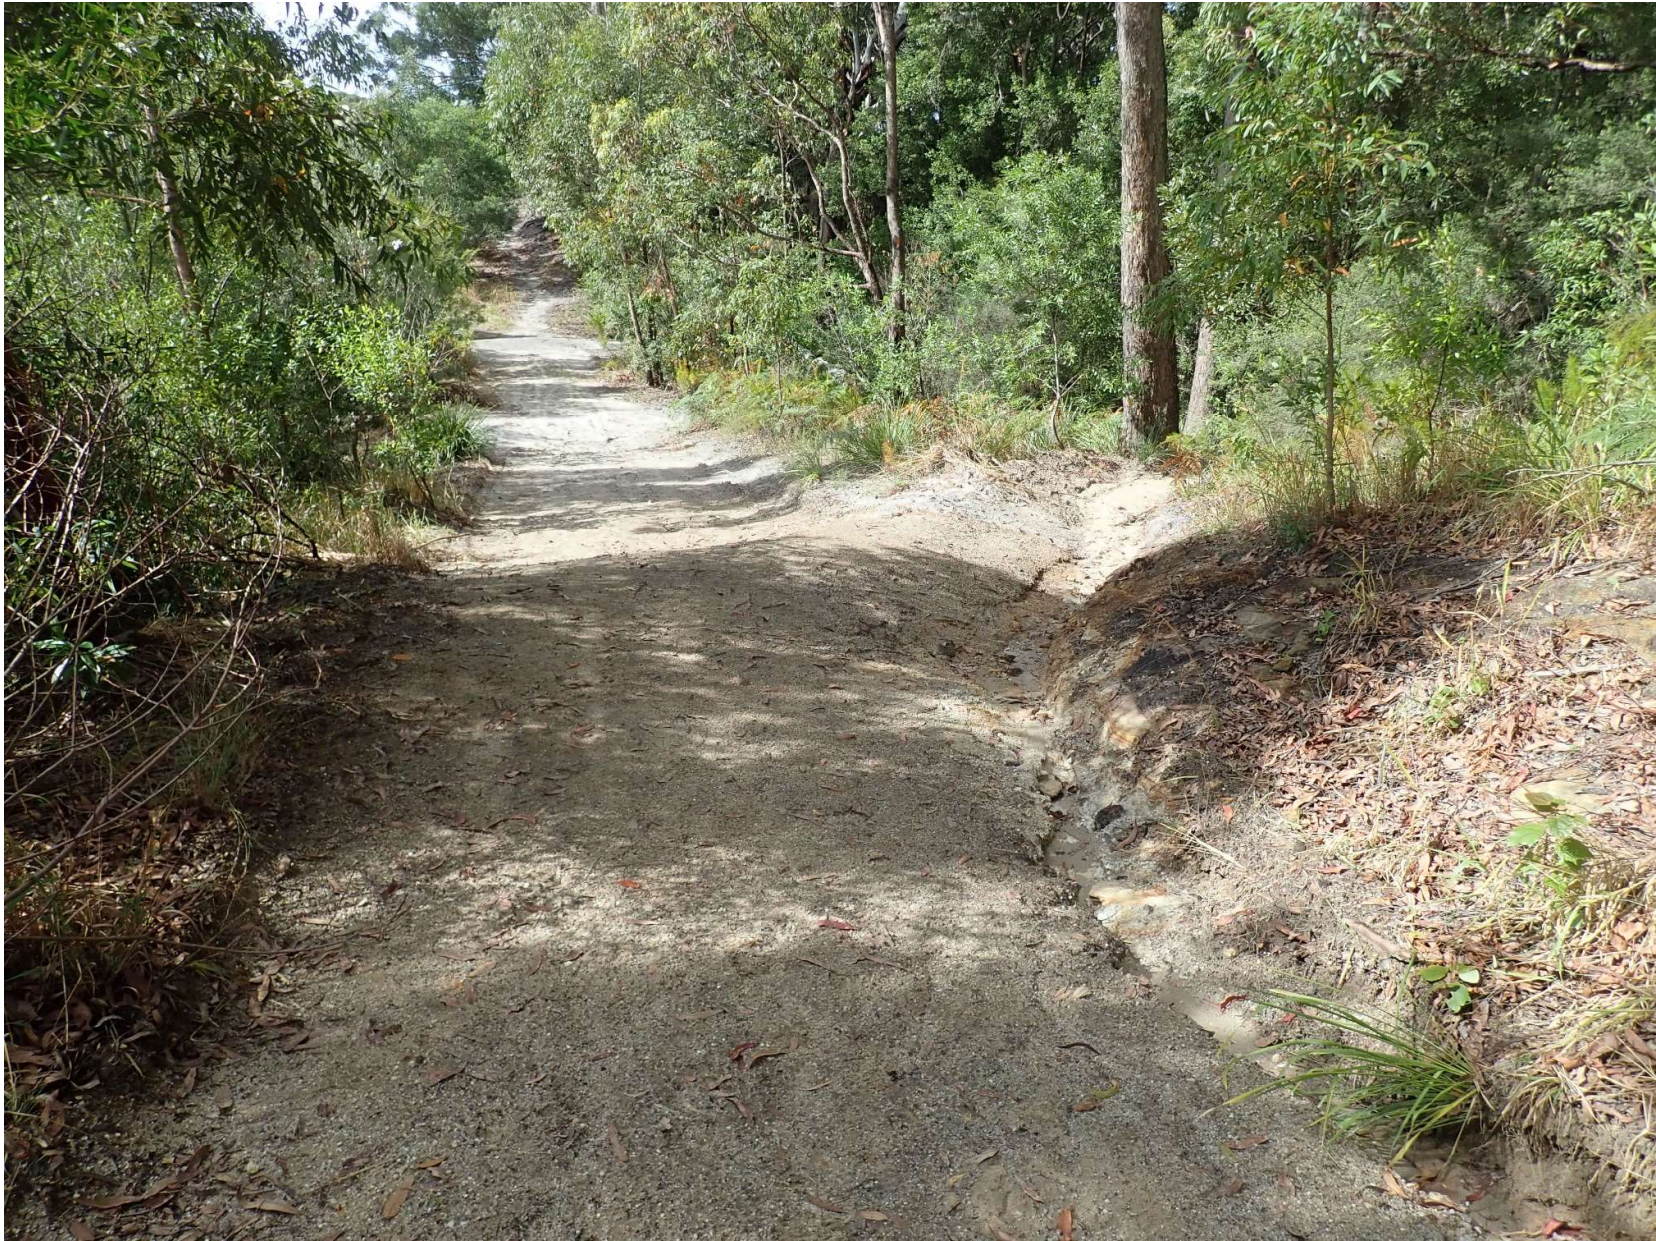
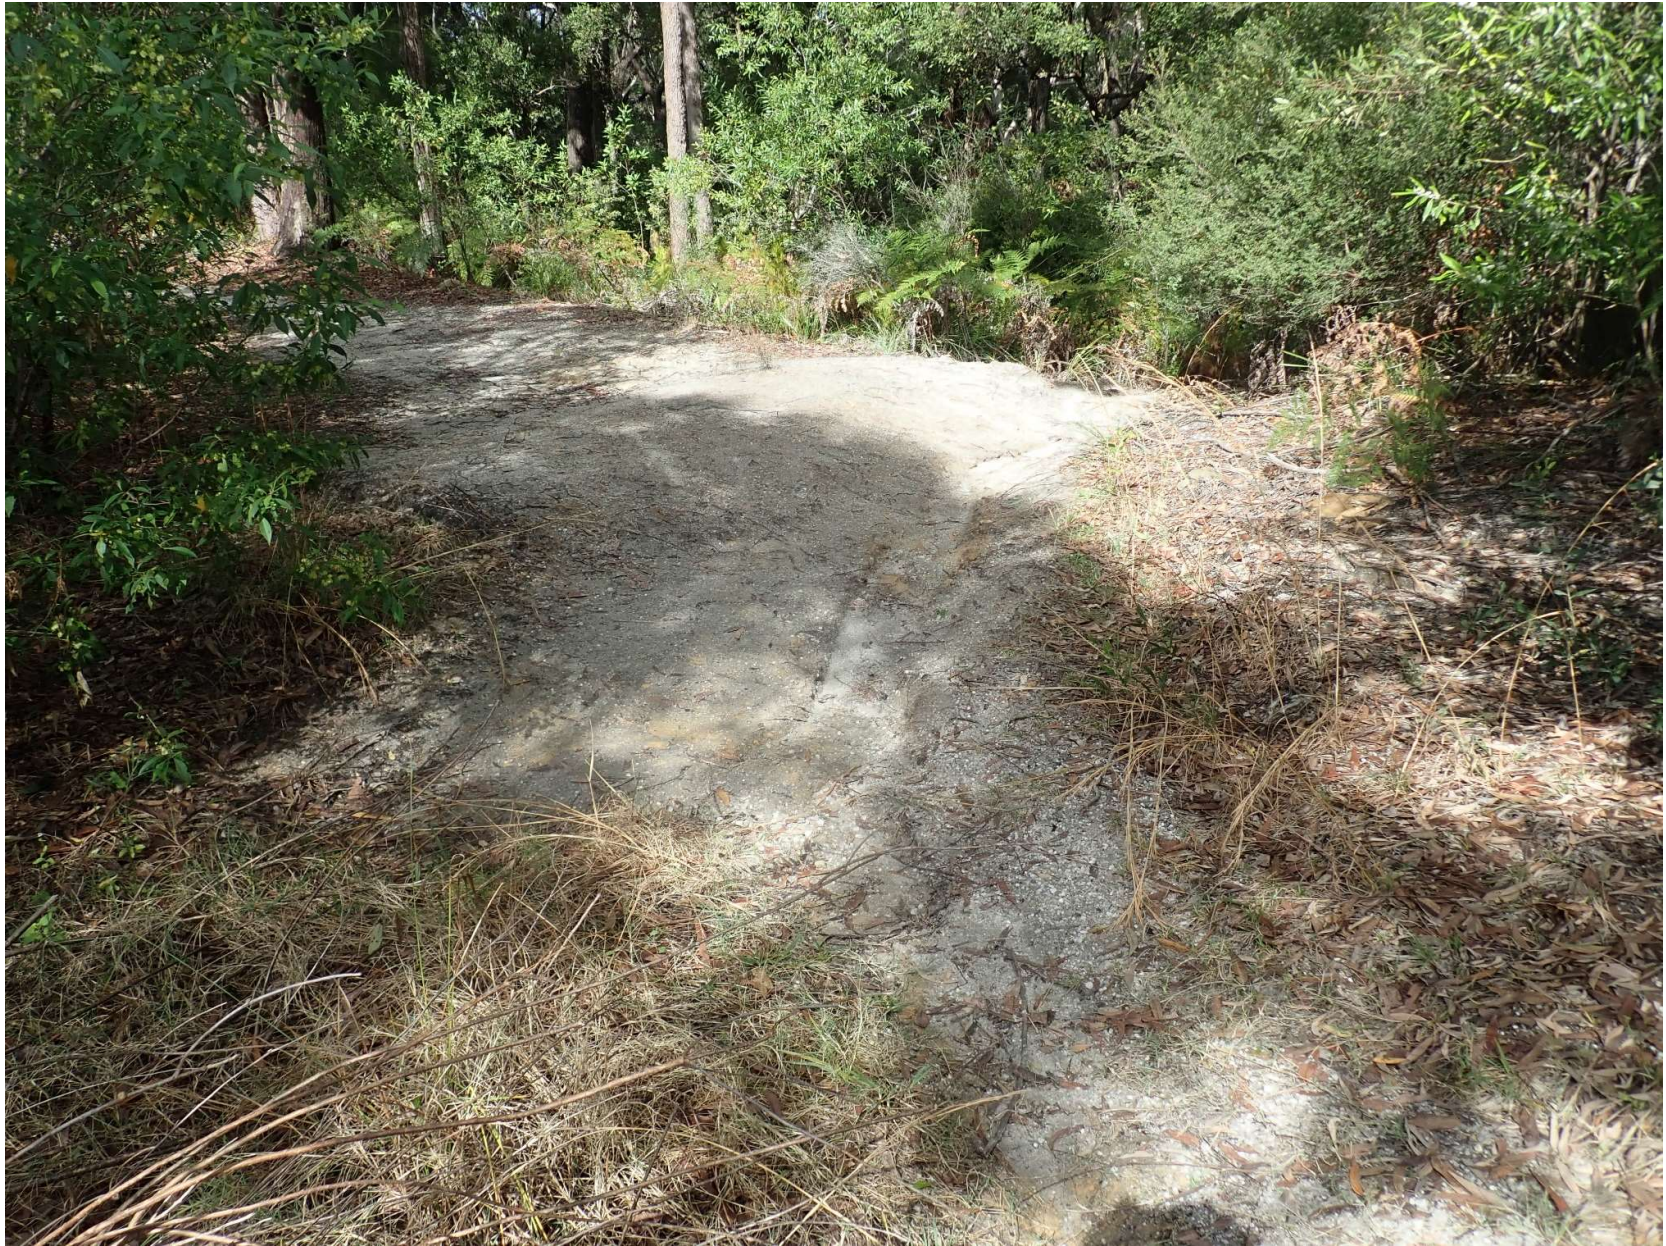
Picture 16 – Woah-boy and repaired road

Picture 17 – Woah-boy and repaired road

Picture 18 – Woah-boy and repaired road

Picture 19 – Woah-boy and repaired road

Picture 20 – Woah-boy and repaired road

Picture 21 – Woah-boy and repaired road

A number of woah-boys were installed and the road surface repaired.

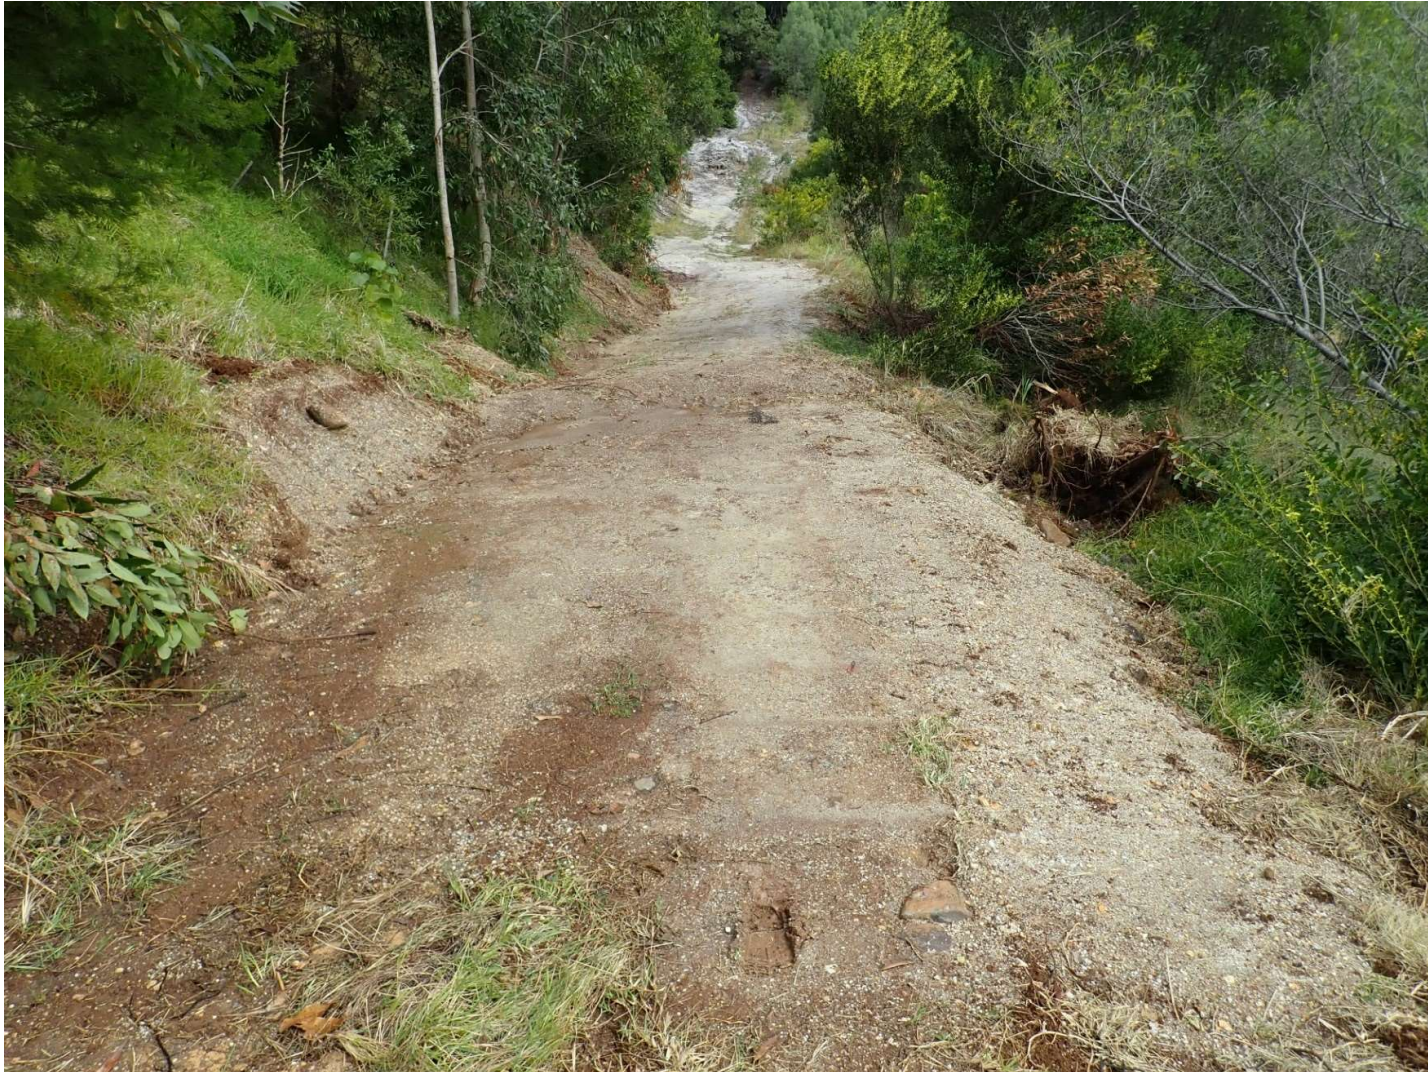
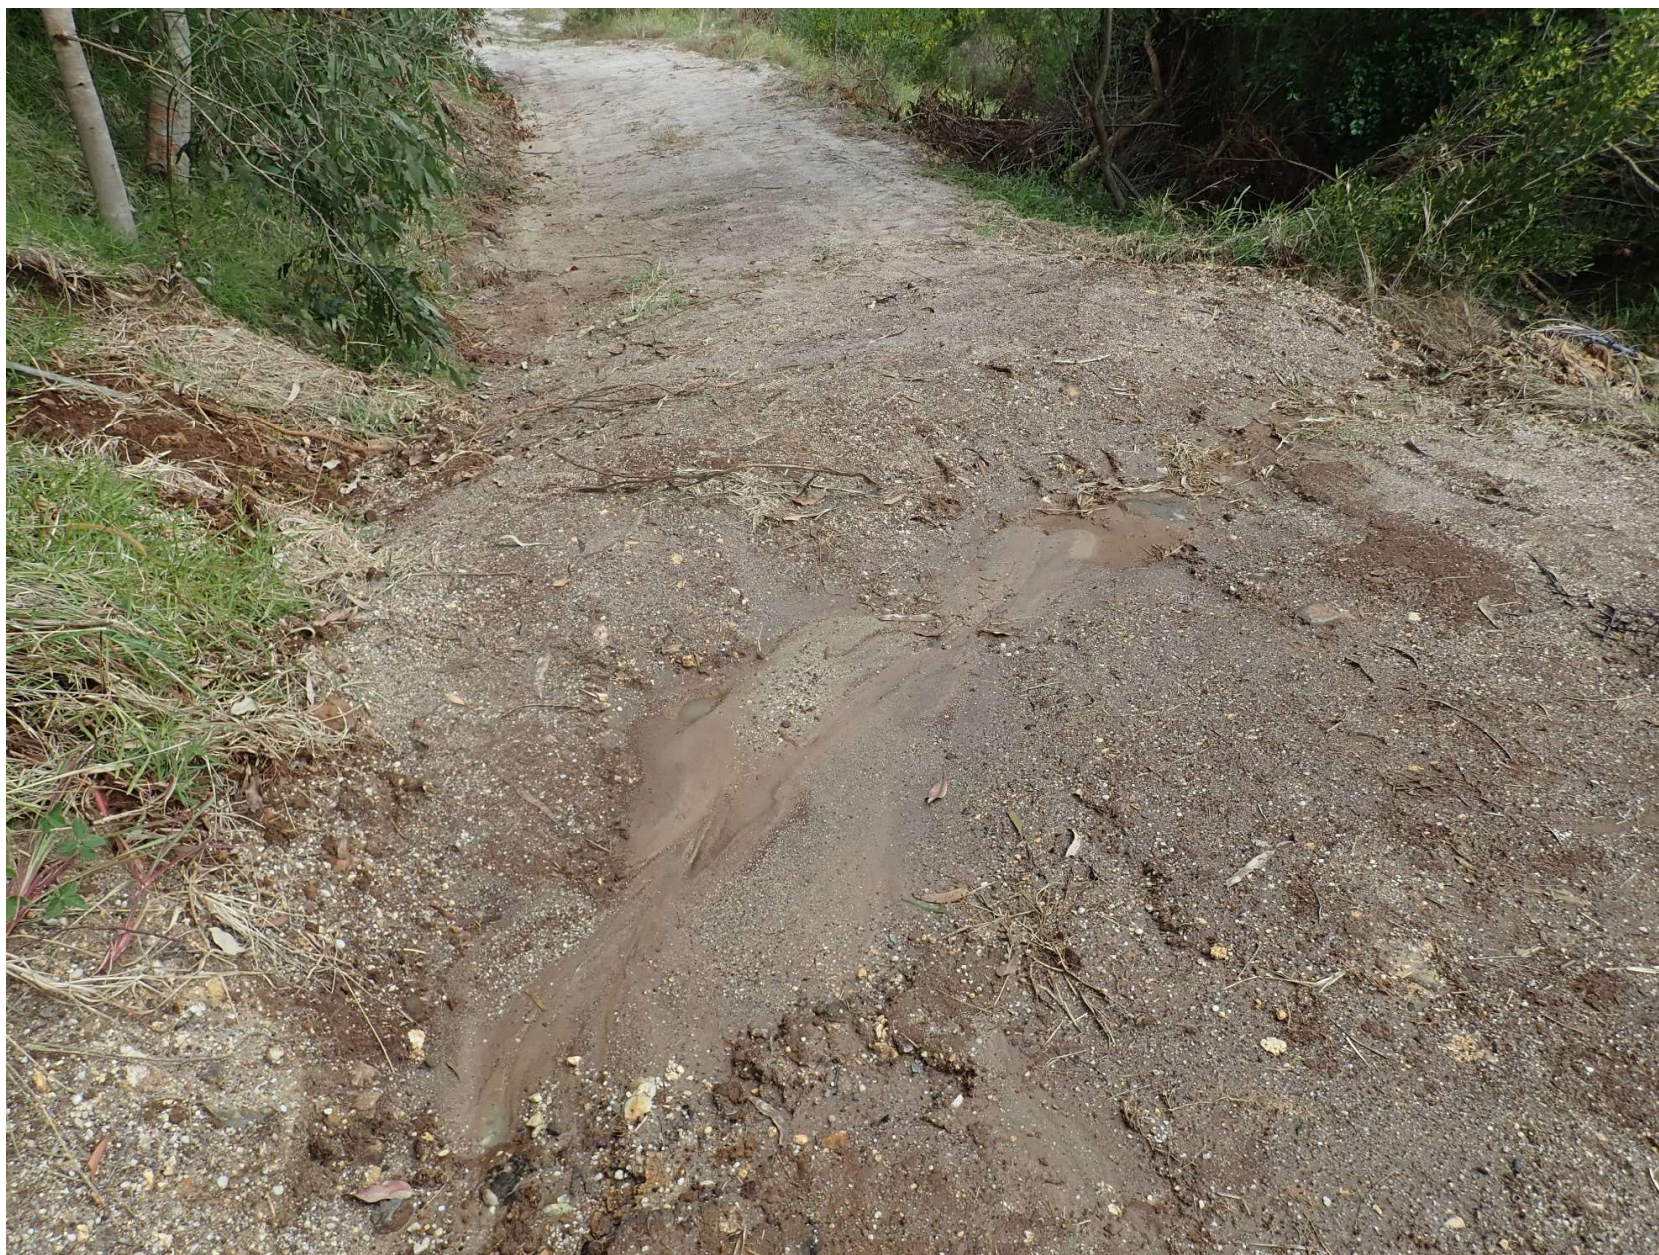
Picture 22 – Woah-boy and repaired road

Picture 23 – Woah-boy and repaired road

A number of woah-boys were installed and the road surface repaired.
