Broken Head Quarry

Enforceable Undertaking Progress Report

Report #21 – September 2024

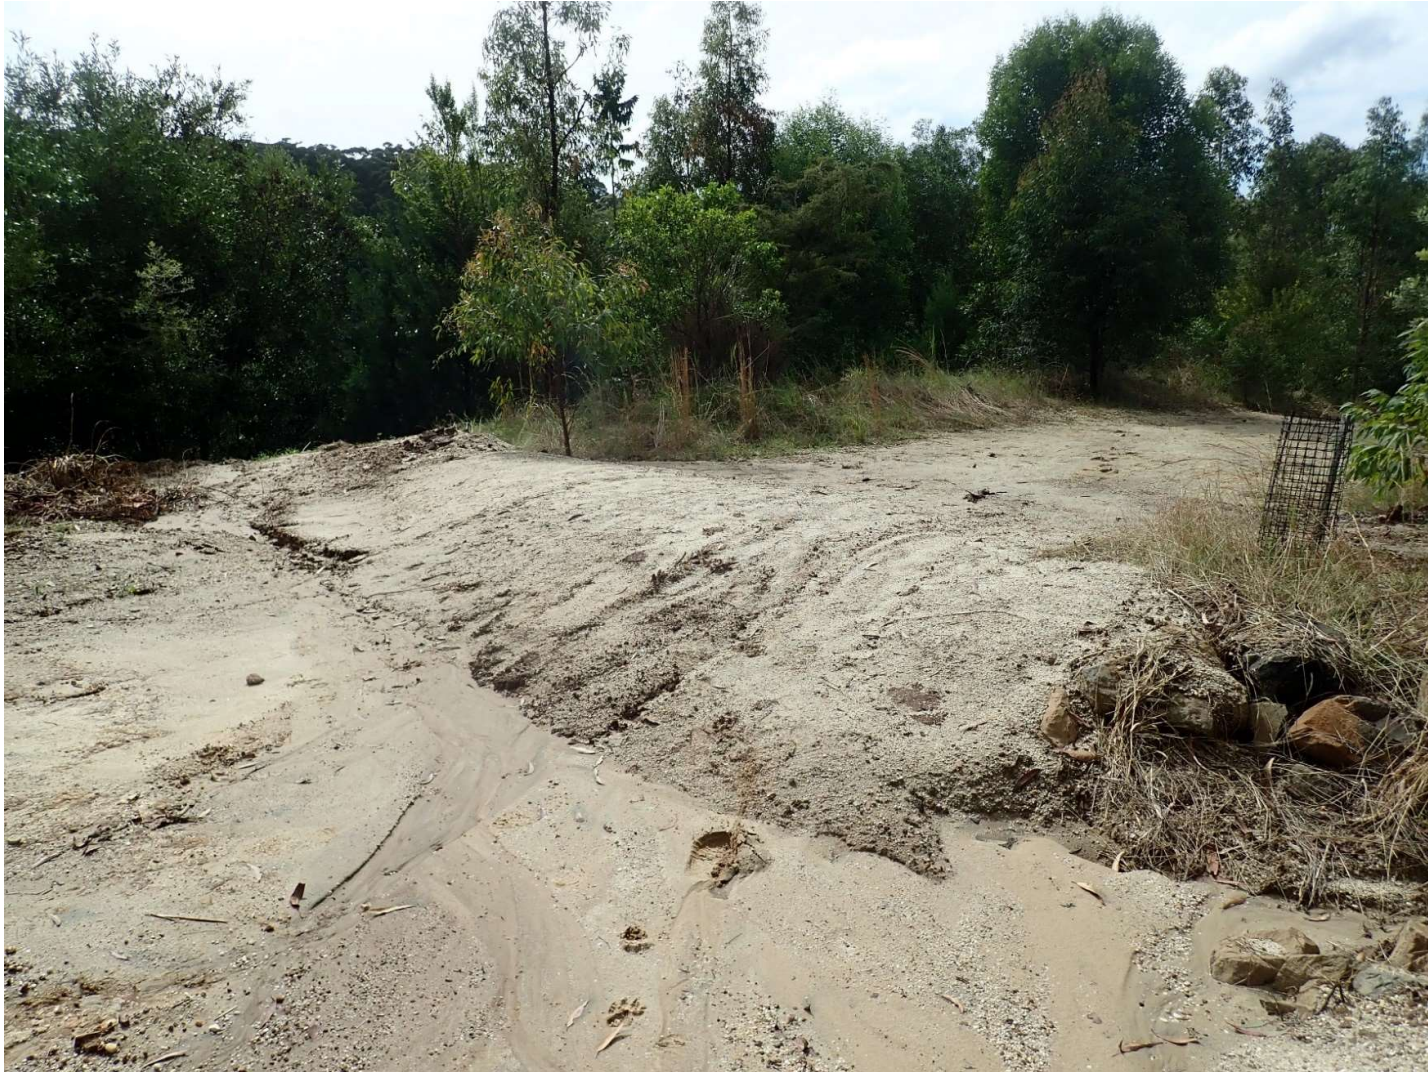
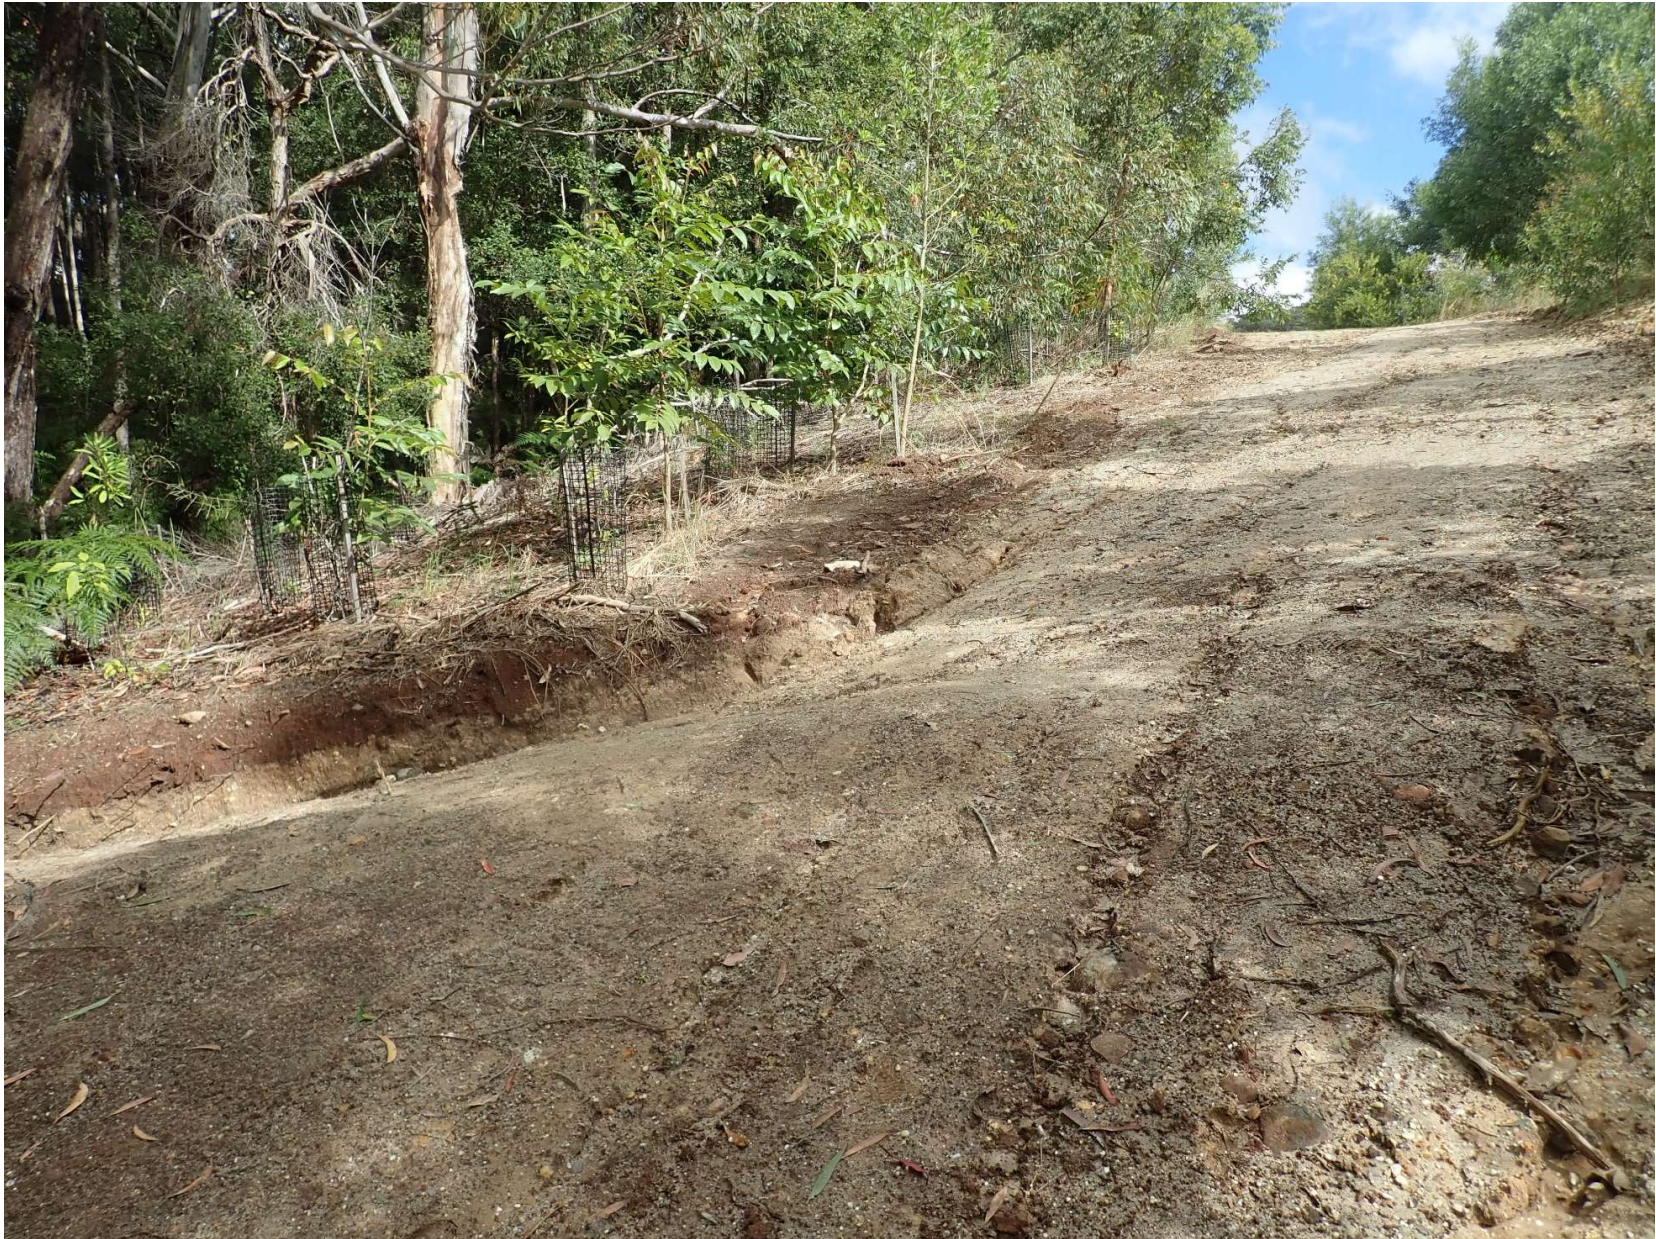
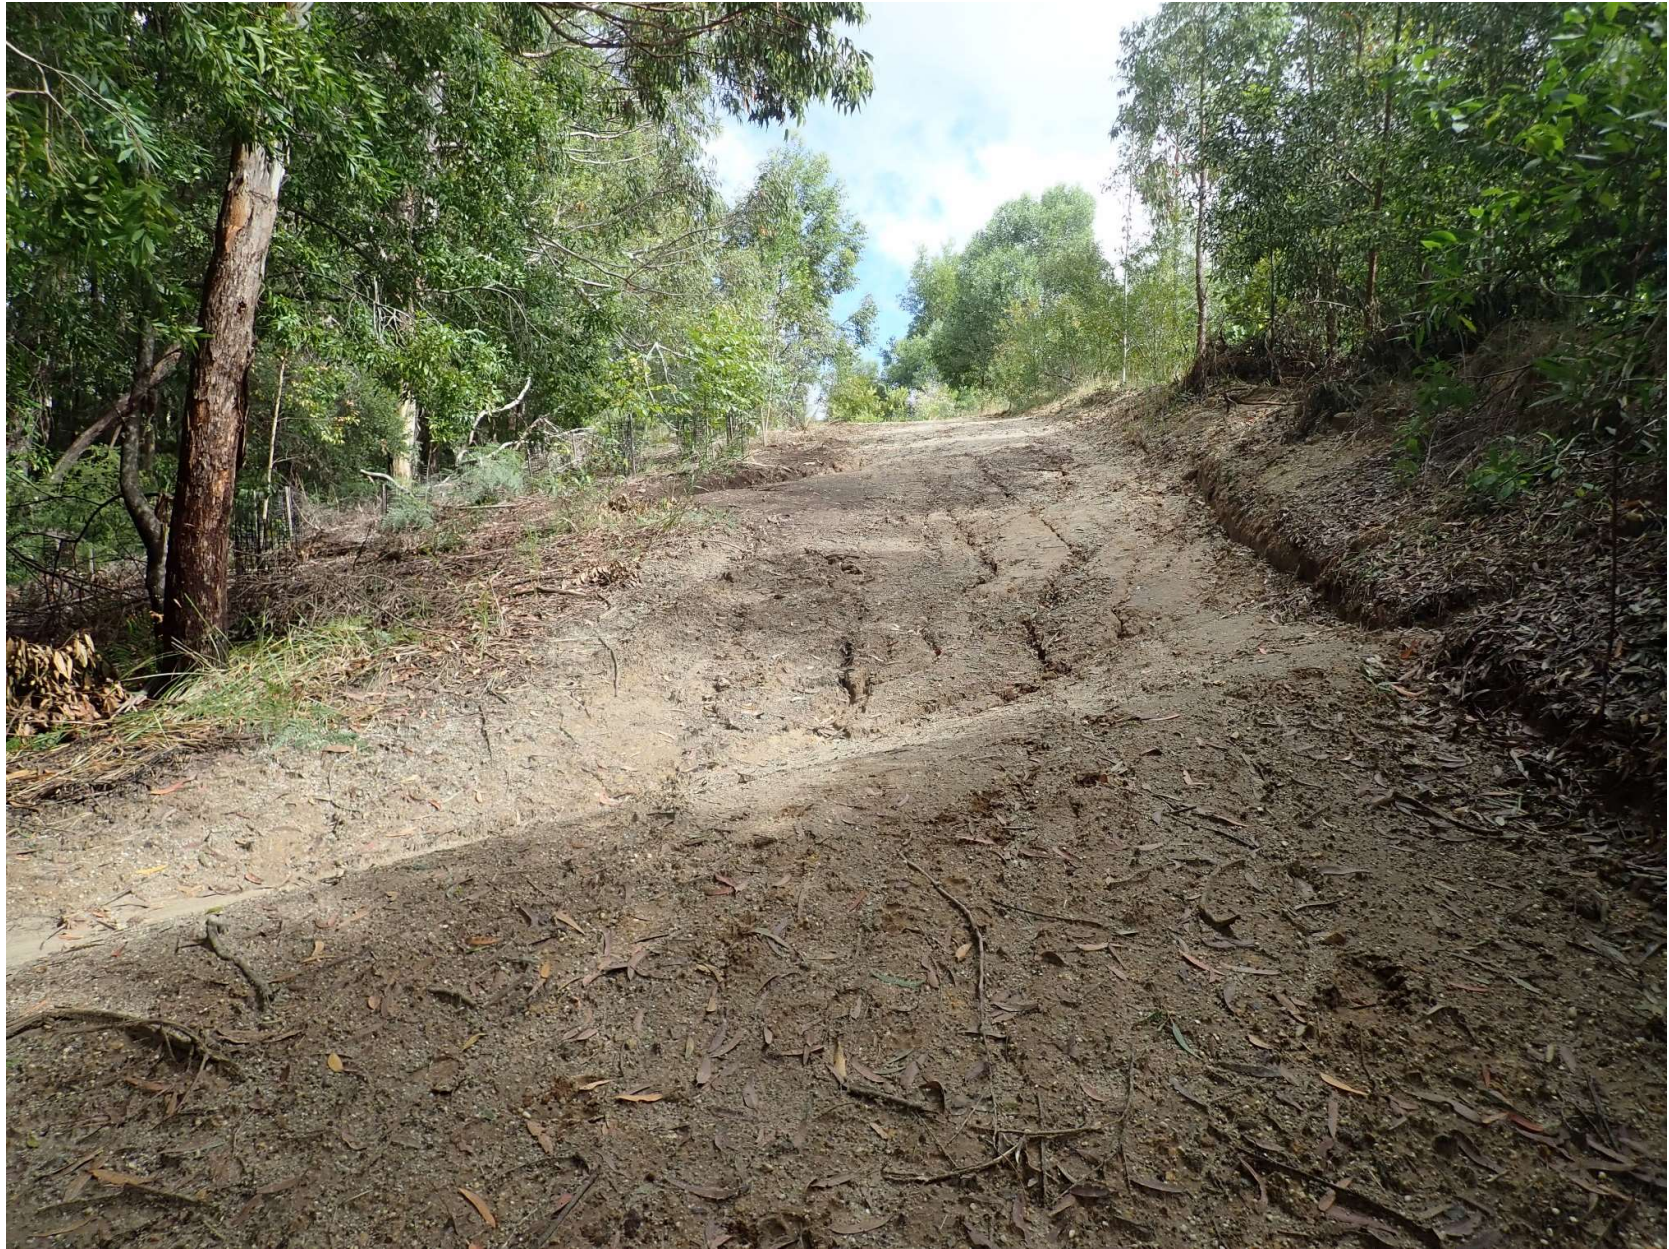
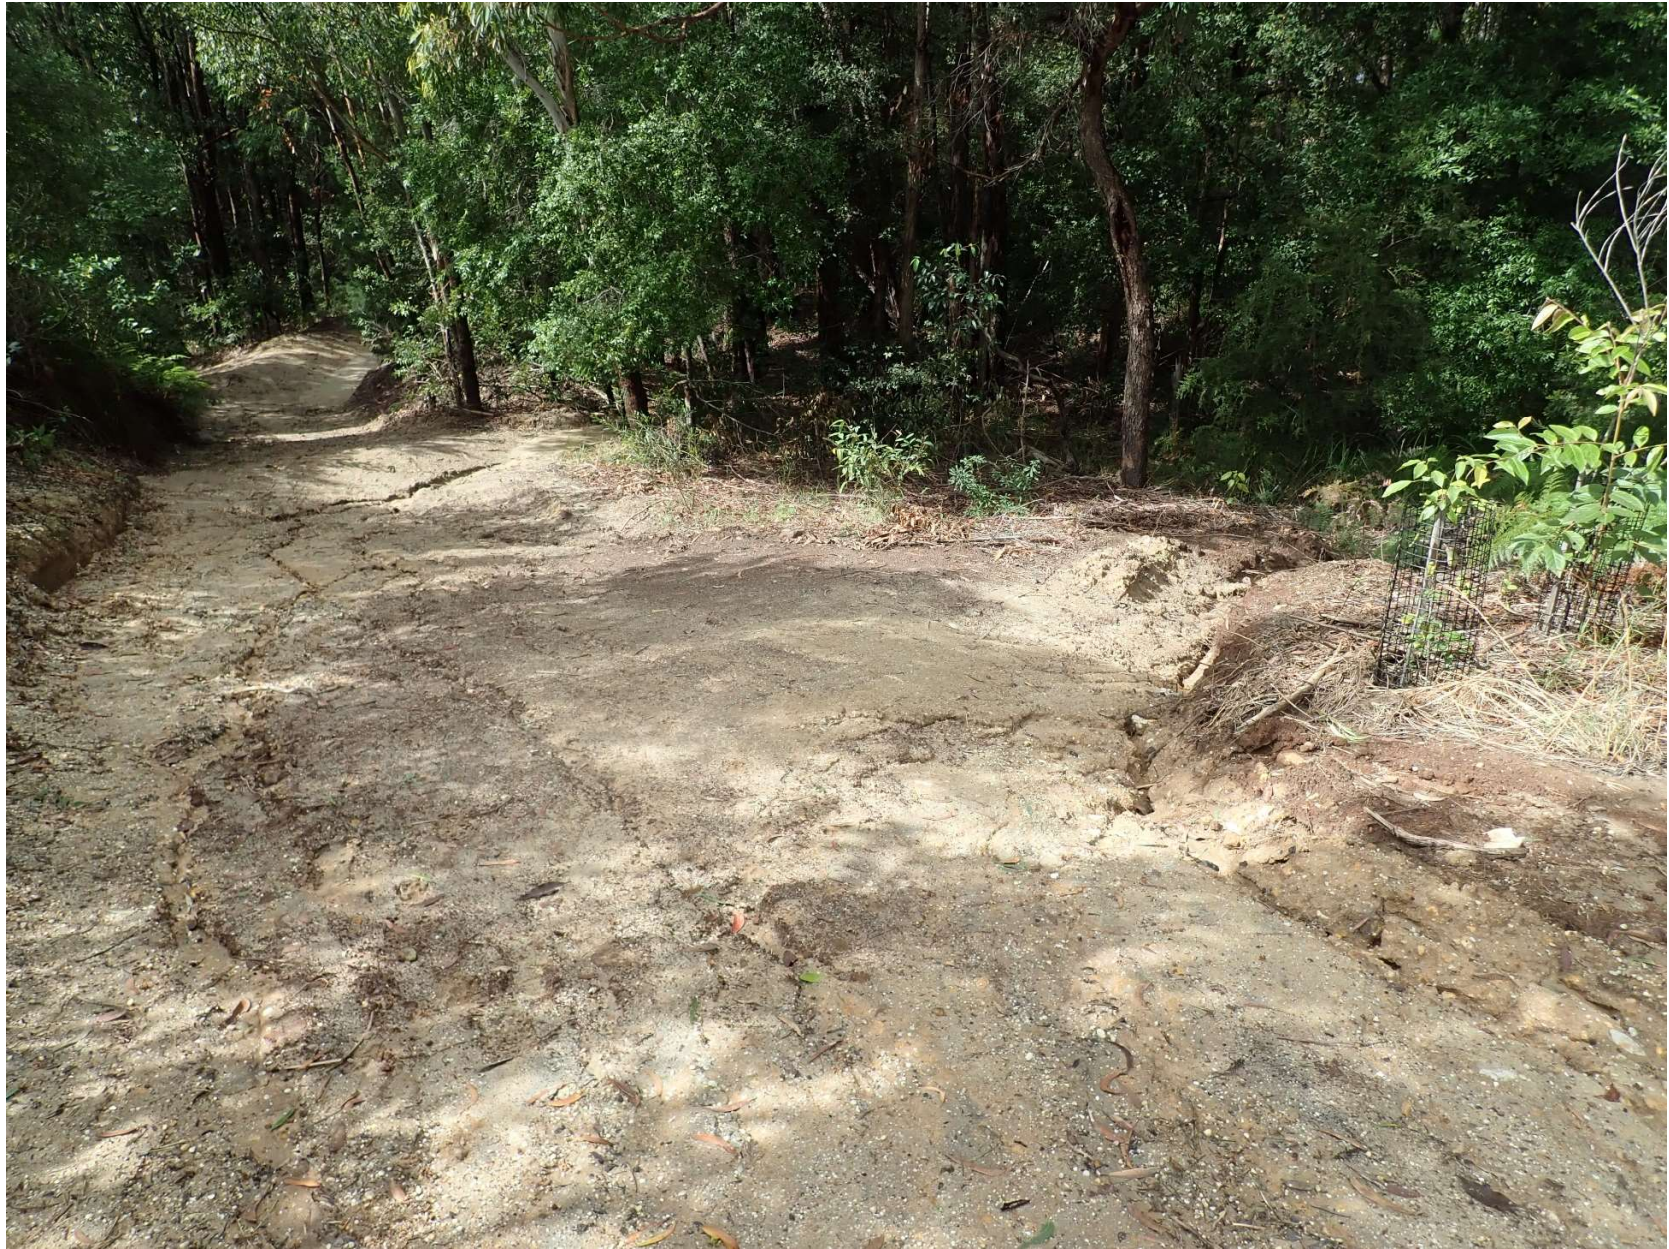
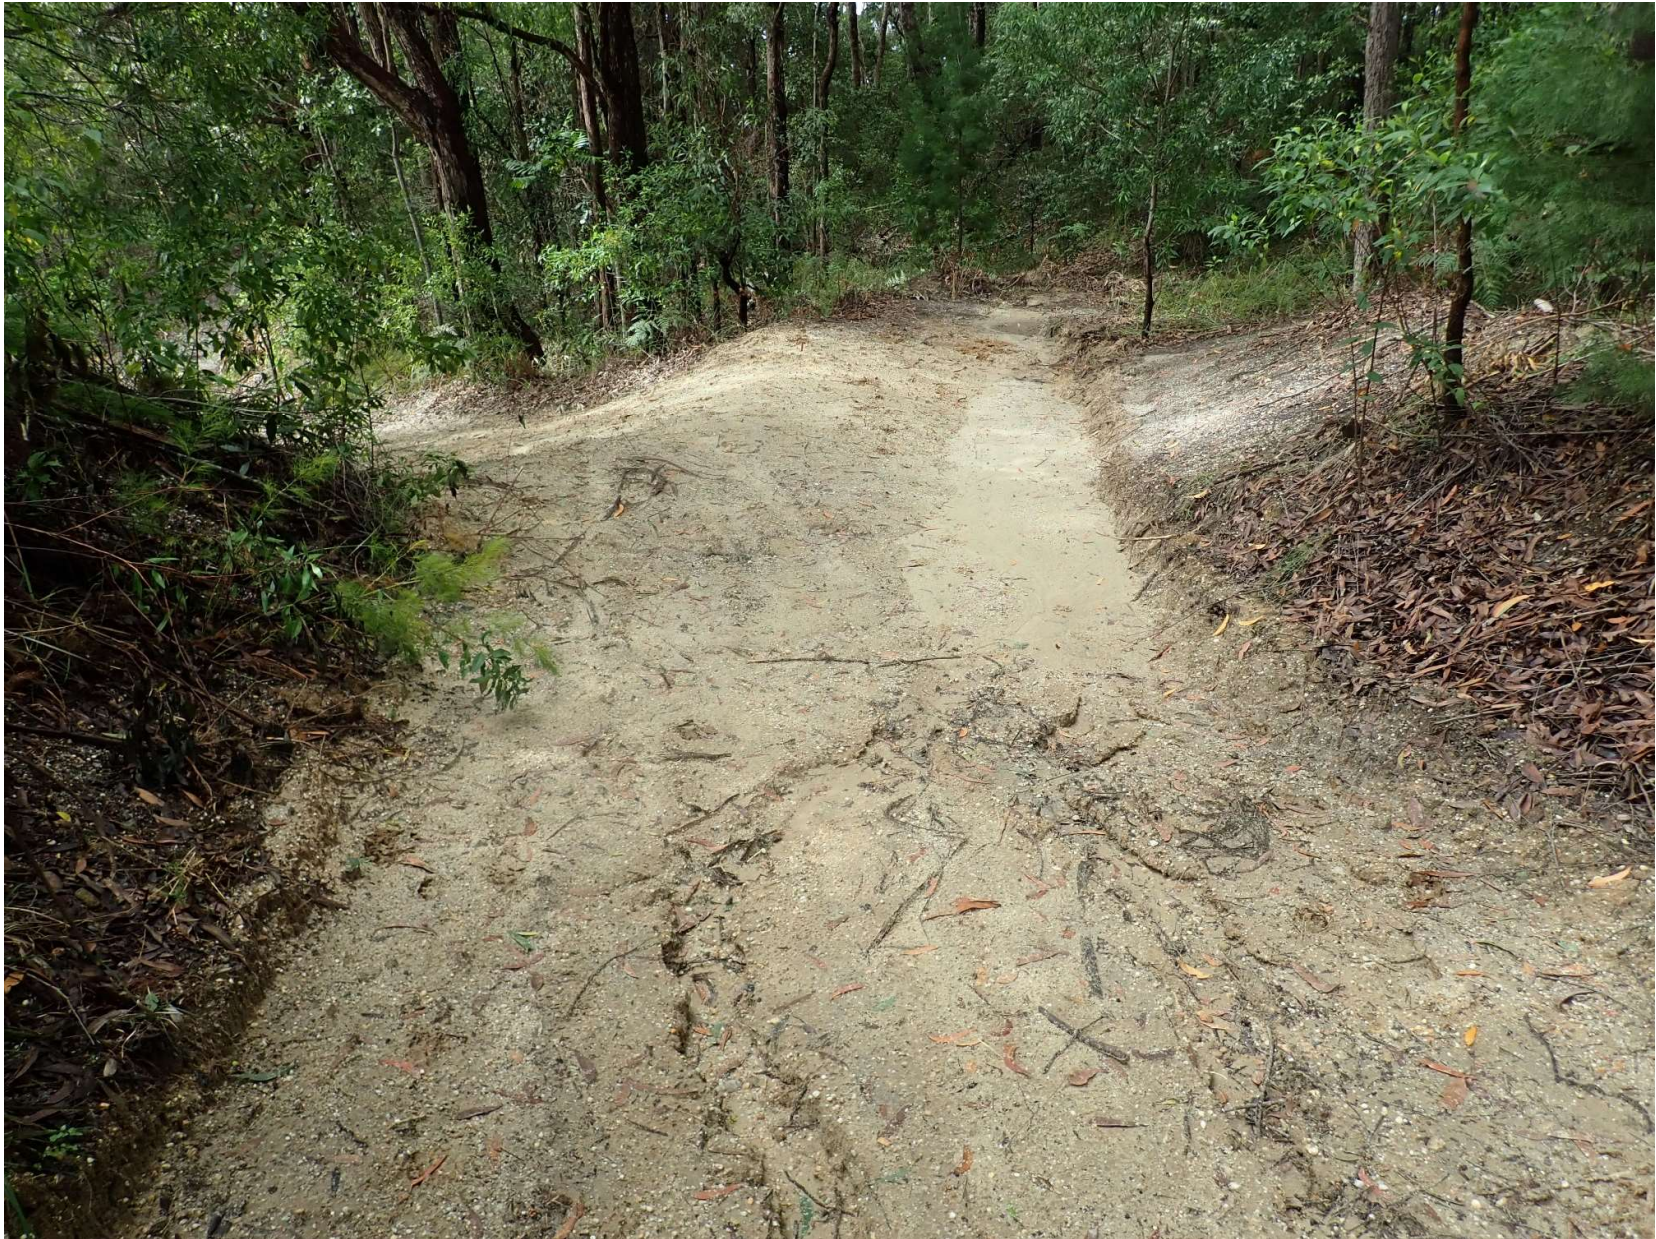
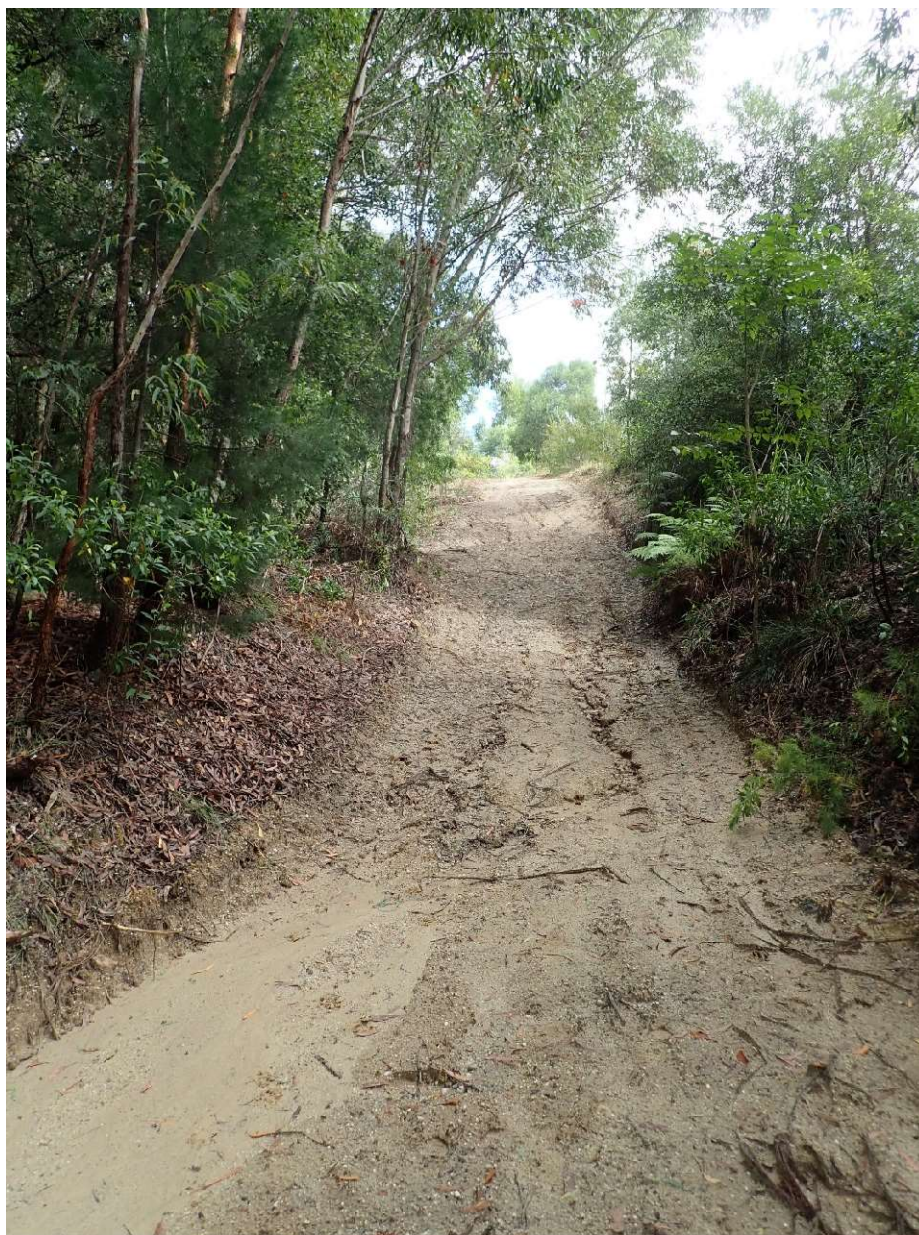
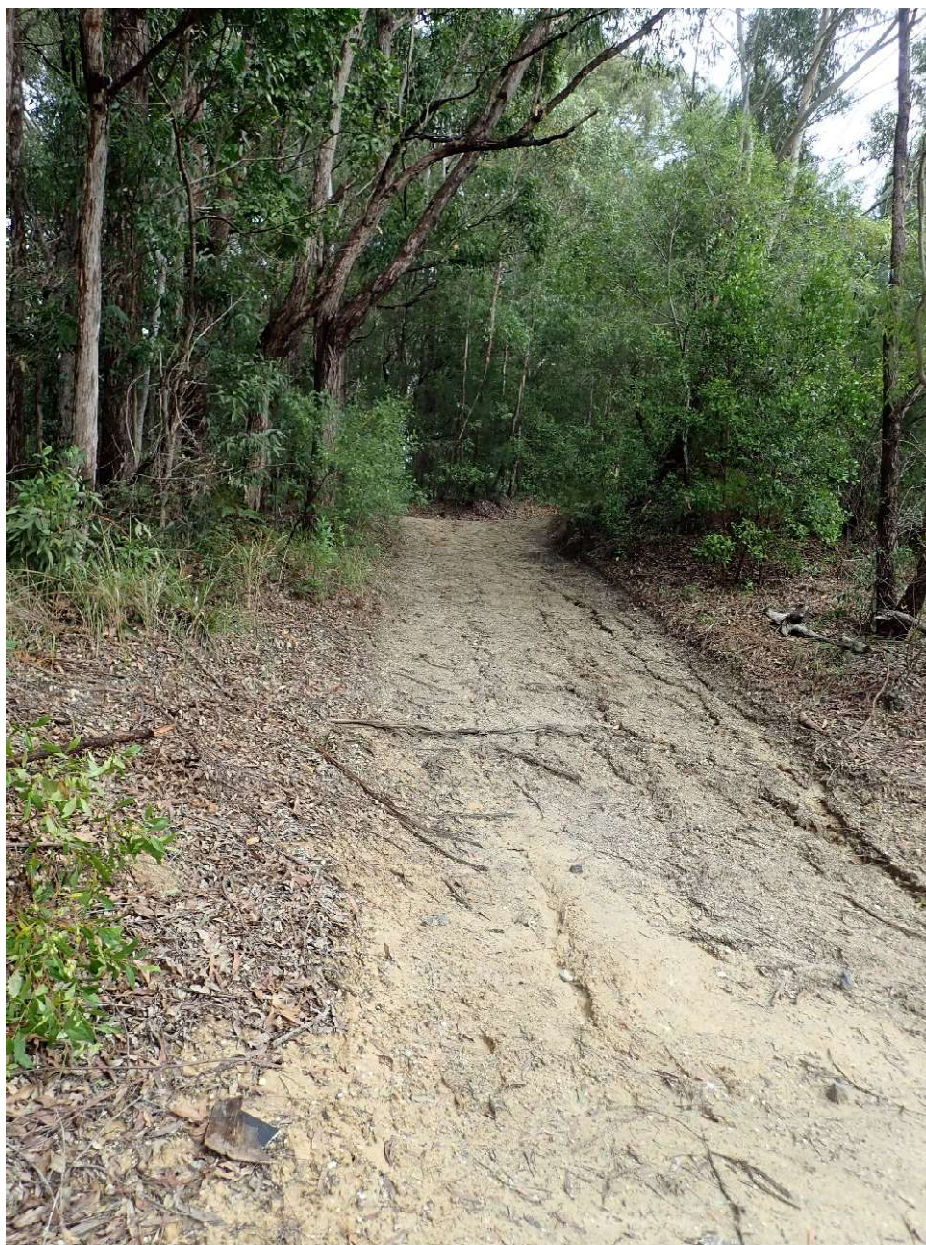
Picture 24 – Woah-boy and repaired road

Picture 25 – Woah-boy and repaired road

Picture 26 – Woah-boy and repaired road

Picture 27 – Woah-boy and repaired road

Picture 28 – Woah-boy and repaired road

Picture 29 –Repaired road

Picture 30 –Repaired road

A number of woah-boys were installed and the road surface repaired.

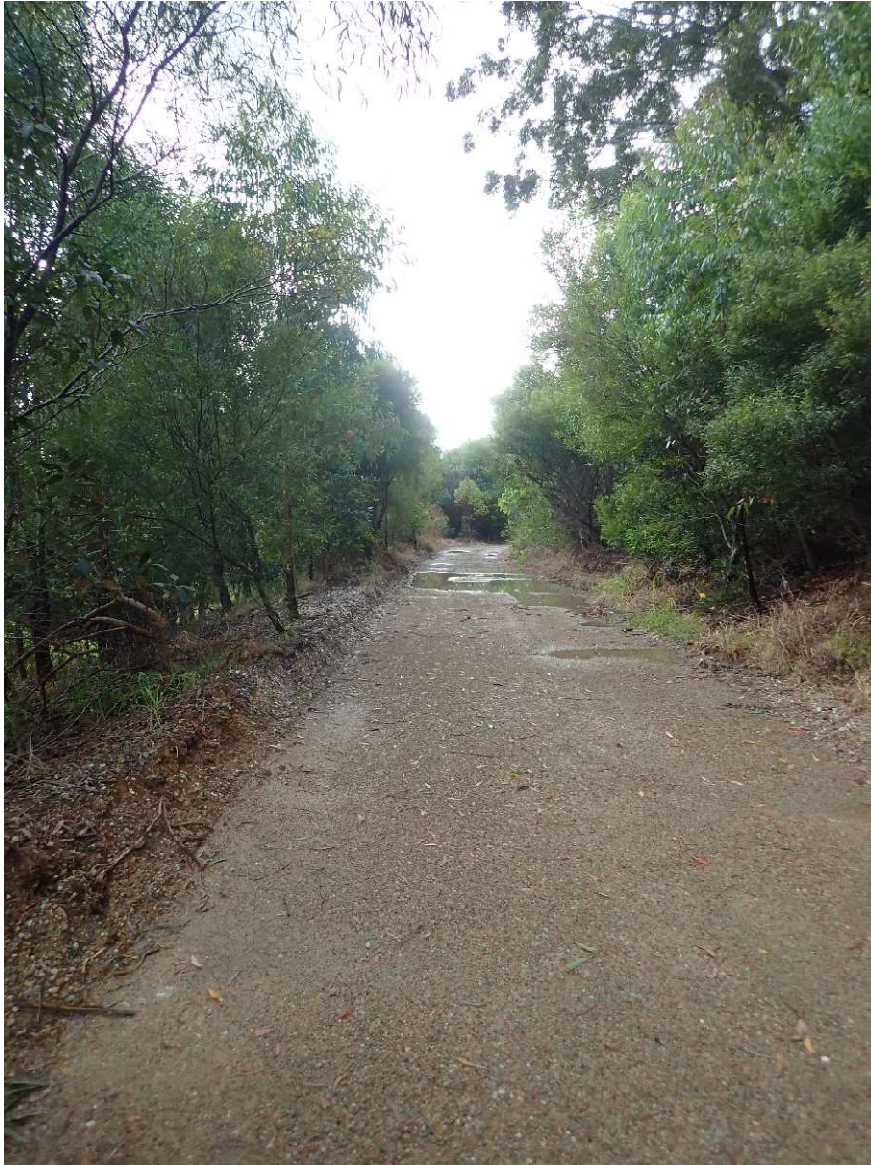
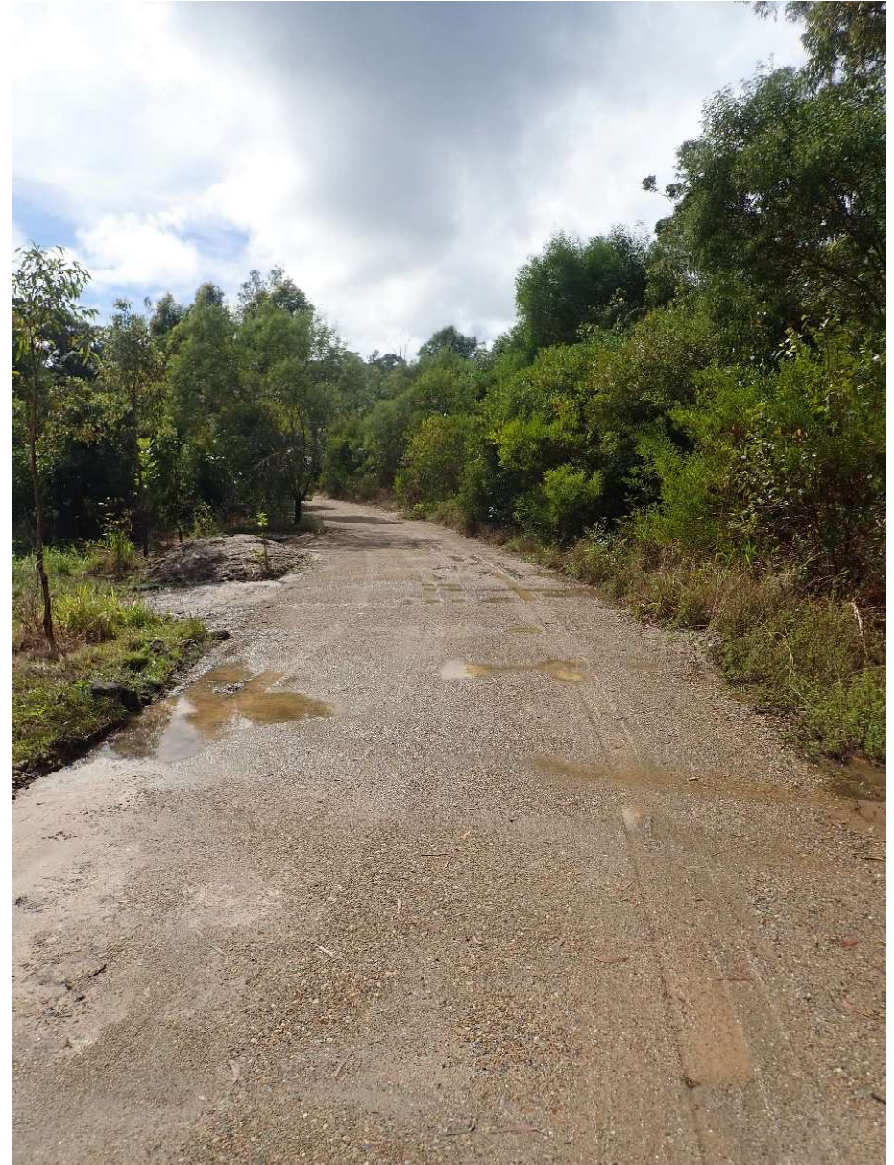
These works are shown in purple in Figure 3. The upper portion of this road is relatively flat, constructed from sand and drains poorly and becomes sodden and hard to navigate in wet weather. The road was resurfaced with road base.

Picture 31 (looking south) & 32 (looking north) – Repaired road

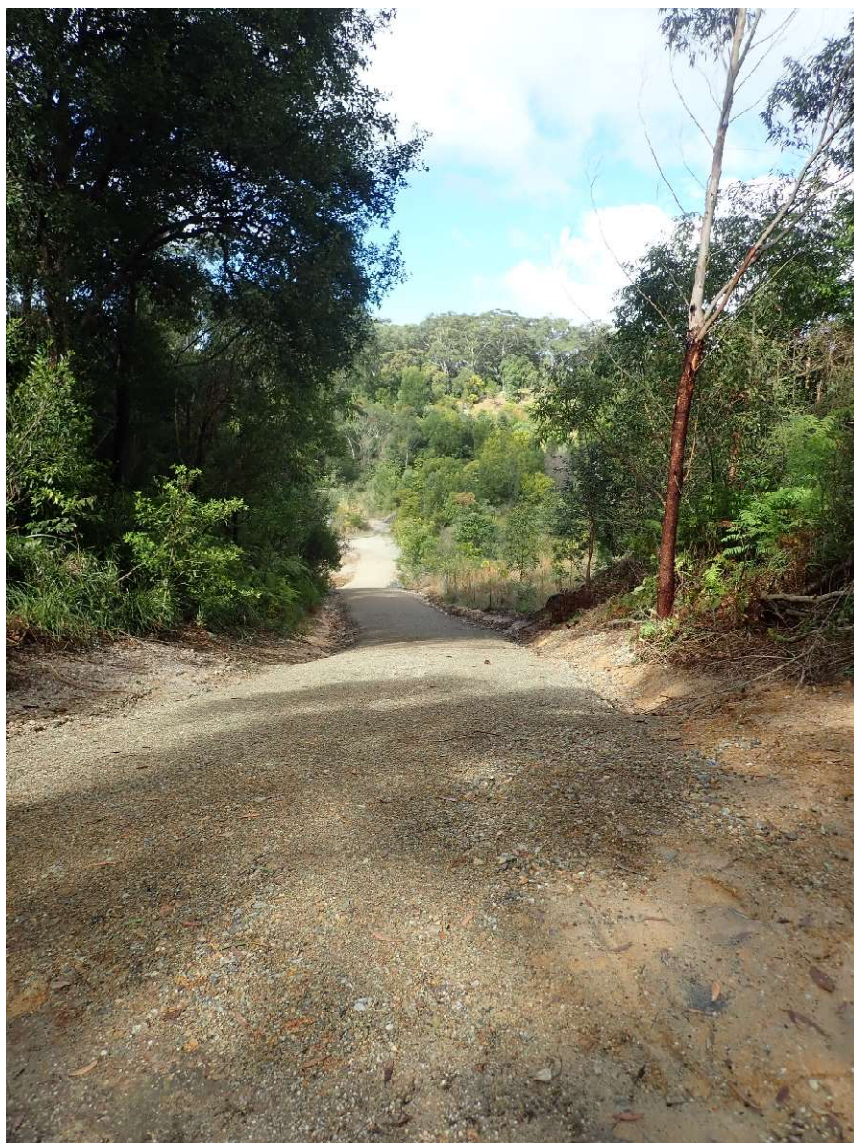
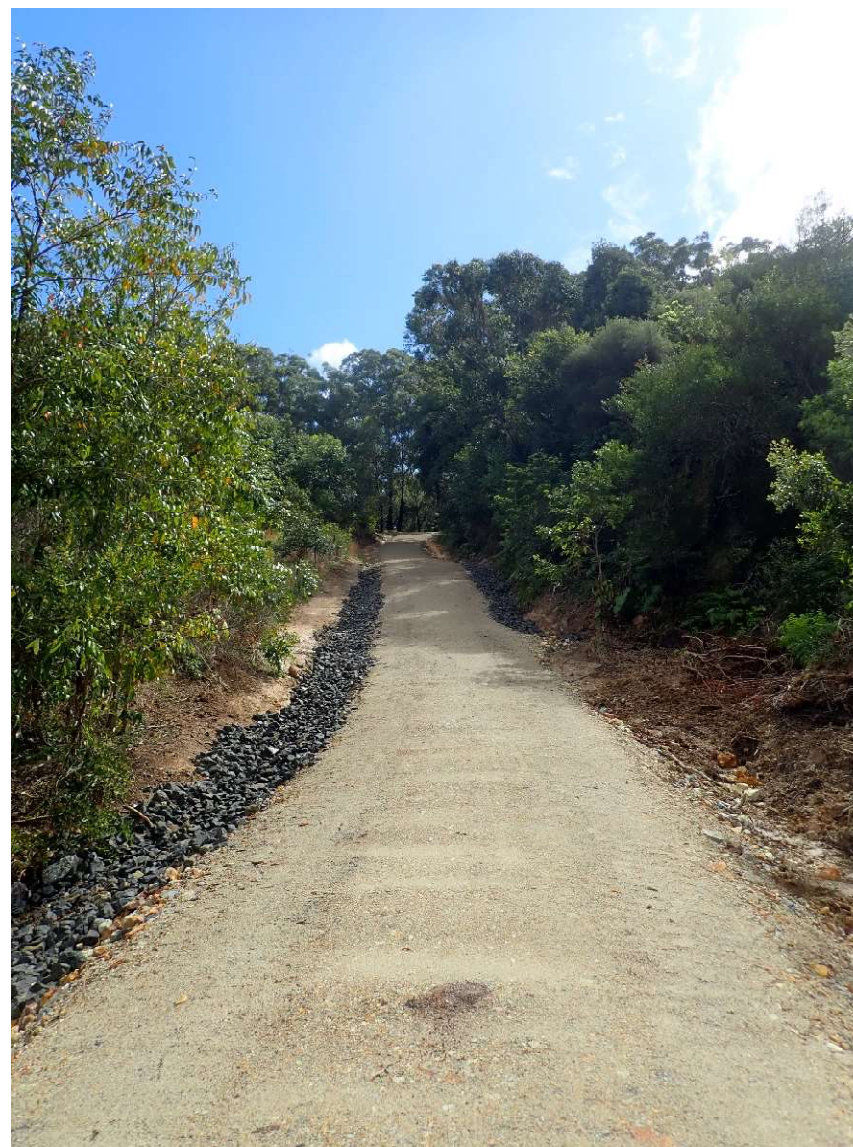
These works are shown in purple in Figure 2. The spillway from the upper dam formerly discharged to the lower dam via drainage lines underneath the road. These drains were blocked and the entry and exit points overgrown, preventing water from travelling under the road surface. This resulted in silting of the road making it un-trafficable, as well as causing water to collect beside the road. In addition, the steeper portion of the road to the west has suffered scour.

Picture 33 (looking down road) & 34 (looking up road) – Repaired road and edge drain

Repairs to rectify these issues were undertaken and drains added to the edge of the road.

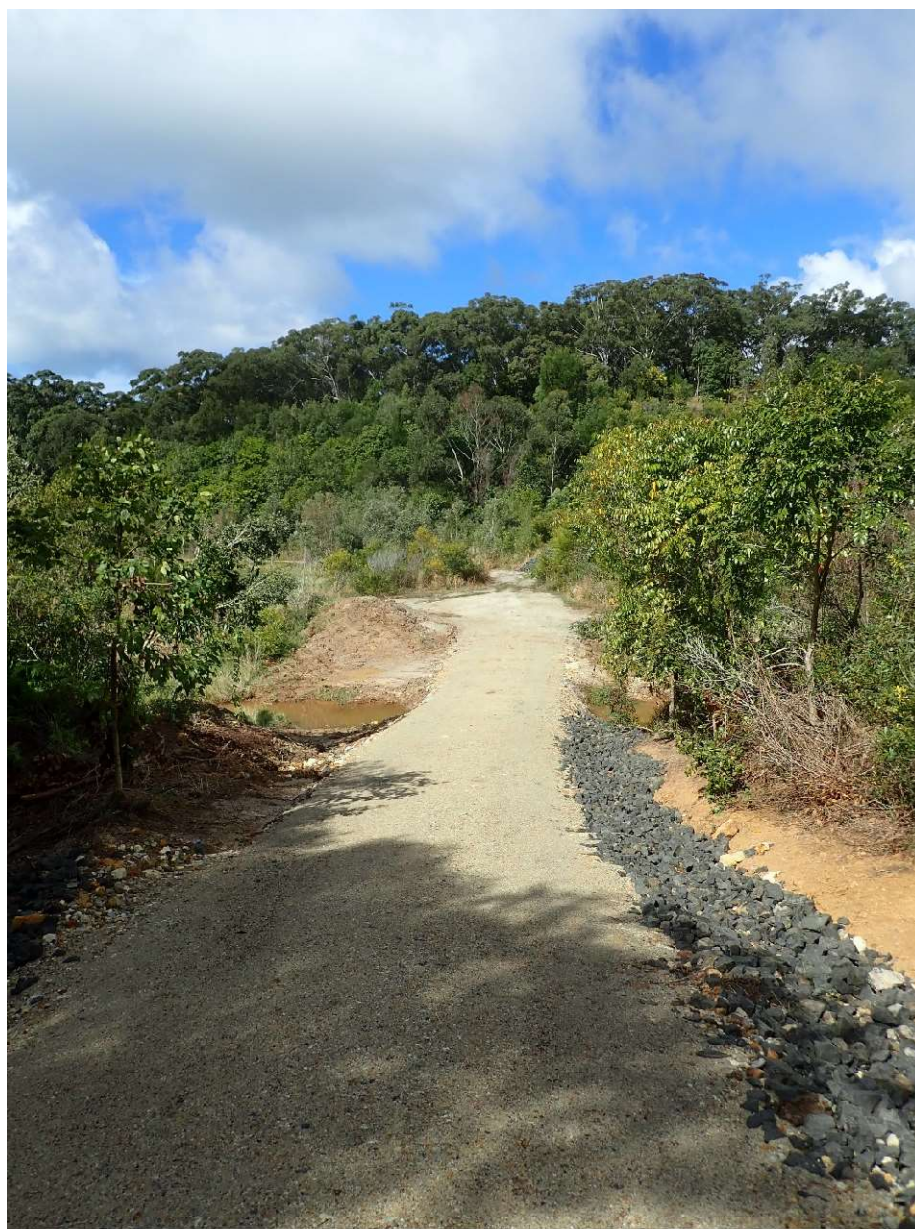
Picture 35 - Repaired under road drains and road surface

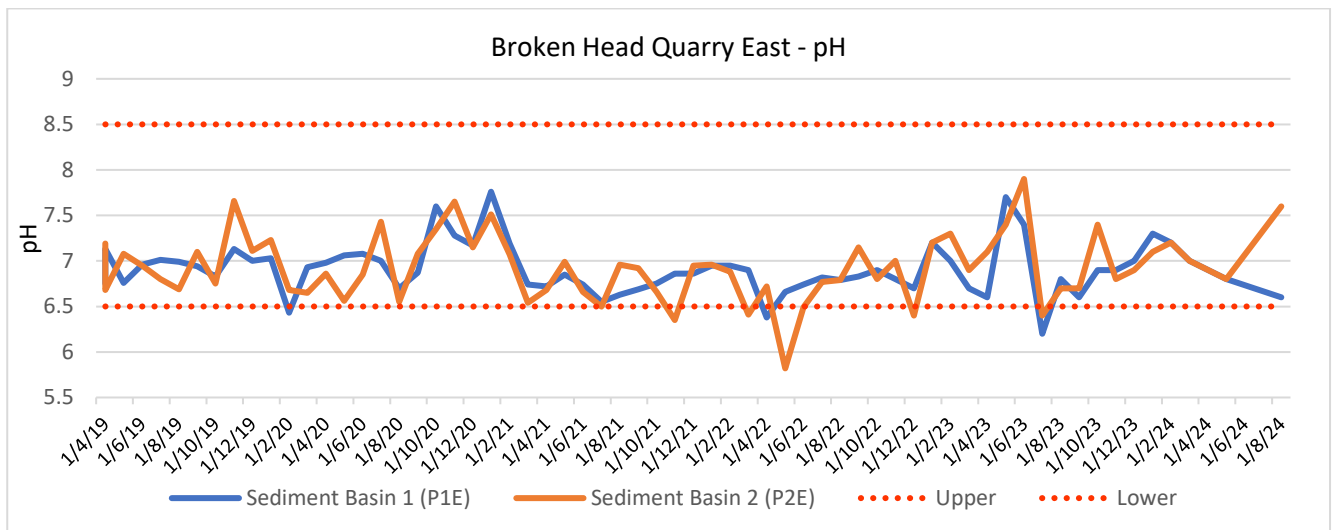
Figure 1: Eastern Sediment Basin Rolling Summary (pH)

Presented in Figure 1 and Figure 2, sediment basin P1E has been pH compliant during all sampling events except for three sampling events occurring in February 2020 (pH 6.43), April 2022 (pH 6.38) and July 2023 (pH 6.20). The pH was found to be slightly below the threshold on all occasions (pH 6.50 - 8.50). Sediment Basin P1E has been TSS compliant on all sampling occasions.

Water quality (pH and TSS) within sediment basin P2E has been compliant on all occasions except for four sampling events carried out in November 2021 (pH 6.35), March 2022 (pH 6.41), May 2022 (pH 5.82) June 2022 (pH 6.49) and July 2023 (pH 6.40).

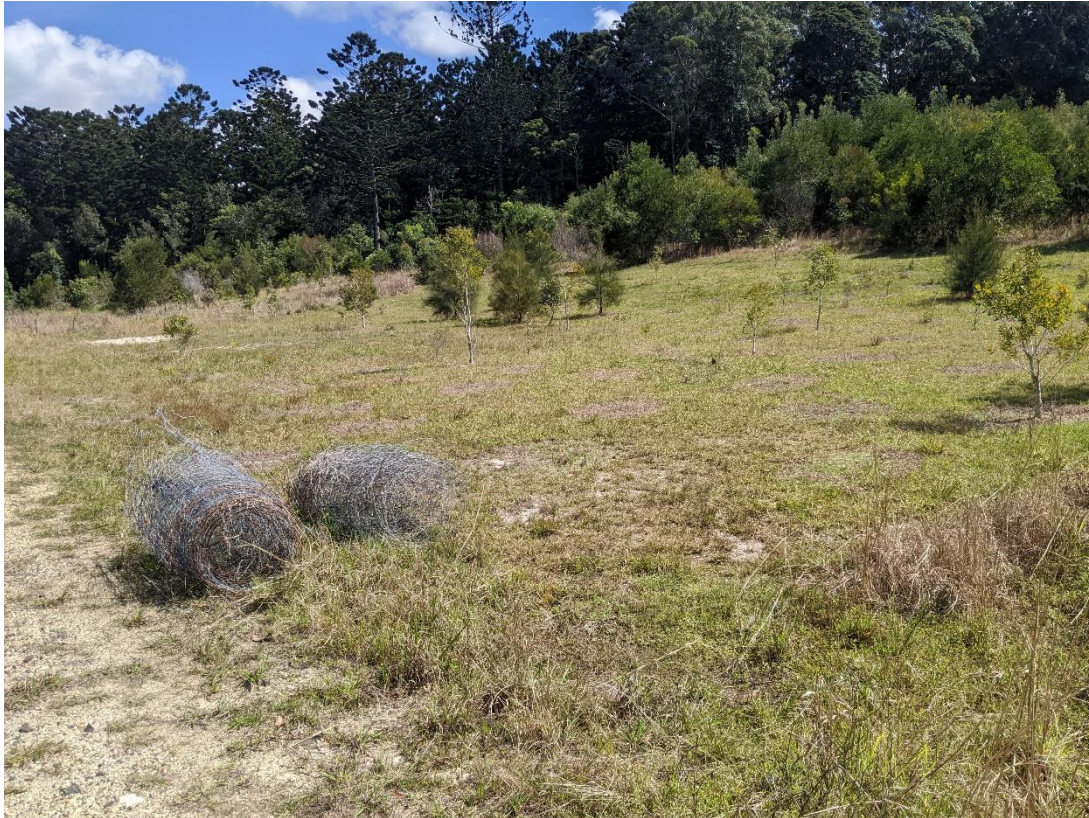
Photo 1 – Recommend infill planting for areas of poor survival rates.

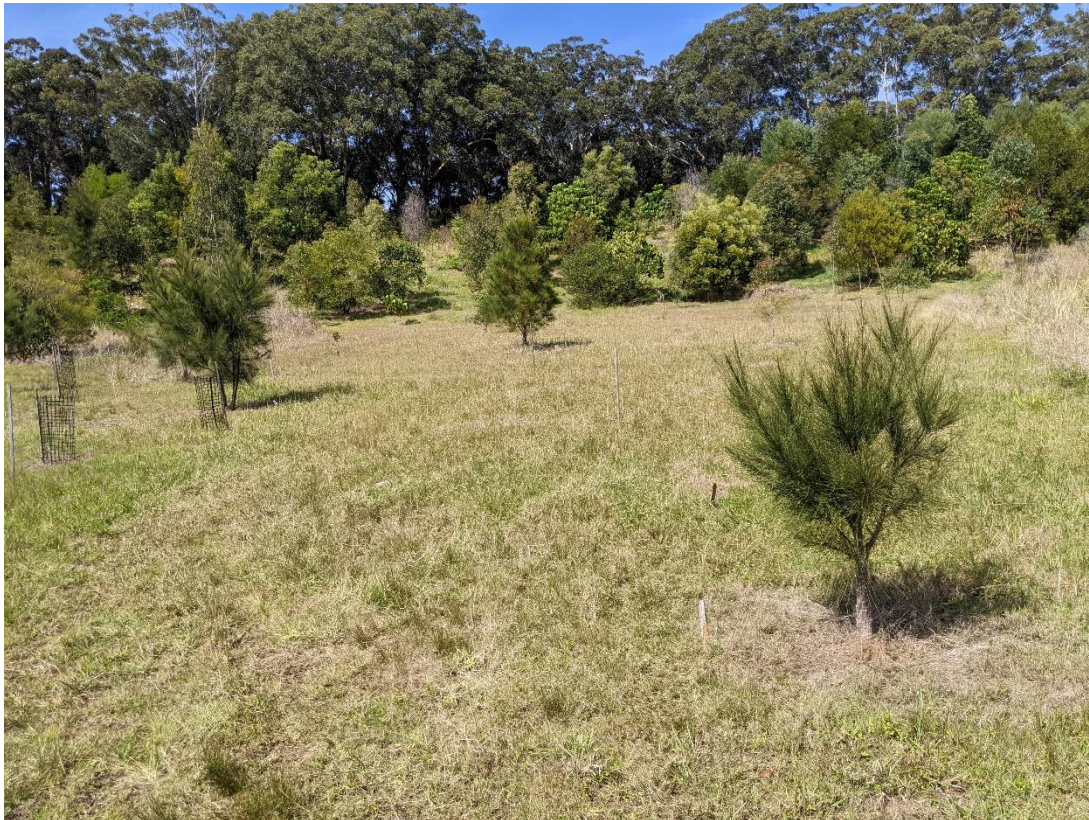
Photo 2 – Recommend infill planting for areas of poor survival rates.

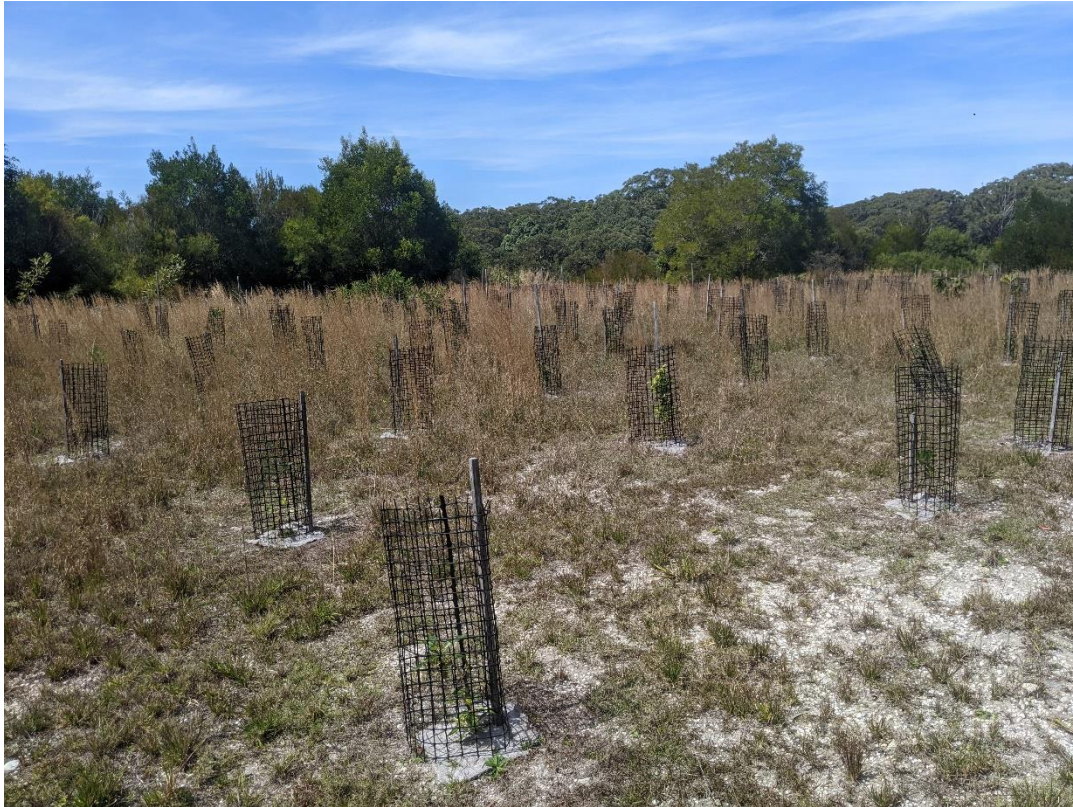
Photo 3 – Recommend infill planting if survival rates drop.

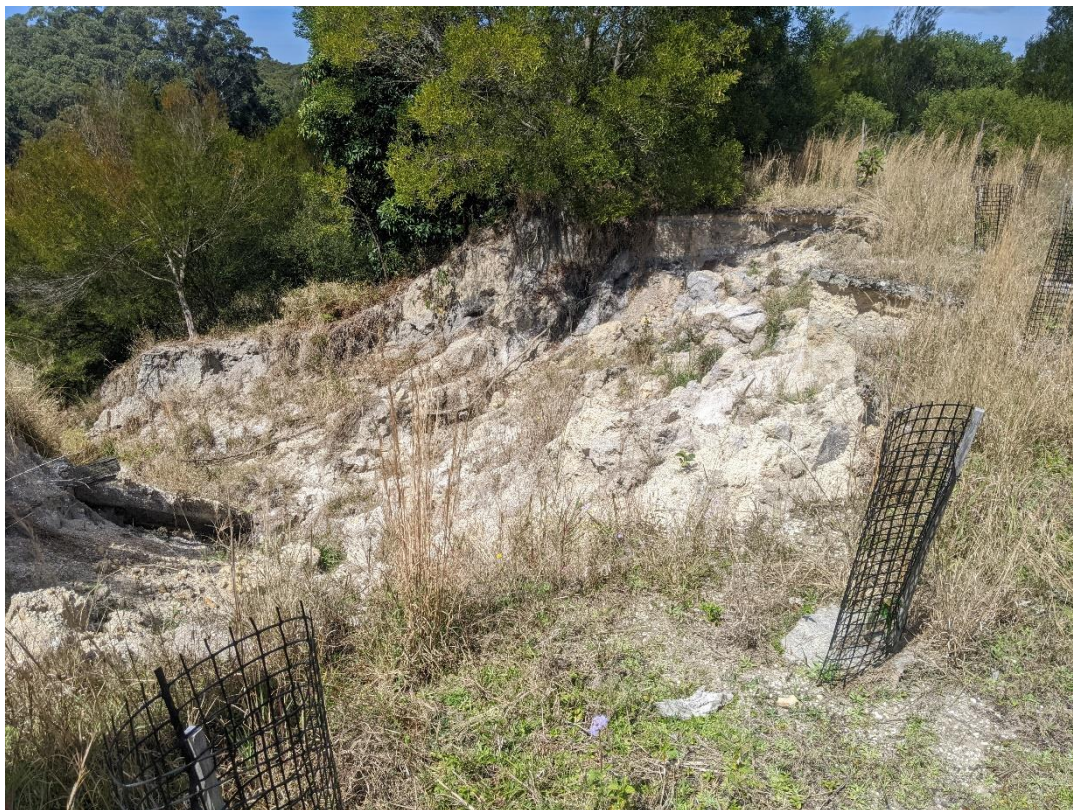
Photo 4 – This area requires repair. Significant mass movement needs to be reshaped and stabilised. Upslope water needs to be diverted or directed downslope.

- repair, reshaping and fill of the original landslide area, with a batter gradient of 1:3;
- repair of road and installation of a culvert under to manage the water in the new drain, cut, form and rockfill road edge drain leading to new drainage pit feeding new culvert;

- trapezoid drain, geofab lined and rock filled to manage runoff that caused the original landslide, down to a new drainage pit feeding new culvert;
- repair, reshaping and fill of the batters adjacent to the original landslide area to replicate the batter gradient and direct surface water to the head of the new drain;

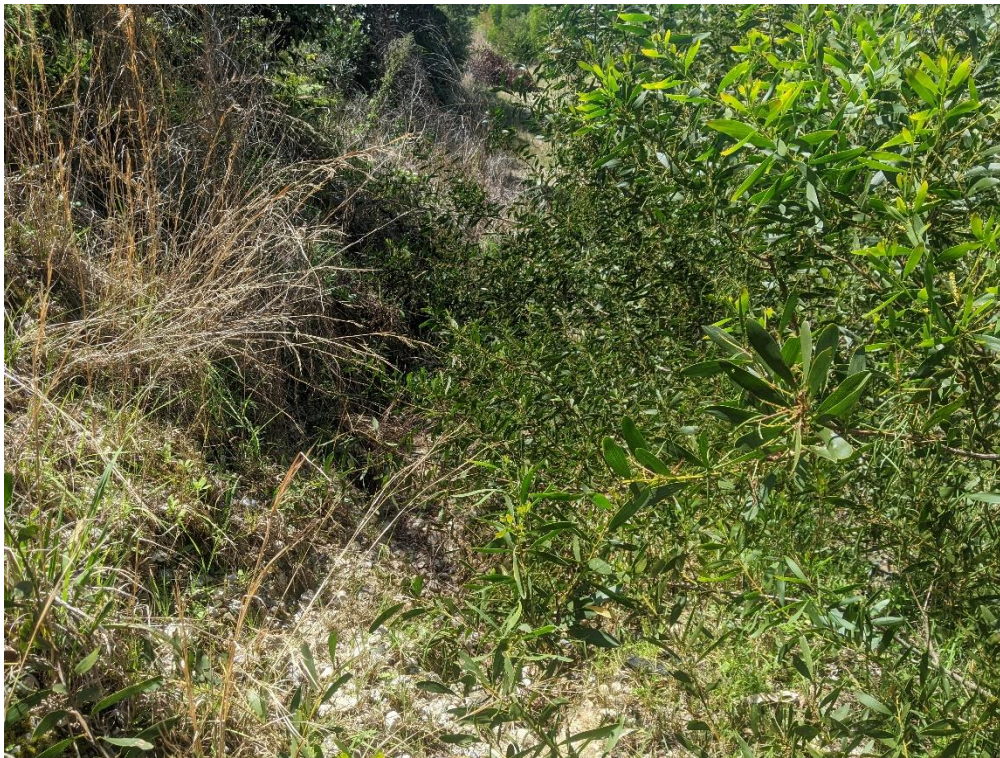
Photo 5 – This internal road is acting as a informal drainage line and is experiencing scour. It needs to be repaired and stabilised.
