Broken Head Quarry

Enforceable Undertaking Progress Report

Report #21 – September 2024

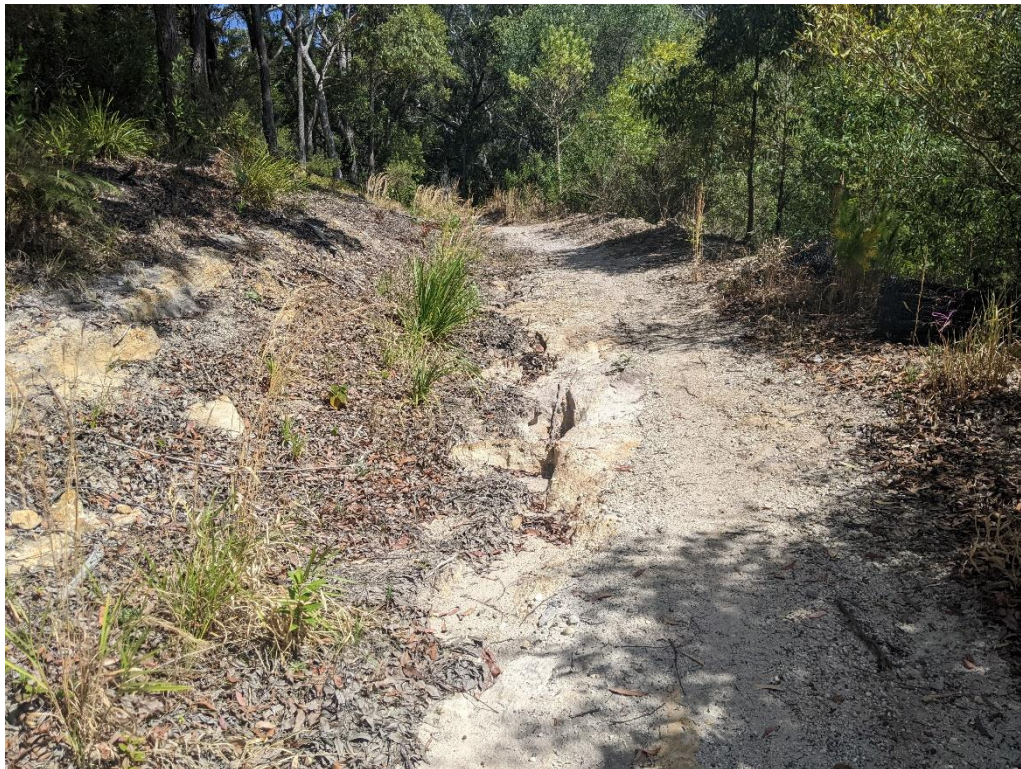
Photo 6 – Please install occasional whoa-boys to prevent scour along fire trail.

A number of woah-boys were installed and the road surface repaired.

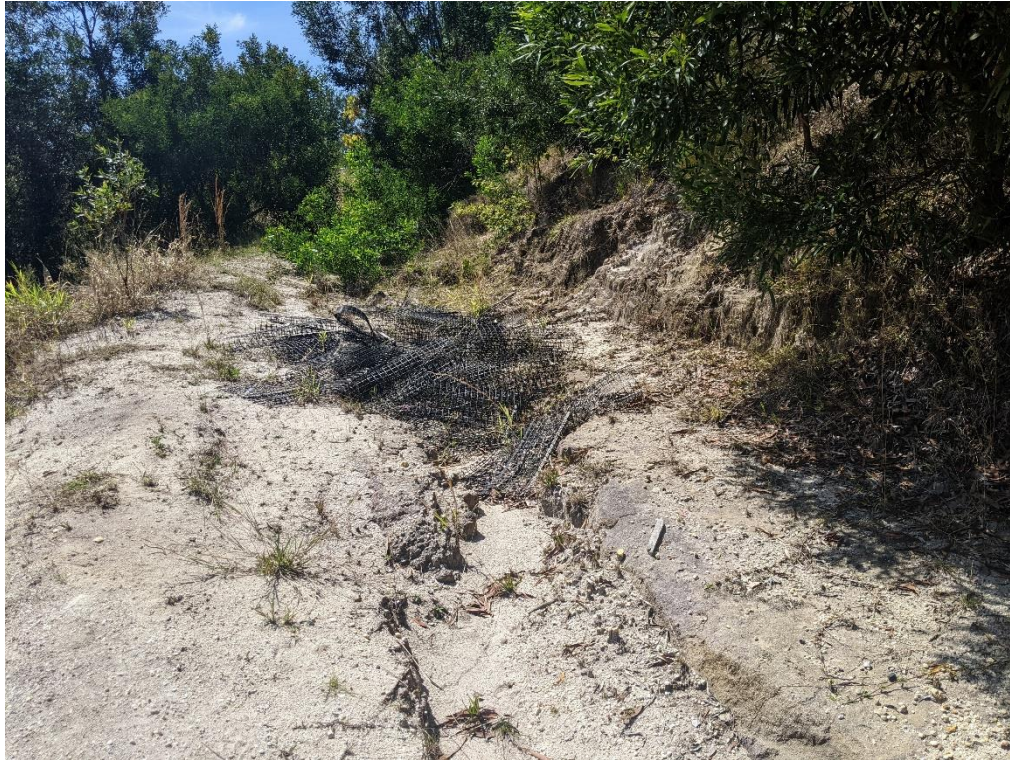
Photo 7 – Please install occasional whoa-boys to prevent scour along fire trail. Please clean up excess treeguards.

A number of woah-boys were installed and the road surface repaired.

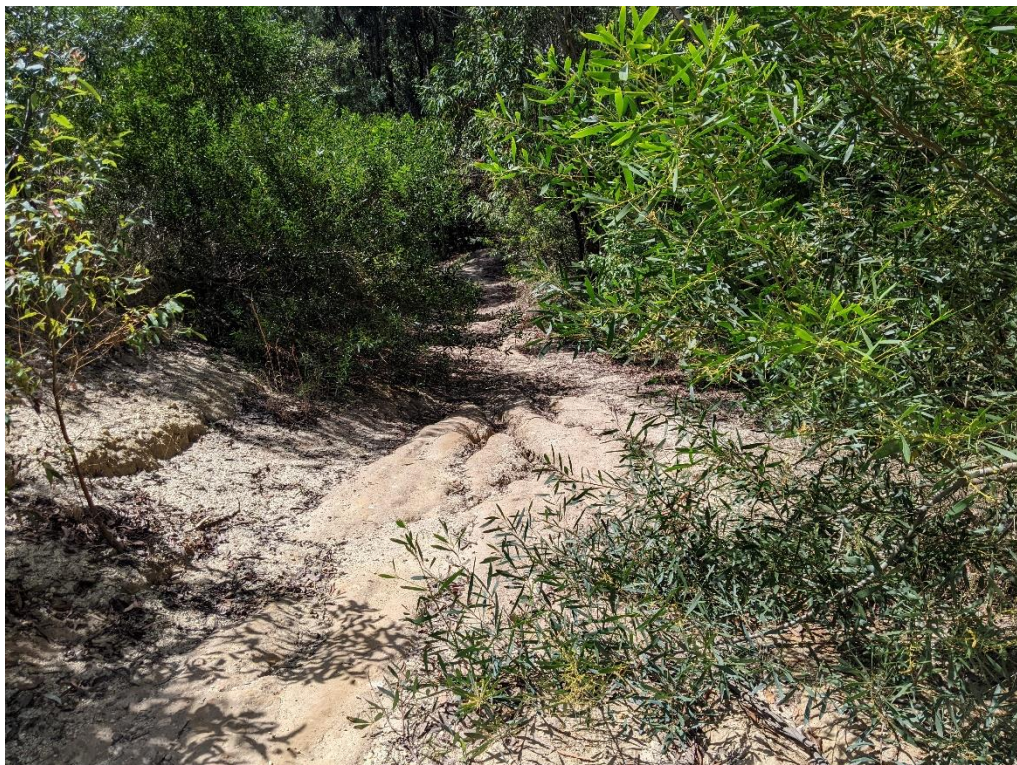
Photo 8 – Please install occasional whoa-boys to prevent scour along fire trail.

A number of woah-boys were installed and the road surface repaired.

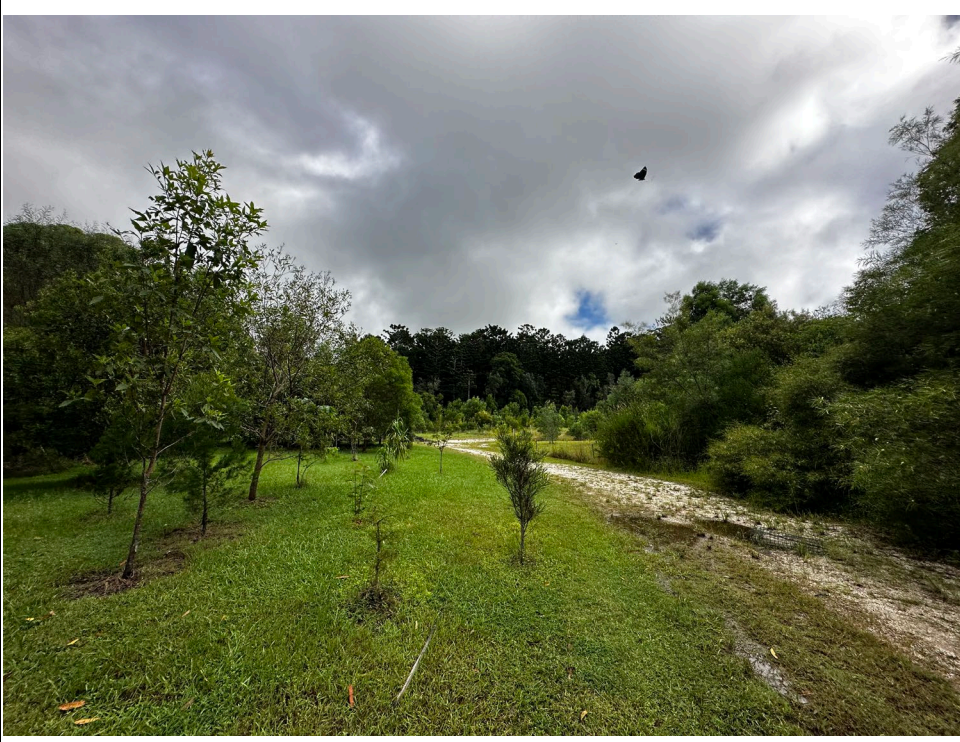
2	13/03/2023	
Description Image showing site stabilization and revegetation area in western portion of quarry

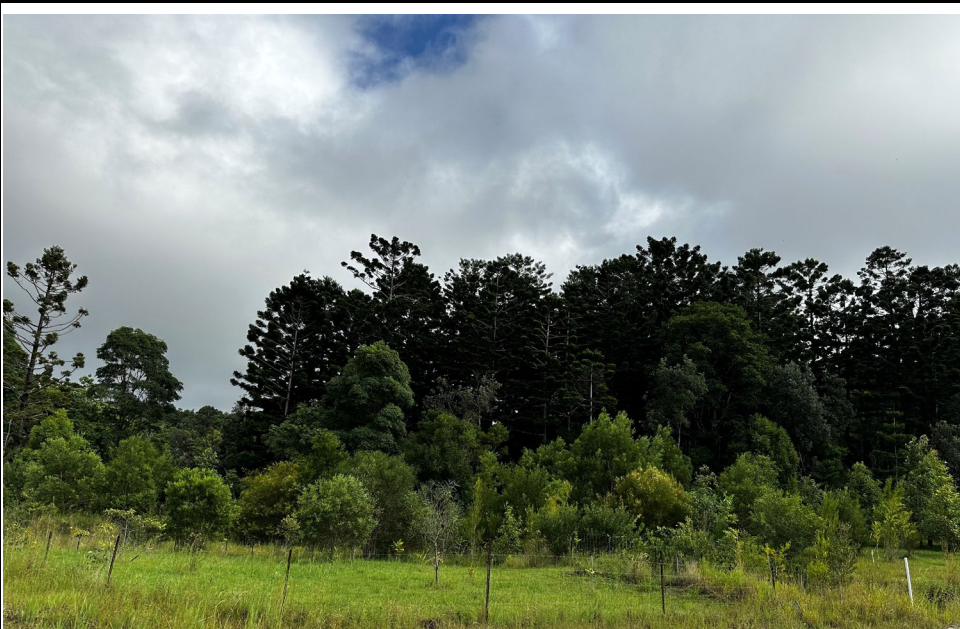
3	13/03/2023	
Description Image showing site stabilization and revegetation area in western portion of quarry

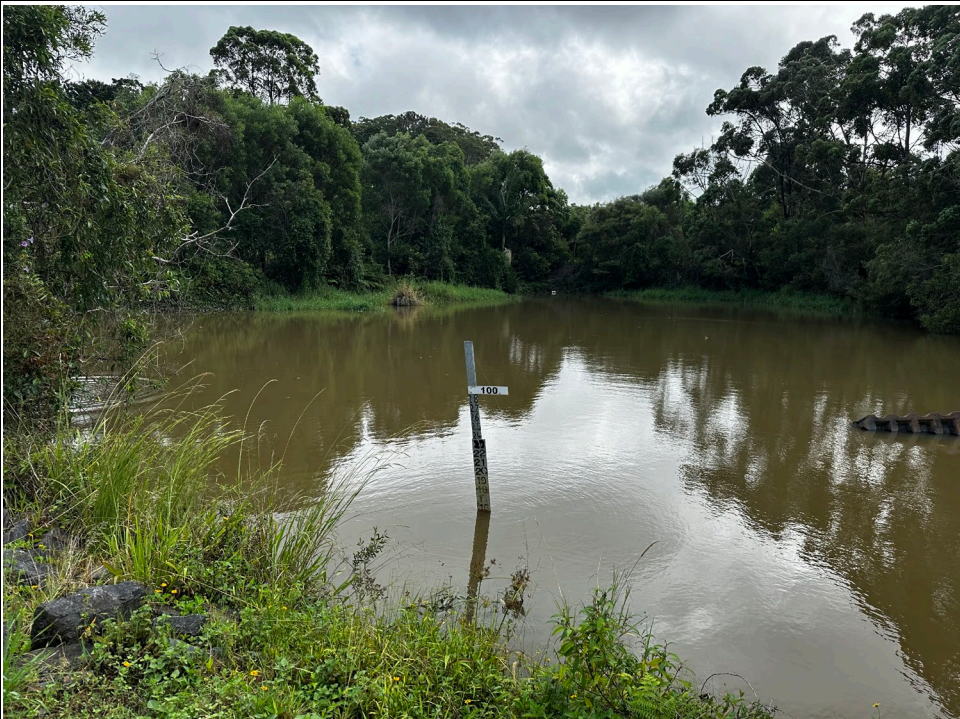
4	13/03/2023	
Description Image showing Sediment Basin (P4). All embankments are stable, inlets and outlets are stabilized with riprap as per Blue Book requirements. Water quality results in Table 1.

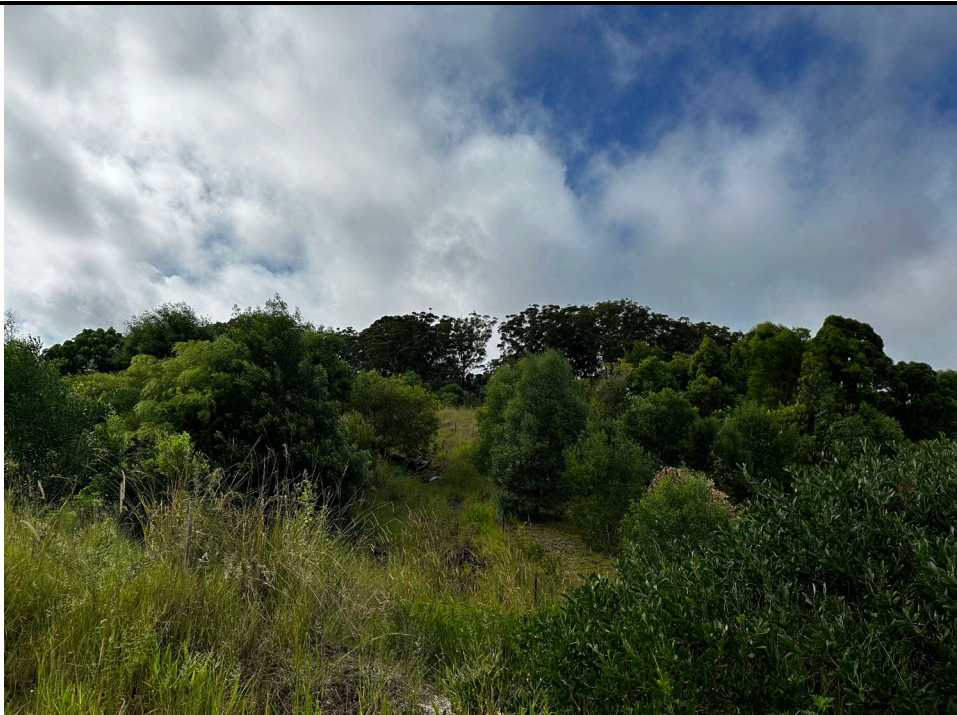
5	13/03/2023	
Description Image showing stabilized batter located within the eastern portion of the quarry

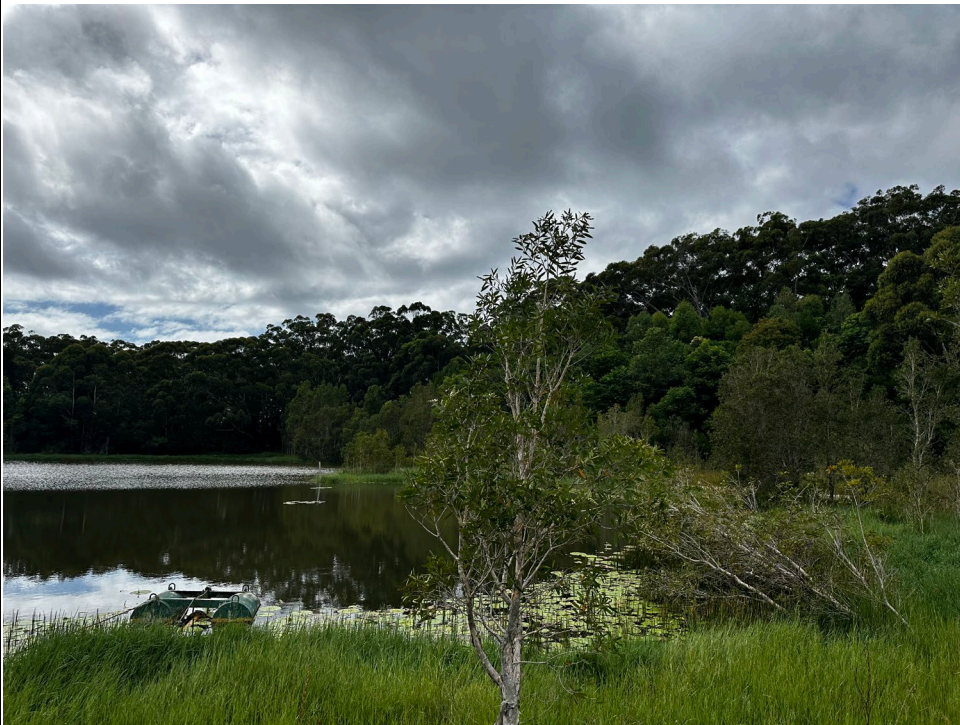
7	13/03/2023	
Description Image showing stabilized (vegetated) sediment basin (P5)
