Service Bulletin

REMOVE AND REPLACE INBOARD/OUTBOARD TRIM TAB ASSEMBLIES

HELICOPTER MODELS AFFECTED: Bell Helicopters, Inc. Models 206L, 206L-1, 206L-3, 206L-4.

NOTICE No.: 33000-3R2

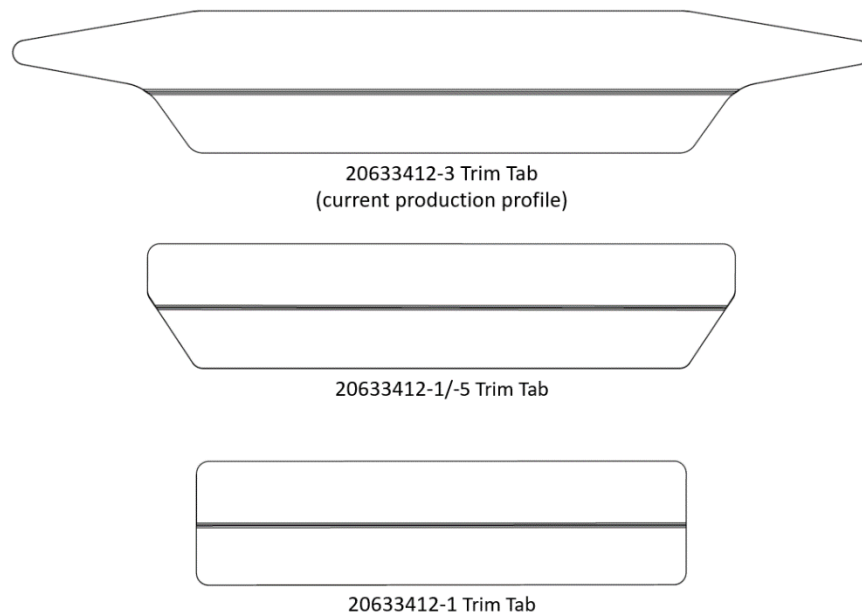
Figure 1 – Trim Tab Profiles

- (1) Reference Figure 1 for profiles of the various trim tab installations. Use a razor blade and trace the profile of the trim tab, cutting through the paint layer, upper and lower surface of the blade. Scoring the paint in this way will allow the trim tab to pull cleanly through the paint layer when it is removed. Only cut into the paint layer. Do not cut into the underlying composite layers.

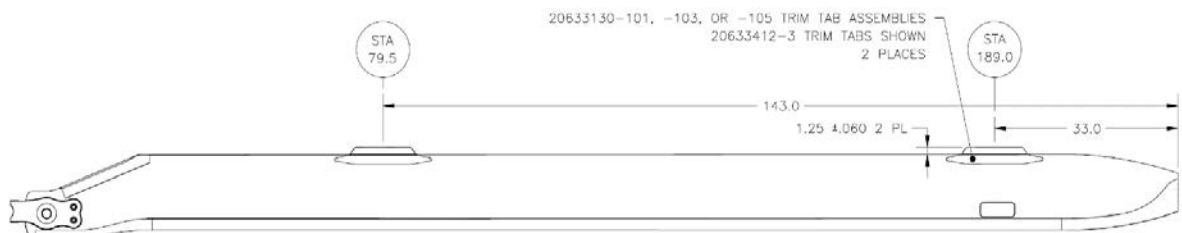
Figure 2 – Trim Tab Locations

- (1) Complete all applicable procedures in Section A. REMOVE EXISTING TRIM TABS.
- (2) Reference Figure 2 for trim tab locations.

- (3) Temporarily locate and center a new 20633130-103 Trim Tab Assembly to the tab-to-blade bond areas indicated in Figure 2 (at STA 79.5 and STA 189.0). Trace the outline of the trim tab assembly onto the blade surface with a permanent marker. Remove the trim tab assembly. Reference Figure 3.
- (4) Mask along the outside edge of the traced trim tab profile with masking tape, polyurethane tape or metal foil tape. The tape will protect the existing paint from sanding damage and serve as a visual guide when enlarging the bond area.

- (5) **INSPECTION:** Verify the trim tab assembly is located correctly per Figure 2. Remove the trim tab assembly and confirm that all areas within the outline are free from old adhesive, paint and any other contaminants. Verify that the prepared surface of the tab-to-blade bond area is clean and ready for adhesive application.

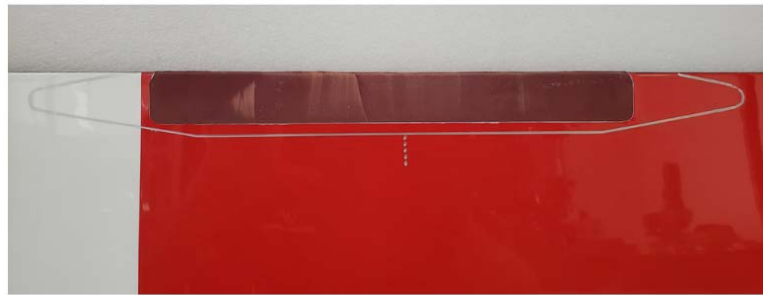
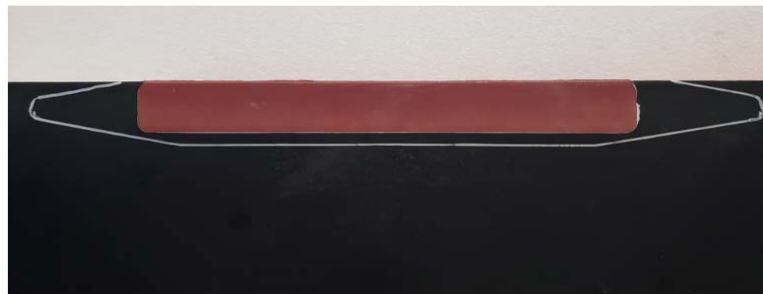
Upper Surface

Lower Surface

Figure 3 – New -103 Trim Tab Assembly Profile Traced onto Blade

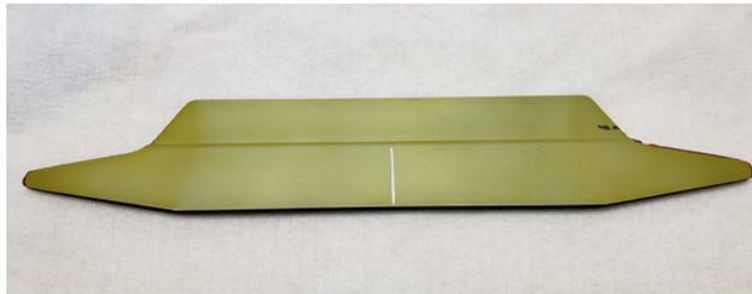
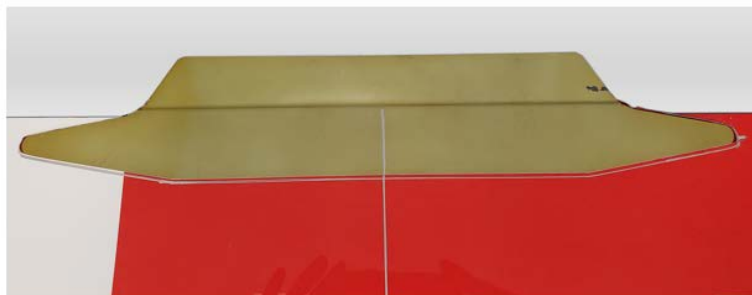
Centerline on Trim Tab Assembly

Centerline on Blade Surface

Figure 4 – Centerline on Trim tab Assembly and Blade Surface

- (2) Remove the trim tab assembly from its packaging and proceed immediately with the remaining steps.
- (3) Measure the length of the trim tab assembly and mark the center with a line (see Figure 4). On the blade assembly, mark the center of the tab-to-blade bond area, using the dimensions indicated in Figure 2. Dry fit the trim tab assembly (20633130-103 shown) to the blade. Align the center mark on the trim tab assembly with the mark on the blade.

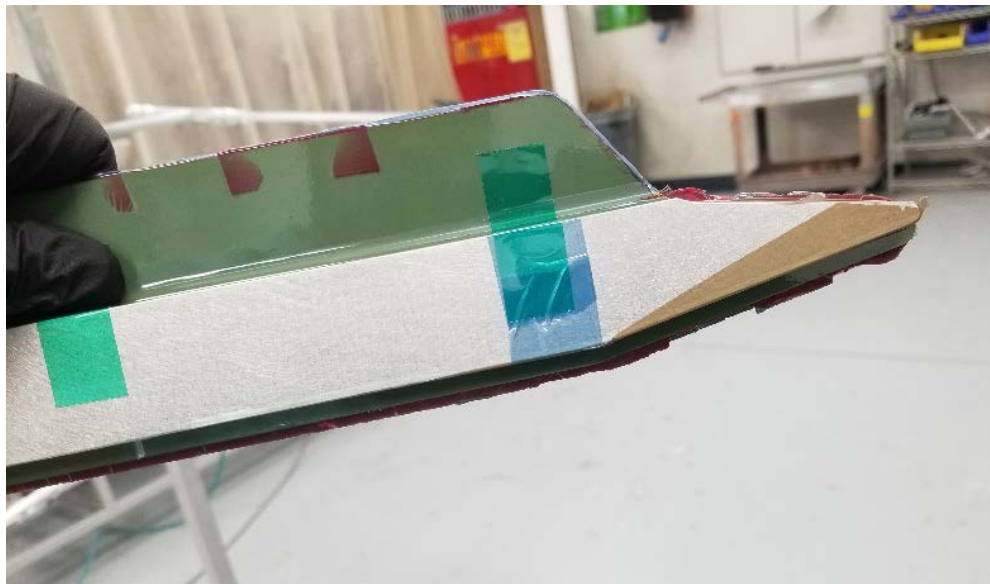
Figure 5 – Metal/Rubber Caul taped to Trim tab Assembly

- (7) **INSPECTION:** Verify that the pre-cured adhesive surface has been scuff-sanded and is clean and free of debris.
- (8) Attach one rubber-backed metal caul (206CS33130-103) to each side of the trim tab assembly with flash breaker tape. Make sure that the rubber side of the caul is in contact with the surface of the trim tab assembly. Ensure that all edges of the trim tab are visible and not covered by the caul plates (Figure 5). Verify there is no tape inside the trim tab assembly.

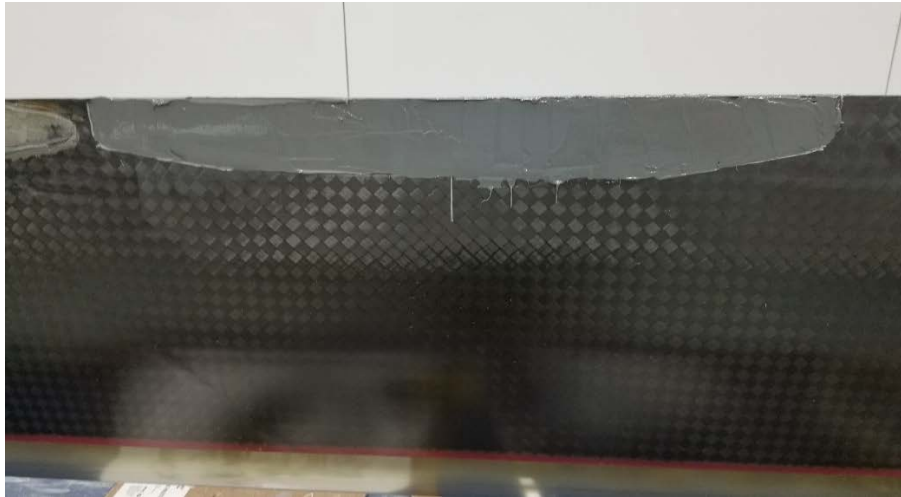
Figure 6 – Adhesive Applied to Tab-to-Blade Bond Area

- (9) Mix 65 to 75 grams of epoxy adhesive per manufacturer's instructions. Refer to the material list on page 2 for a selection of suitable adhesives. Apply a thin layer of adhesive to the blade assembly such that the entire outlined area of the tab-to-blade bond area is coated (Figure 6). Apply a similar thin layer of adhesive to the inner surfaces of the trim tab assembly (Figure 7). Verify 100% coverage of the adhesive on all bonding surfaces.

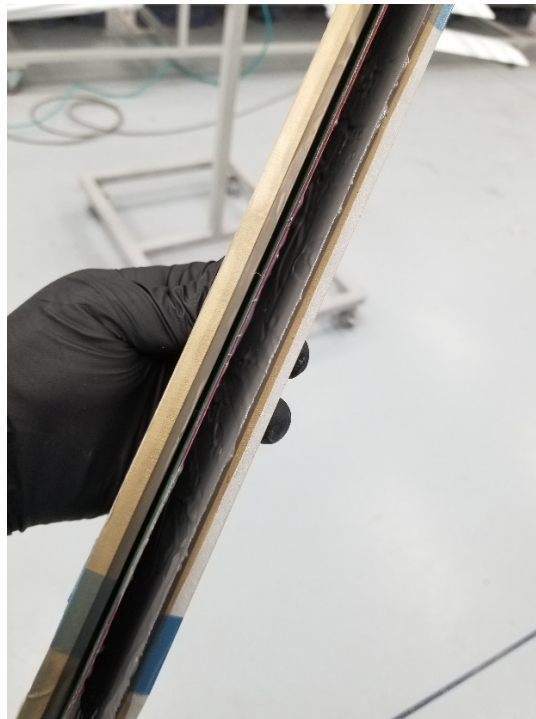
Figure 7 – Adhesive Applied to Inner Surfaces of Trim Tab Assembly

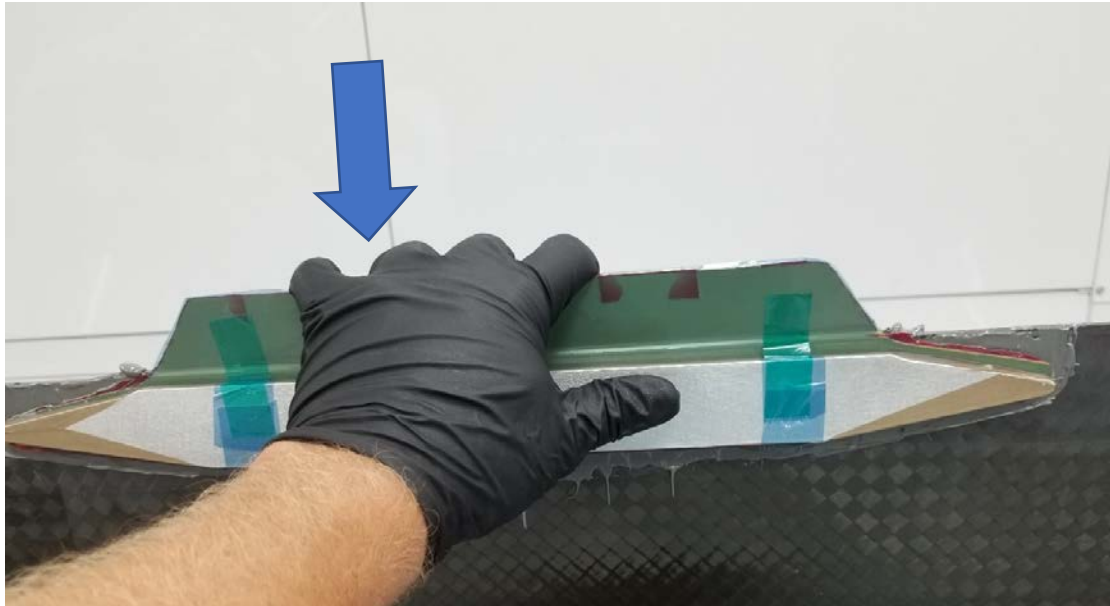
Figure 8 – Slide Trim Tab Assembly onto Blade

- (10) Hold the trim tab assembly parallel to the trailing edge of the blade and visually align the centerline mark on the trim tab assembly with the centerline mark on the blade. When the marks are aligned, slide the trim tab assembly onto the blade (Figure 8). If possible, do not make any more adjustments to the installation. Press the trim tab assembly firmly against the trailing edge of the blade. The adhesive will provide some resistance as it squeezes out around the edges of the trim tab assembly (Figure 9). Continue to apply pressure until the squeeze-out ceases and the trim tab assembly seats firmly against the trailing edge of the blade.

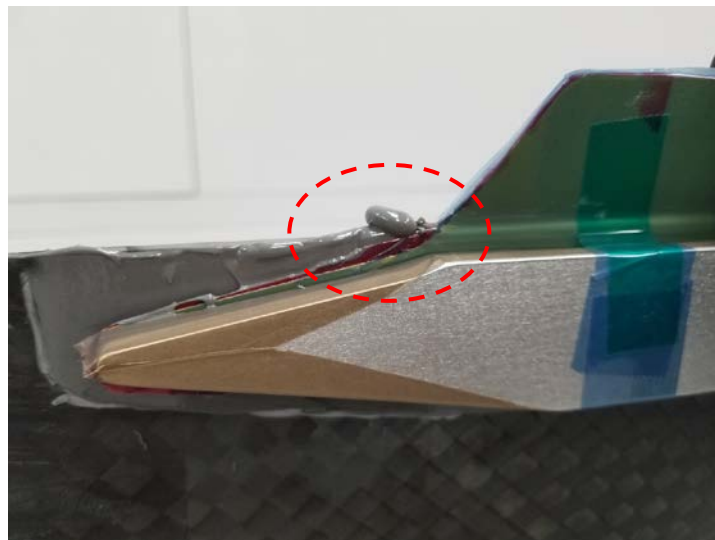
Figure 9 – Adhesive Squeeze Out from Joggle Joint

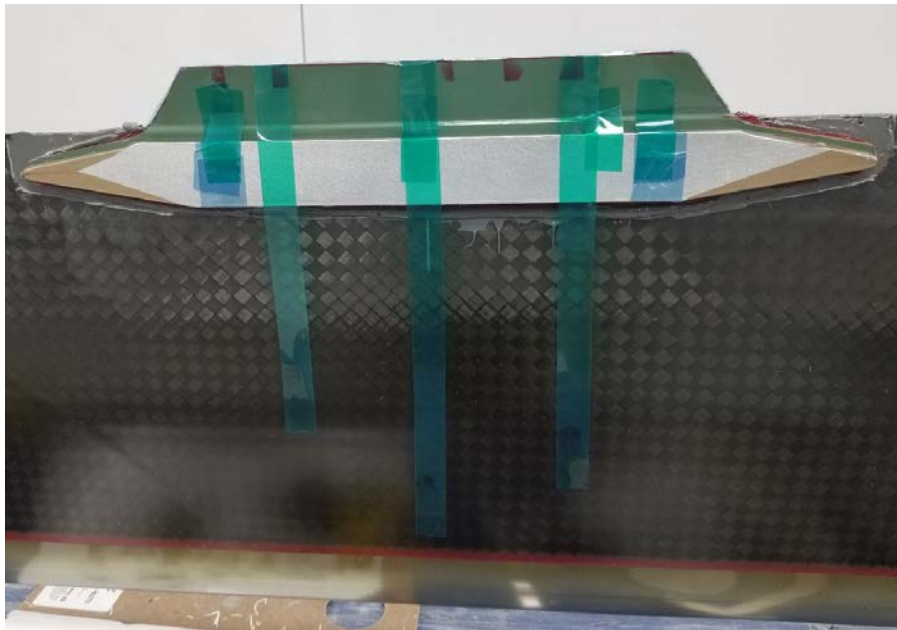
Figure 10 – Tape the trim Tab Assembly in Place to Prevent Movement

- (11) Keep the trim tab assembly seated firmly to the trailing edge of the blade. Use flash breaker tape to hold the assembly in place. Extend the tape from the trailing edge of the trim tab to the blade surface. (Figure 10).

NOTE: The trim tab assembly will slide out of position when clamping force is applied. It is important to hold the trim tab assembly in place with tape so that clamping force can be applied evenly across the metal caul plate. It is considered best practice to wrap the tape completely around the blade assembly to keep the trim tab assembly firmly seated to the trailing edge, and to prevent the assembly from moving during the room-temperature cure.

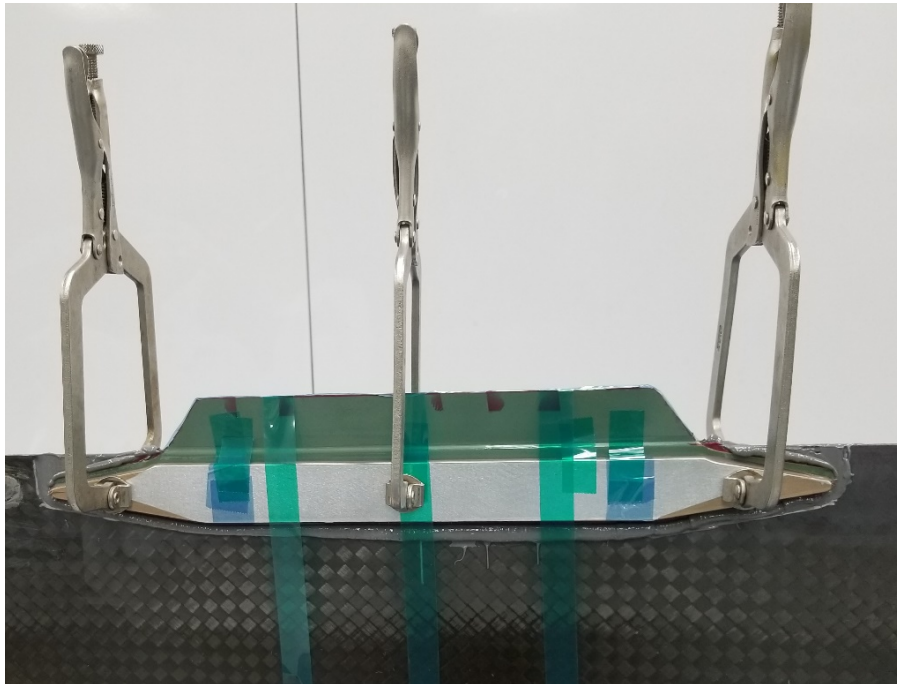
Figure 11 – Installation of Clamps Prior to Cure

- (12) Clamp the caul plates using a minimum of three (3) C-clamps, vise grip clamps, or cantilever clamps (Figure 11). Install the first clamp at the center of the caul plates. This will permit even distribution of the adhesive as pressure is applied. Apply the second and third clamp 1.0 – 2.0 inches from the ends of the caul plates (Figure 12). Only apply clamp pressure to the caul plates and not to any part of the trim tab assembly. Ensure good adhesive squeeze out along all edges (Figure 11 and Figure 12). If adhesive is not seen on all edges, do the following: use additional clamps to apply more force, incrementally increase clamp pressure, adjust clamp locations, or remove the tab and apply additional adhesive. With all changes, always work from the center of the trim tab assembly to the outboard ends of the trim tab assembly, driving adhesive toward the extreme tips of the trim tabs.

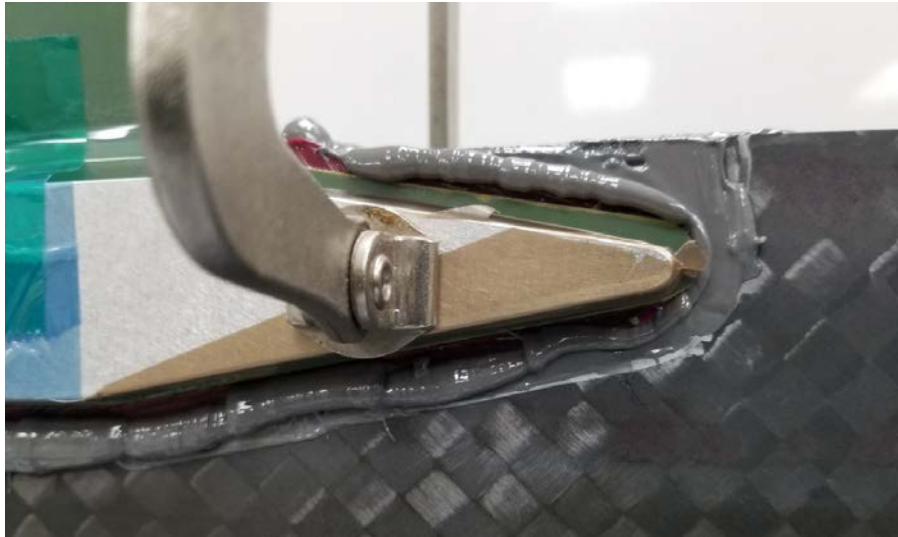
Figure 12 – Adhesive Squeeze Out at End of Trim Tab Assembly

- (13) **INSPECTION:** Verify that adhesive squeeze-out is visible around all edges of the trim tab assembly. Confirm that the trim tab joggle is seated against the trailing edge of the blade. Verify that the clamps will not slip or move during the cure.

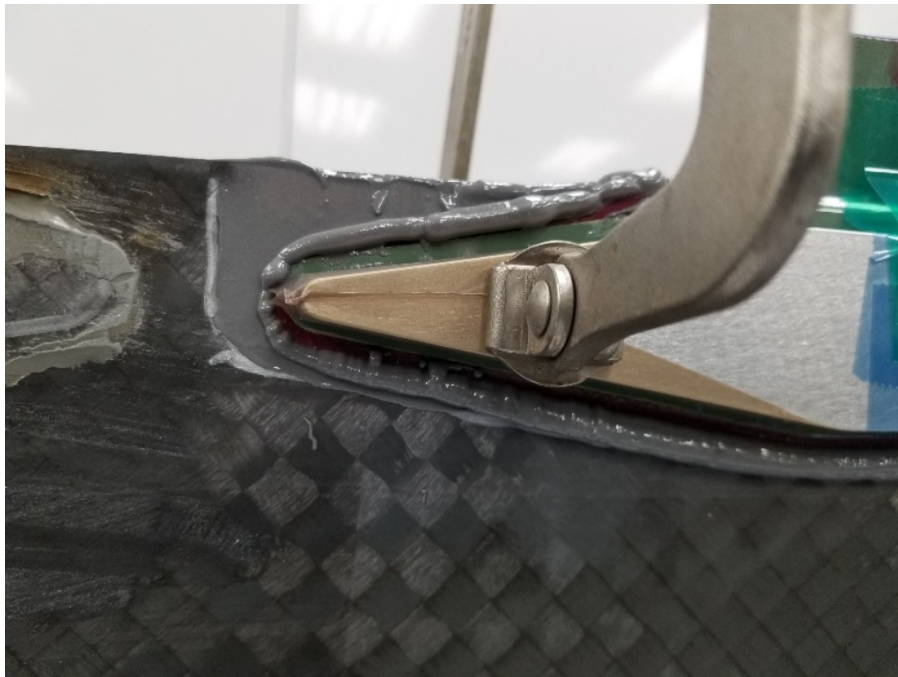
Figure 13 – Adhesive Squeeze Out at End of Trim Tab Assembly

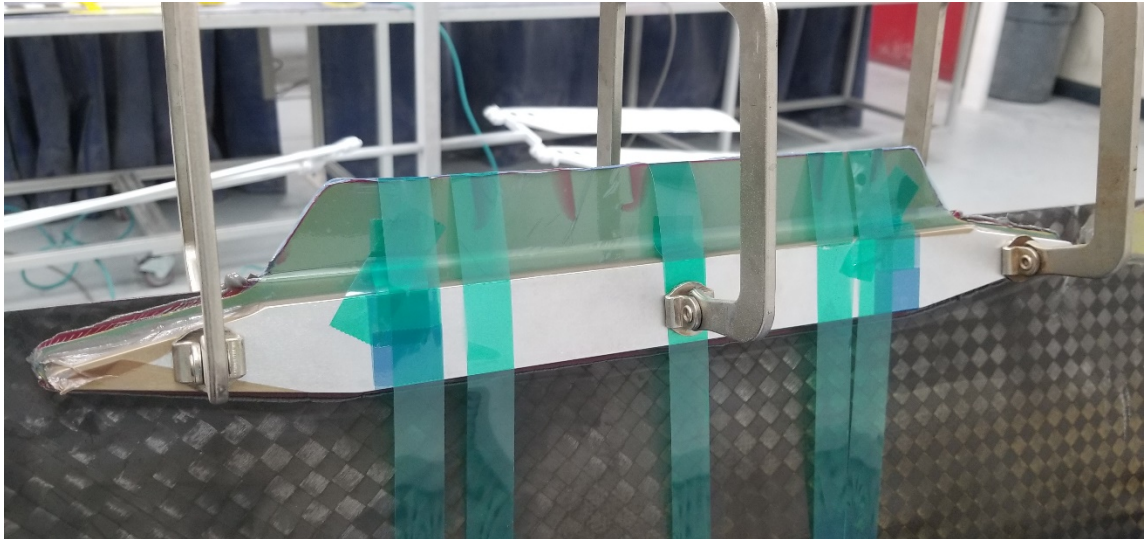
Figure 14 – Complete Trim Tab Assembly Installation Ready for Cure
