Case Study UV Lining Foss Las Race Course

<b>Case Study Number:</b>	<b>Case Study 1</b>
<b>Title:</b>	Foss Las Race Course Carmarthen
<b>Client:</b>	Welsh Water
<b>Location of Services:</b>	
<b>Contract Value:</b>	N/A
<b>Contract Dates:</b>	2023
<b>Scope of Services:</b>	<ul style="list-style-type: none"> <li>● Enabling Works</li> <li>● CCTV</li> <li>● Jetting</li> <li>● UV Lining</li> </ul>

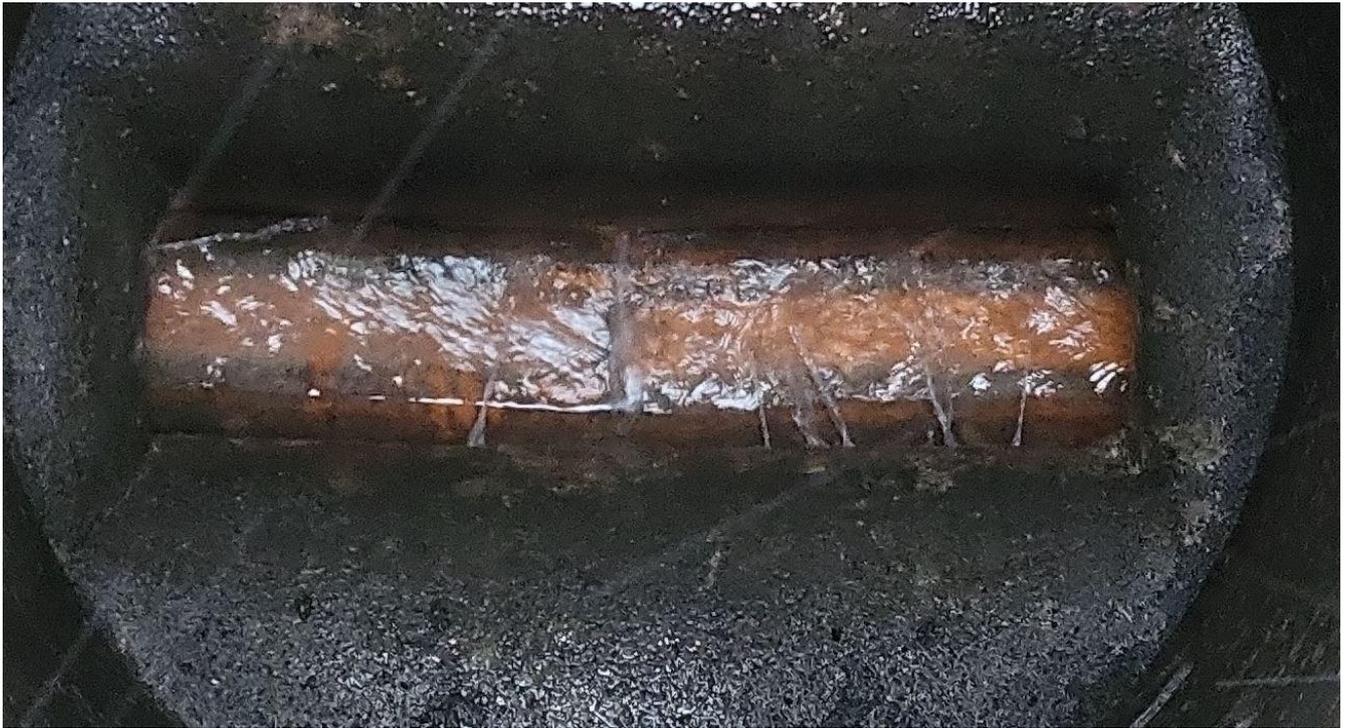
Drainforce were tasked to resolve infiltration gushing into the sewer system at Foss Las Race Course Llanelli. The pipe in question a 225mm clay pipe approximately 570m long.

**Photo of Infiltration Gushing before works.**

It was agreed that we would make a liner long enough to line through all the Manholes which had infiltration thus sealing the system.

This was only possible with the use of our Mega UV lining Rig which has a 300m Air Conditioned Cable allowing Drainforce to seal though 5 Manholes in one single pull.

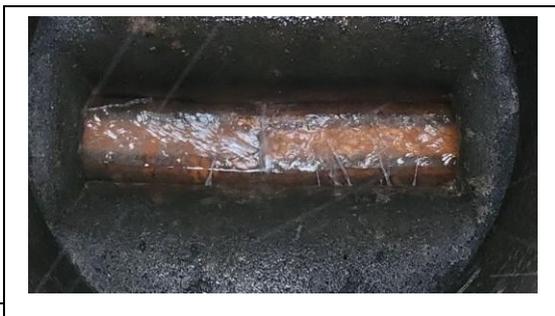
**Photo before lining showing gushing infiltrating**  
**Photo after lining with the system sealed**

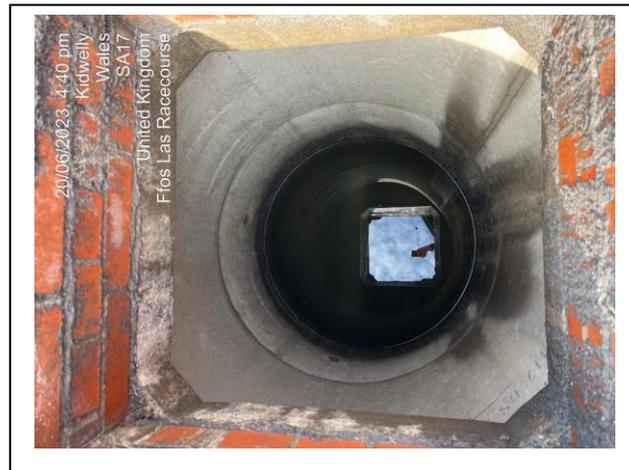
The liner was cured in line with all protocols and a post survey completed after the works.
