| <b>Case Study Number:</b> | <b>Case Study 1</b> |
| <b>Title:</b> | Kingsbridge Trunk Sewer Desilting Project |
| <b>Client:</b> | Dŵr Cymru Welsh Water |

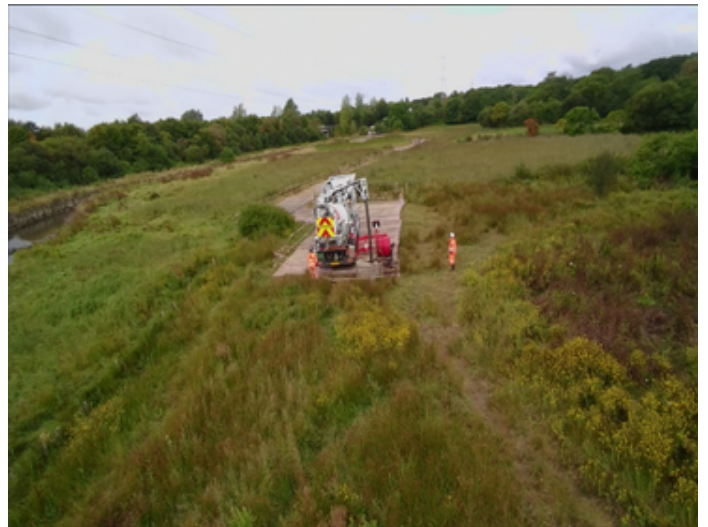
Photo of Bog Matt road

Before works commenced, detailed planning was undertaken to establish safe access to the location. The site was situated within environmentally sensitive ground and required the construction of temporary access routes using bog mats to allow specialist plant and equipment to safely reach the working area. Dedicated exclusion zones, vehicle control measures and pedestrian routes were established before operational activity commenced
