ECO@JUMRUM ESTATE

Water Management Plan

CLIENT: JIM PAPAS CIVIL ENGINEERING DESIGNER PTY LTD
PROJECT: ECO@JUMRUM DEVELOPMENT
REPORT: WATER MANAGEMENT PLAN
DATE: DECEMBER 2014

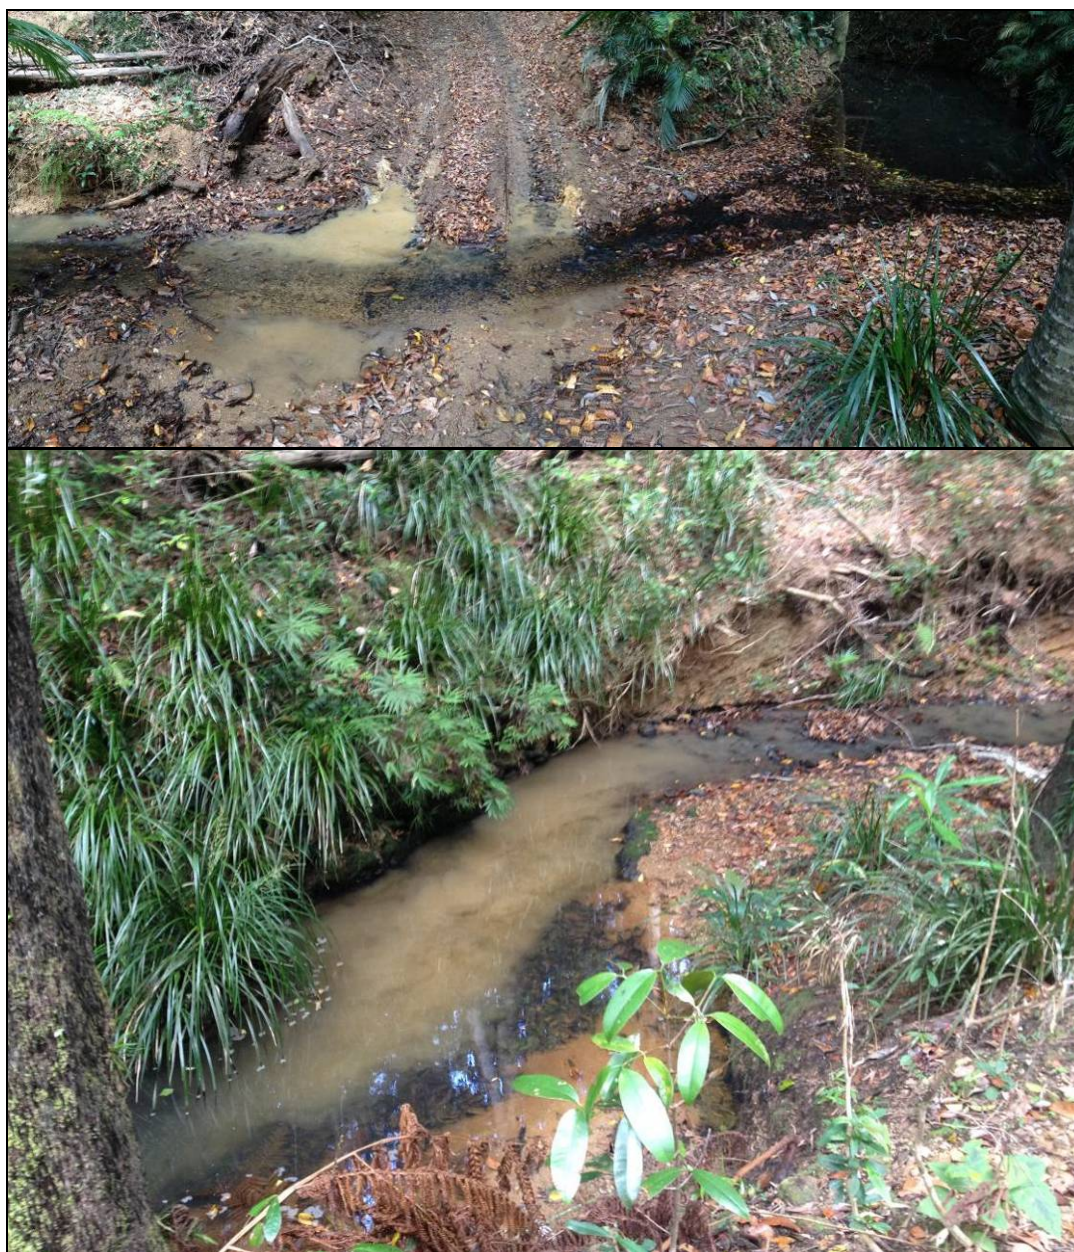
Figure 7: Sediment plume at the low level road crossing (top); and immediately downstream (bottom)

The volume of sediment transported downstream is relatively minimal, although dispersion and transport is constant year round, while there is flow (note photographs in Figure 7 were

taken in November 2014, prior to any wet season rains). In its current state, during a high flow event the crossing will be damaged further. In spite of this, the volume of sediment disturbed by the crossing would be relatively minimal compared to the volume of sediment already within the water column at the time of the high flow event. Conversely, during base flow/low flow events the volume of sediment already within the water column is minimal. Subsequently, the dispersion and transport of fine material has a relatively high impact during these low flow conditions, effectively smothering the downstream habitat until a higher energy event flushes the system.

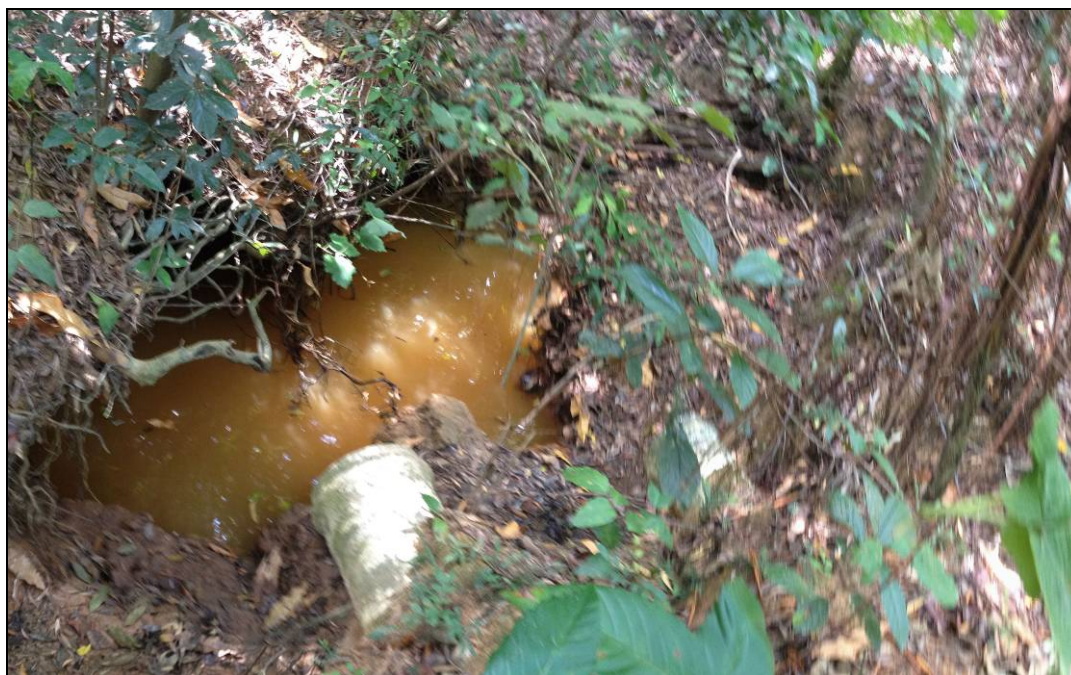
Figure 9: Scour hole on downstream side of culvert

Erosion downstream of a culvert is generally considered the 'norm' and should be expected. However, the erosion occurring downstream of the culvert at the development site appears to be quite significant as a scour hole has developed (Figure 9). While this scour hole will act as an energy dissipation mechanism, significant erosion is still expected to continue.

The developer is aware of the issues associated with this crossing and has commissioned a contractor to place geo-textile fabric within the scour hole downstream of the culverts to stabilise the bed and reduce bank erosion. The geo-textile fabric is then to be armoured with rock (of appropriate diameter) to act as an energy dissipation mechanism and further reduce any erosion that is currently occurring. This armouring will also be placed up the bank and around the culvert outlets to limit undercutting.

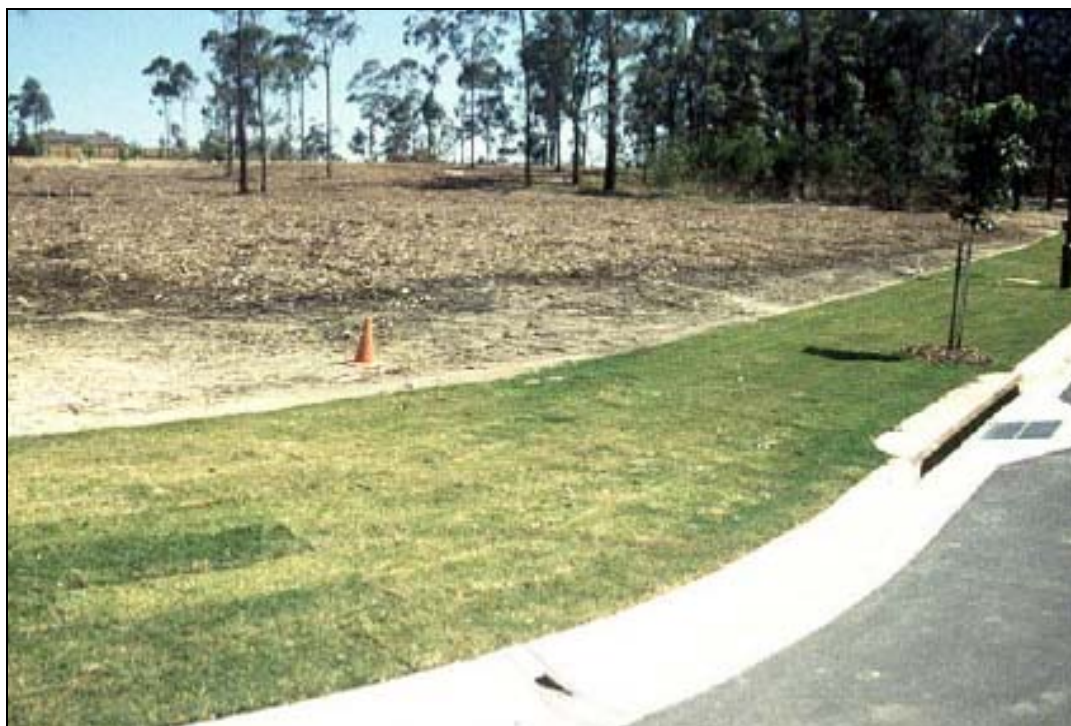
Figure 12: Use of a grassed filter strip for erosion control and sedimentation

It is recommended these works be used to reduce the volume of soil lost from cleared areas when developing the site. The approved engineering drawings state that the back of all kerb and channel areas will have at least a 400 mm wide turf strip installed. The remaining disturbed areas (including verges, batters of cut and fill, etc.) within lots will be either seeded or hydro-mulched as appropriate to promote vegetation growth; similar to that shown in Figure 12.

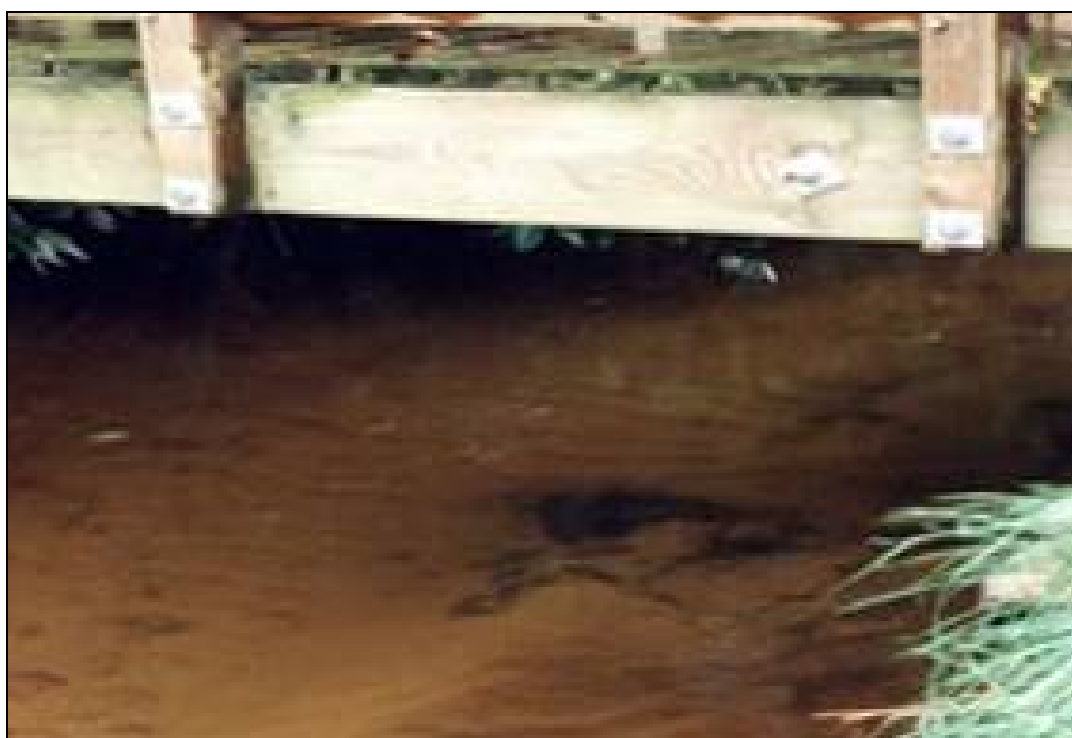
Figure 13: Example of bed smothering

- Bed smothering – where everything on the bed of the river (i.e. woody debris, rocks, etc.) is coated in a layer of fine sediment (Figure 13).
- Turbid flows – where the clarity of water is greatly decreased downstream of a disturbance (Figure 14). However, during high flow events it is expected that the turbidity of waters within the stream will greatly increase. During these times there may not be a noticeable difference between upstream and downstream of the disturbance. During low flow periods waters within the stream should be mostly clear in shallow sections (Figure 15) and deeply dark for deeper sections (Figure 16).

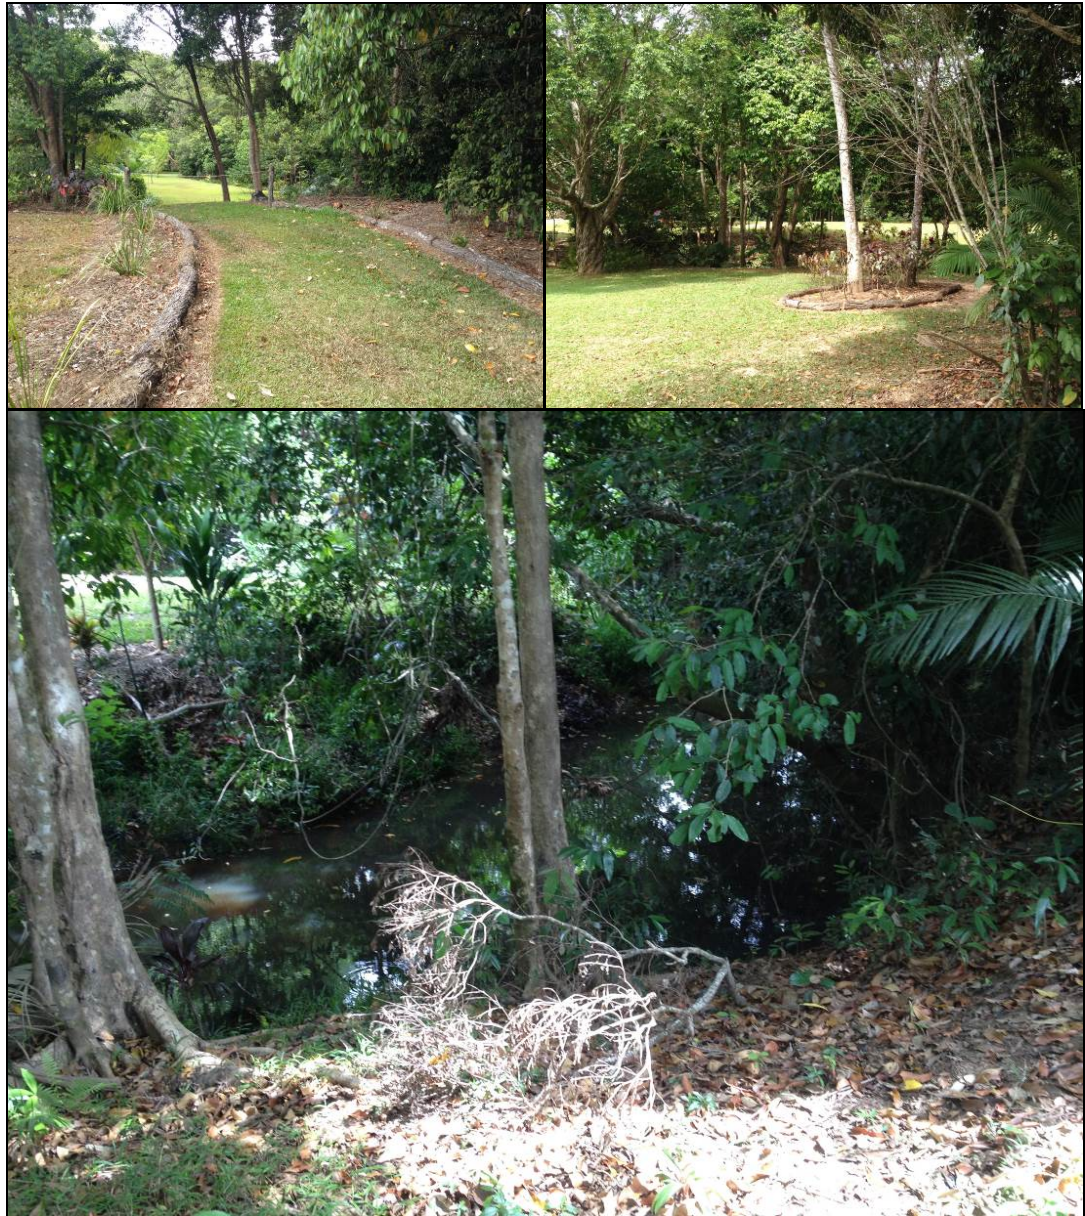
Figure 19: Downstream monitoring site including the entrance from Fallon Road (upper left); the right hand turn after the entrance (upper right); and the monitoring point (bottom)

The downstream monitoring point is situated 45m from the boundary of Lot 11 and is adjacent to 26 Masons Road, Kuranda (Figure 19). Access is provided by walking through a small section of parkland to Jumrum Creek (Figure 19).

The site has been placed at this location so that it is upstream of any impacts caused by Fallon Road on water quality. C&R's experience is that road crossings of creeks can have a minor, local impact immediately downstream. Macroinvertebrate numbers can be reduced in a local area as a result of hydrocarbons washing off the road. Hence, the monitoring point has been located upstream of Fallon Road so that impacts such as this are not attributed to the development of the eco@jumrum estate.

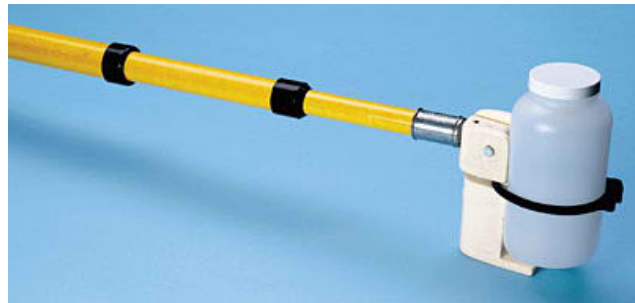
Equipment	Description / Use	Number / Comment	Photograph
Sampling Pole (desirable)	The sampling pole is used to lower a sample bottle into the water column from a distance. This can be used to sample the water column away from the bank.	1x Used to access water column

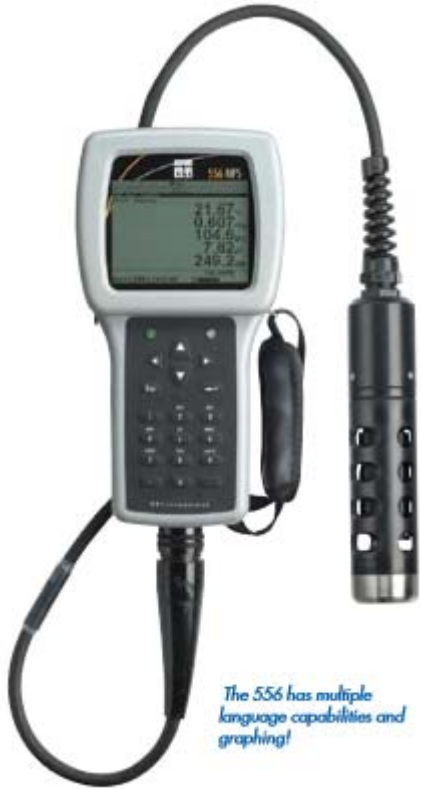
Equipment	Description / Use	Number / Comment	Photograph
	dissolved metals. Multiple filters may be required per sample.	sampling site	
Esky	Sample bottles are put into an esky with ice bricks to keep cool and prevent over-heating.	1x – enough to hold all sample bottles	SGS Australia to provide Esky
Ice Bricks	Ice bricks are required to cool the samples.	Multiple	SGS Australia to provide Ice Bricks. If not, frozen water bottles or commercially available ice bricks may be used.
In-situ meter (pH, EC, Temperature, Turbidity, Dissolved Oxygen)	Not all parameters monitored can be analysed by the laboratory as they will change with increasing time within the sample bottles. Subsequently an in-situ meter is required to measure pH, electrical conductivity, , temperature, turbidity and dissolved oxygen

<p>The 556 has multiple language capabilities and graphing!</p> <p><i>NOTE: This is an example only. Water quality meters can be purchased from outlets such as Hydroterra, John Morris Scientific or Thermofisher.</i></p>
