# GRUNDFOS

Right-sizing pumps for net zero

Lekshman Biju  
Senior Aftermarket Sales Engineer

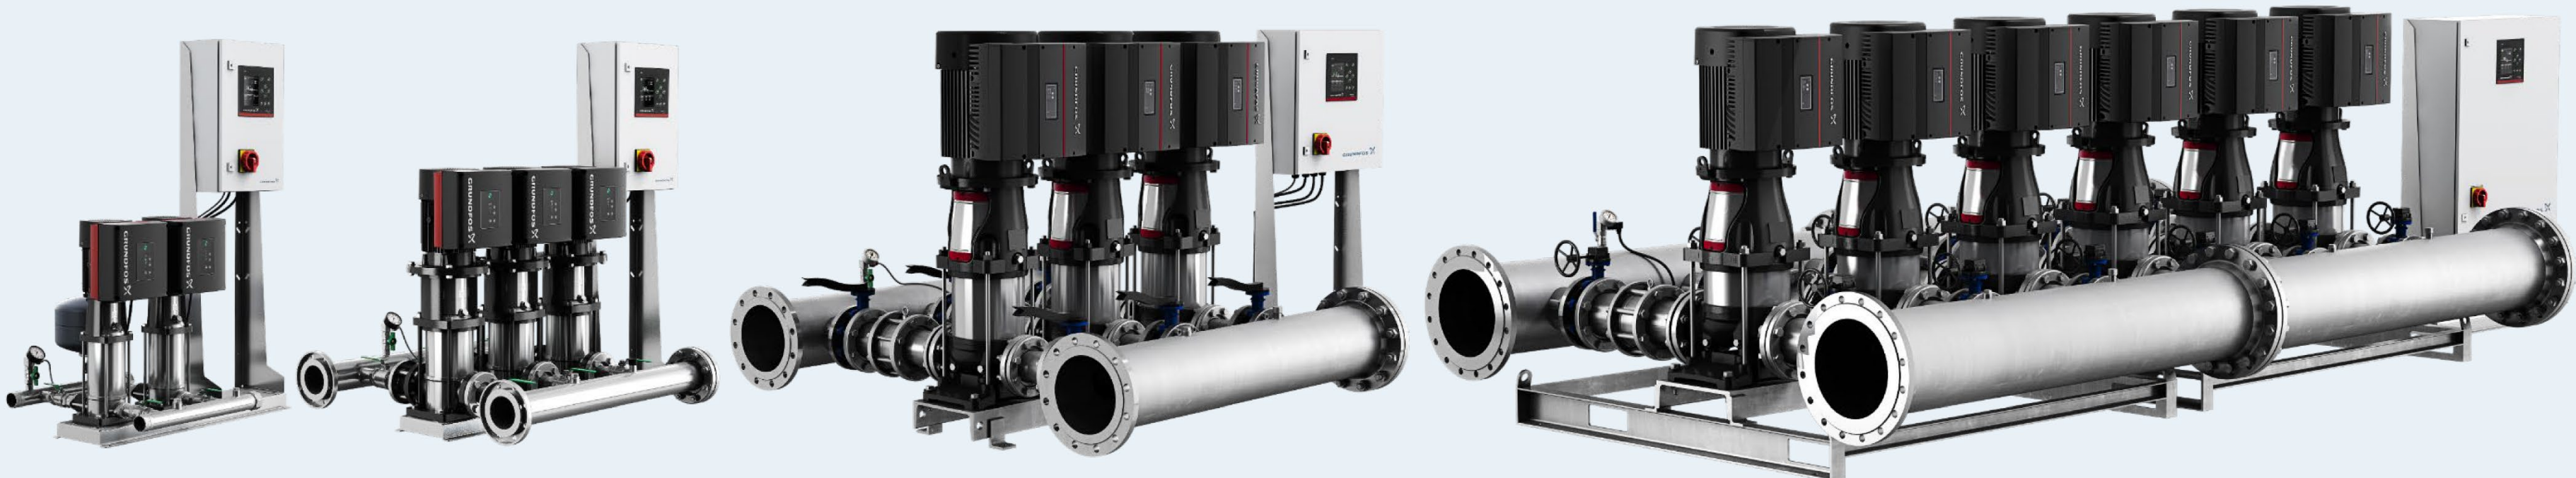
# Multi Pumps Systems

- The right combination: Flow Split & Quantity
- Operate closer to BEST EFFICIENCY POINT
- Lesser Maintenance

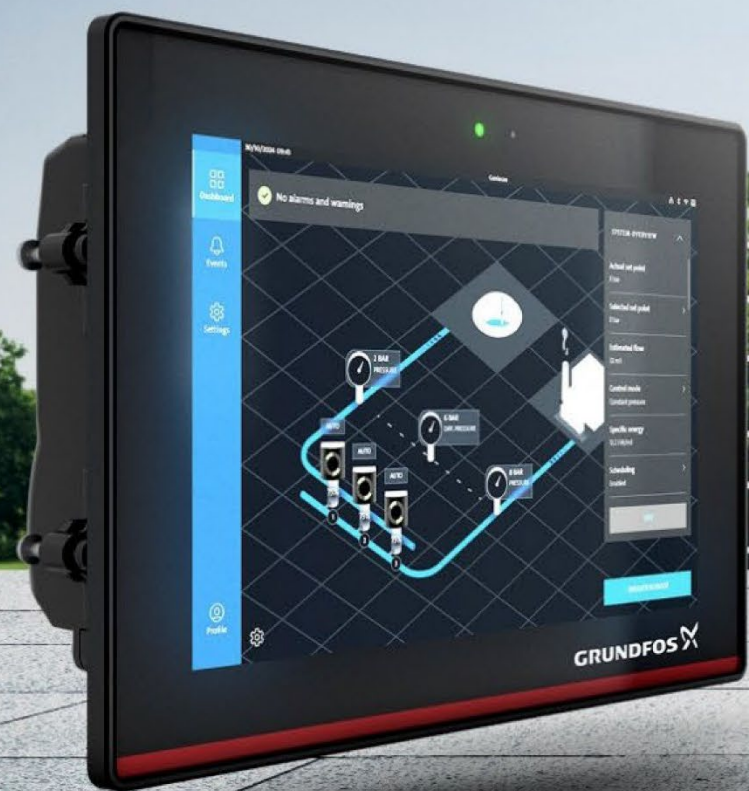
# Factory Set Controls

- **Power Optimized Pump Sequencing**

- **Proportional Pressure control**
