MnDOT's Experience Using Paver-Mounted Thermal Profiling to Improve Mat Laydown Quality – and Experiences when Incentives are Part of the Contract

Rebecca Embacher | Advanced Materials and Technology Engineer
48th Annual Ohio Asphalt Paving Conference
February 1, 2023

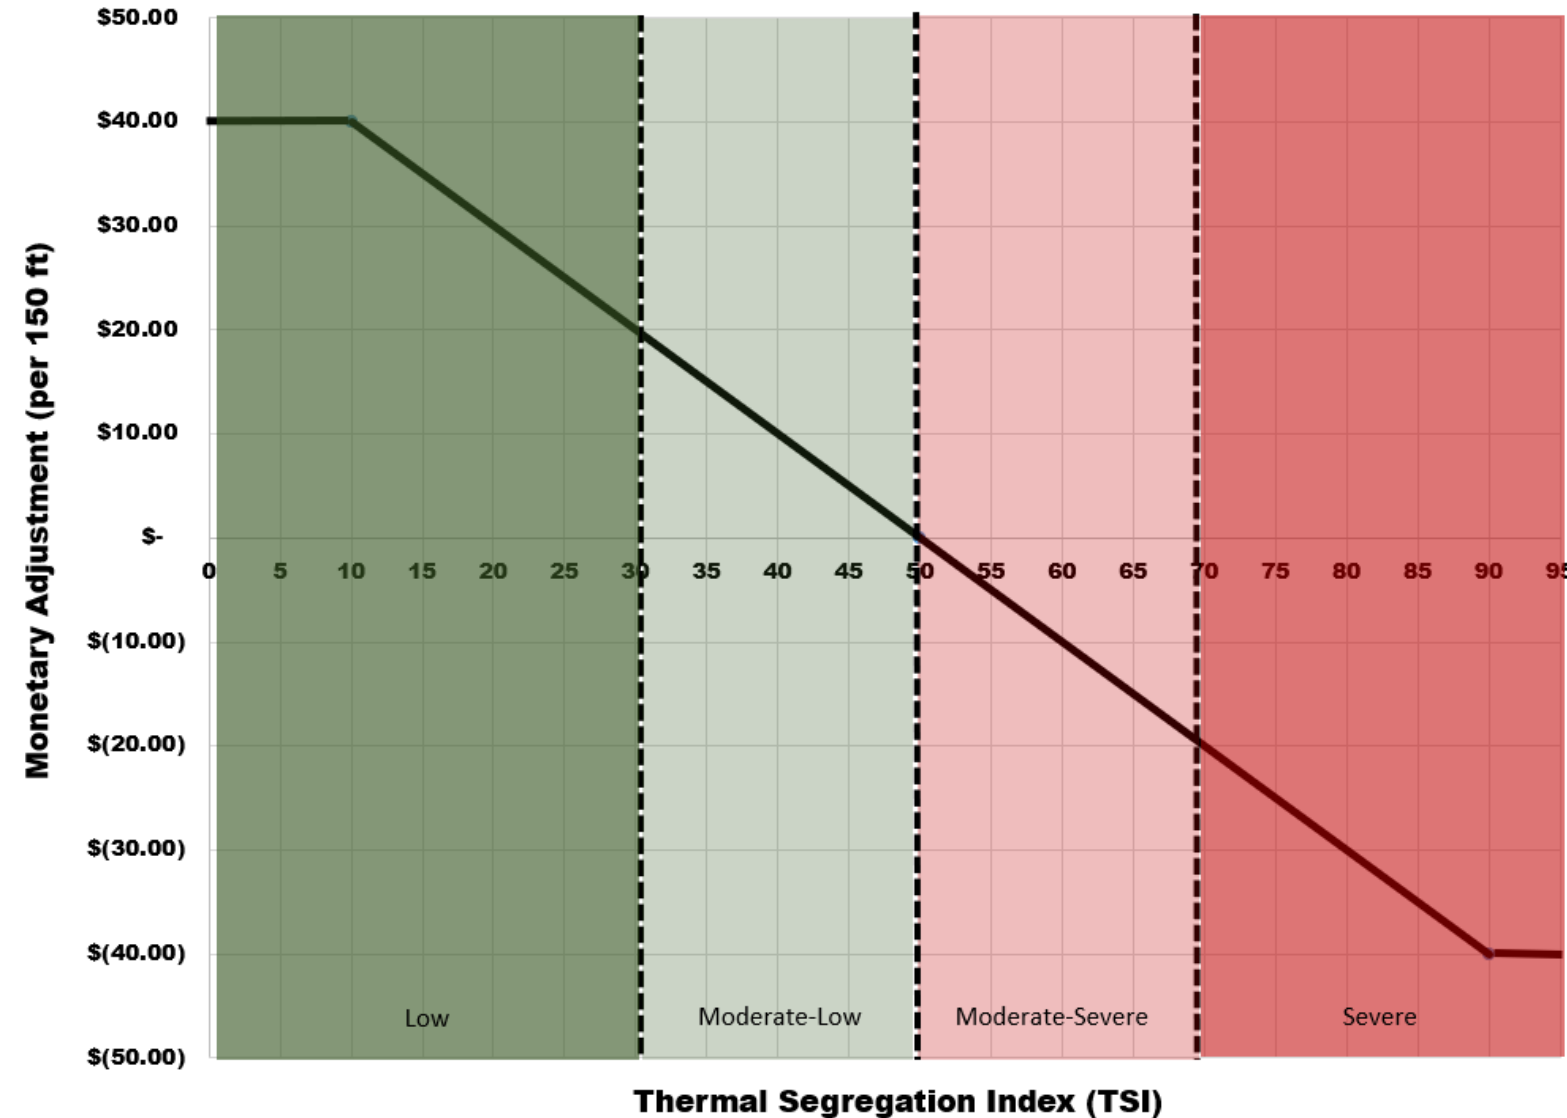
Monetary adjustments for thermal segregation

$$PA_{TSI} =$$

$$\begin{cases} \$40 \text{ when } TSI \leq 10 \\ PA_{TSI} \text{ when } 10 < TSI < 90 \\ -\$40 \text{ when } TSI \geq 90 \end{cases}$$

$$PA_{TSI} = (50 - TSI) \times 0.025 \times \$40$$

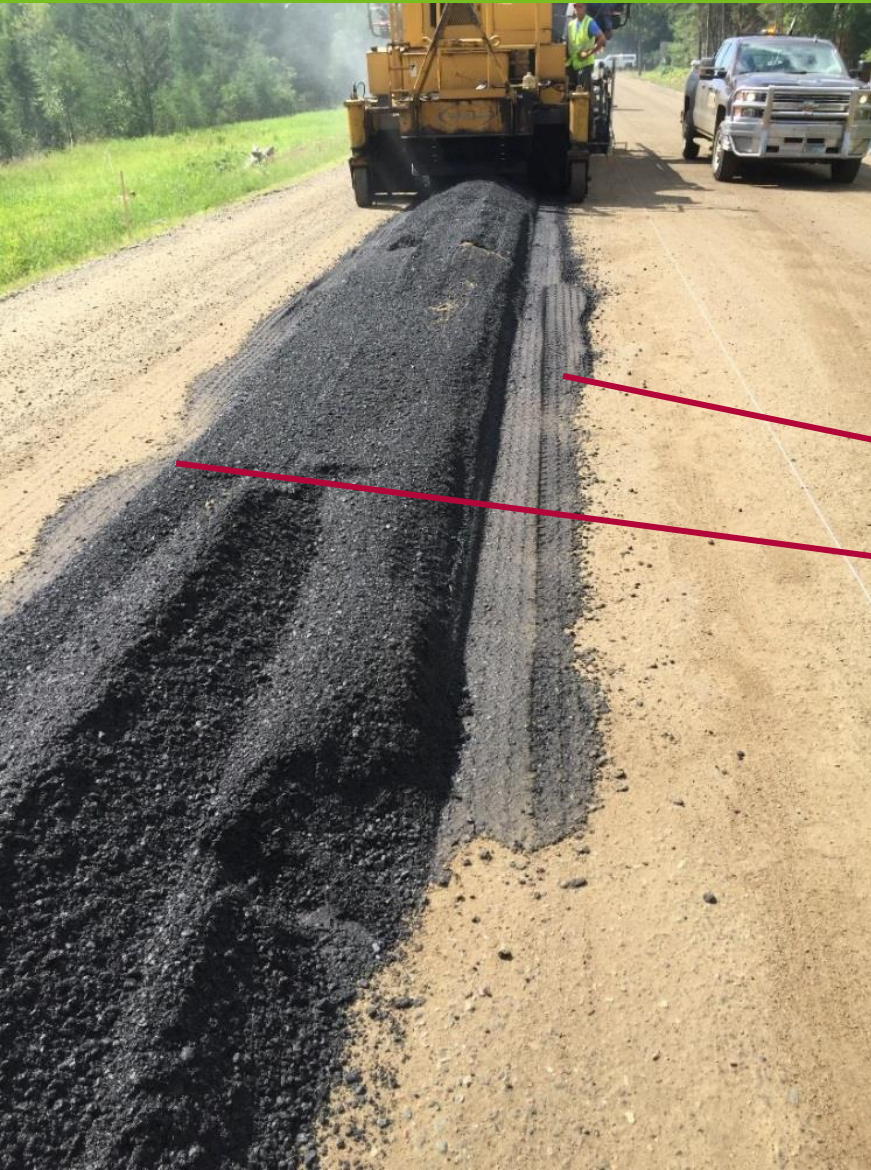
Trucks Driving on Windrows after Dump

Trucks driving on windrows can cause material and thermal segregation.

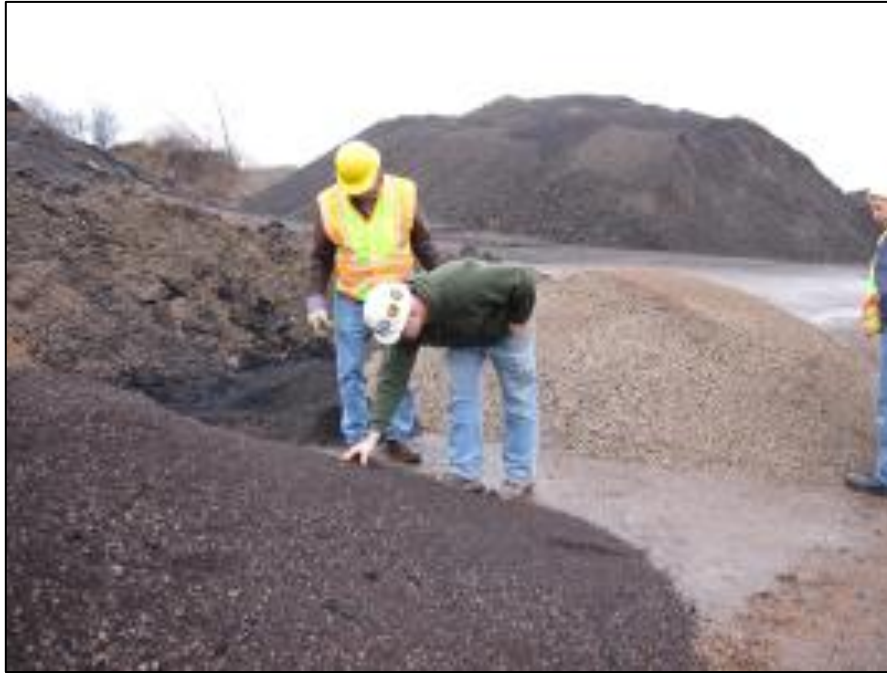
Failing density

Saturated aggregate
in stockpiles from
heavy rain.

Monitor stockpiles for material changes, saturated aggregate, etc.
