## CLIENT SUCCESS PROJECTS

## NYC MEDICAL CARE FACILITY PLATE AND FRAME HEAT EXCHANGER

### The Challenge: Extend life of 25-year-old plate & frame heat exchanger

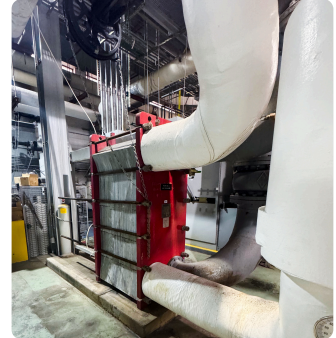
A critical healthcare facility was operating a 25-year-old plate and frame heat exchanger that had never been dye-penetrant tested, creating risk from unknown plate integrity, obsolete components, and potential internal leaks. With chiller reliability at stake and minimal allowable downtime, the facility needed to extend the unit's life without triggering a costly full replacement.

- Onsite coordination: isolated and drained exchanger with facility staff
- Plate removal: opened frame and removed plates
- Cleaning and testing: cleaned plates and performed dye-penetrant testing
- Regasketing: installed new OEM gaskets
- Reassembly: rebuilt plate pack and torqued to OEM specifications
- System restart: pressurized and leak-tested
- Documented: system performance of chiller, condenser, and heat exchanger

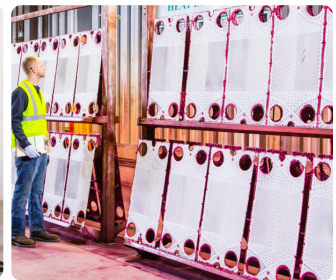
Full Service Regasketing
