WESTCO Electrical & Equipment Corp. Case Study

Enhancing Predictive Maintenance and System Uptime in Cold Storage Facilities

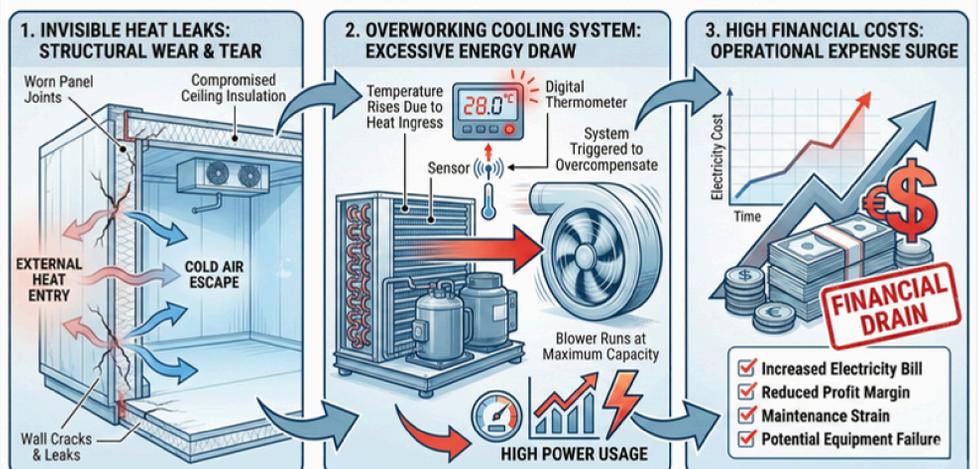
THE CHALLENGE: UNSEEN THERMAL LEAKS & HIGH ENERGY CONSUMPTION

- Infiltration of Warm Air:** The structure of the cold storage— the walls, ceilings, and the joints where panels meet— wore out, developing infiltration that allow external heat to enter.
- High Financial Costs:** The main complaint of the cold storage facility was that their electricity was too strong and their consumption was high.
- Overworking Cooling System:** The cold storage drops below the required level because of the heat leak, which then triggers the blower to consume excessive electricity to cool the room down

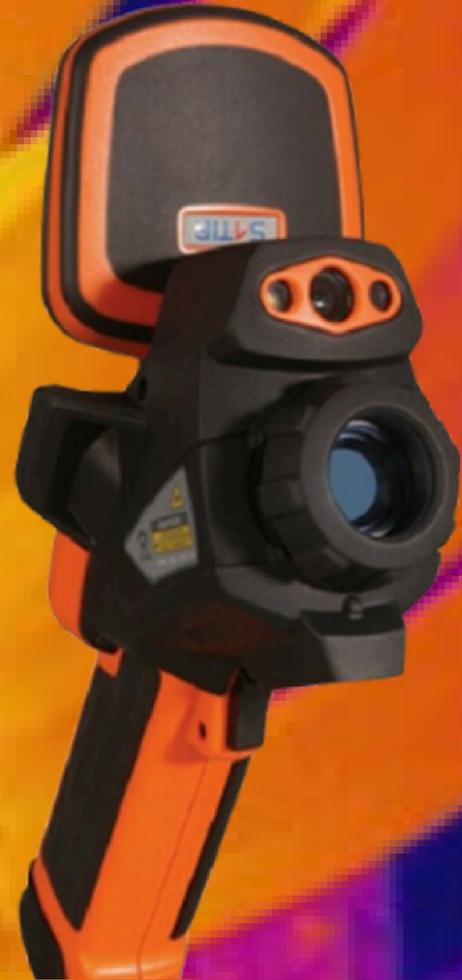
THE SOLUTION: SATIR HOTFIND S

DETECTS UNSEEN FLAWS

Insulated Cold Storage Wall

Temperature Measurement: -18°C (Should be -20°C)

Leaks and Hot/Cold Spots Visible

Captures Heat Distribution

**Detects Unseen Flaws:** It utilizes a specialized camera to capture an **infrared image** that displays the heat distribution, making leaks and hot/cold spots visible. In the said cold storage, it detected a temperature measurement of -18°C in an area that should've been sealed to maintain -20°C.
- ✓

**Spot Repair Targets:** The **thermal image** points out the exact location of the fault, serving as the basis for the client to know exactly what to repair.
- ✓

**Planning and Minimizes Downtime:** The problems are detected early, giving clients time to plan their corrective action— perform preventive maintenance while the system is running, minimizing downtime.

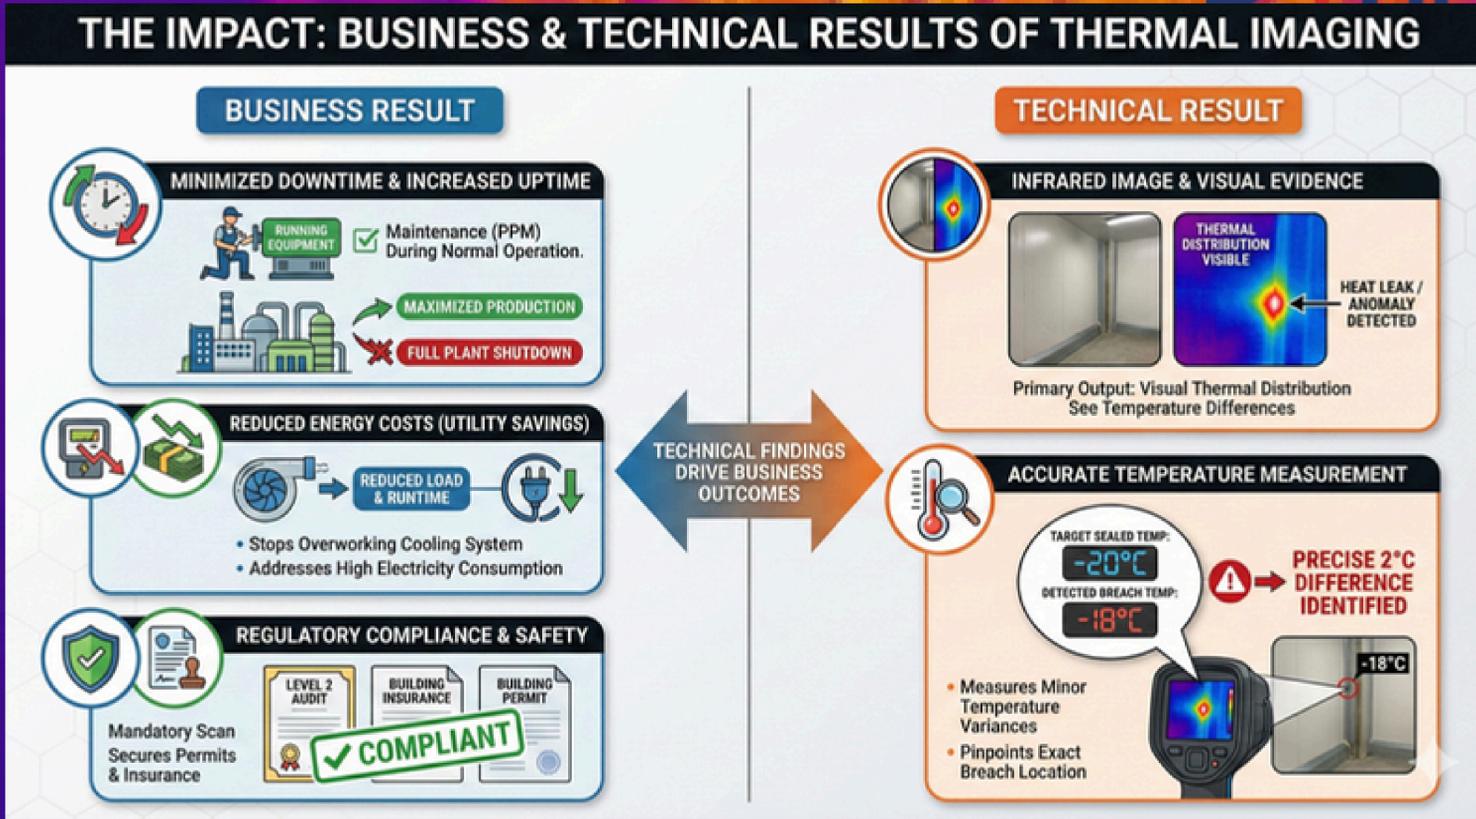
The Impact

- Infrared Image and Visual Evidence:** The primary output is a visual **infrared image** which allows the user to see the thermal distribution—specifically, where the temperature differs from the norm.
- Accurate Temperature Measurement:** The test specifically measured a breach where the room was supposed to be sealed at -20°C , but the camera detected a spot on the wall or joint measuring -18°C , indicating that the thermal camera measured a minor 2°C temperature difference.

- Minimized Downtime and Increased Uptime:** The services allow for maintenance (PPM) to be conducted while the equipment is in normal operation, meaning the client doesn't have to shut down the entire plant.
- Reduced Energy Costs (Utility Savings):** By identifying and repairing, the facility stops the cooling system (blower) from having to run constantly to fight the heat, which directly addresses the client's frustration with high electricity consumption.
- Regulatory Compliance and Safety:** The thermal scan is frequently a mandatory part of a Level 2 audit and is often a required test for securing building insurance and building permits.
