In December 2023, just before the Christmas holidays, an island community was plunged into a blackout. The cause was identified as faults on Phases A and B of the submarine cable connecting Roma, Quezon, to Alabat Island.

## The Solution

## The Challenge / Assessment After Testing

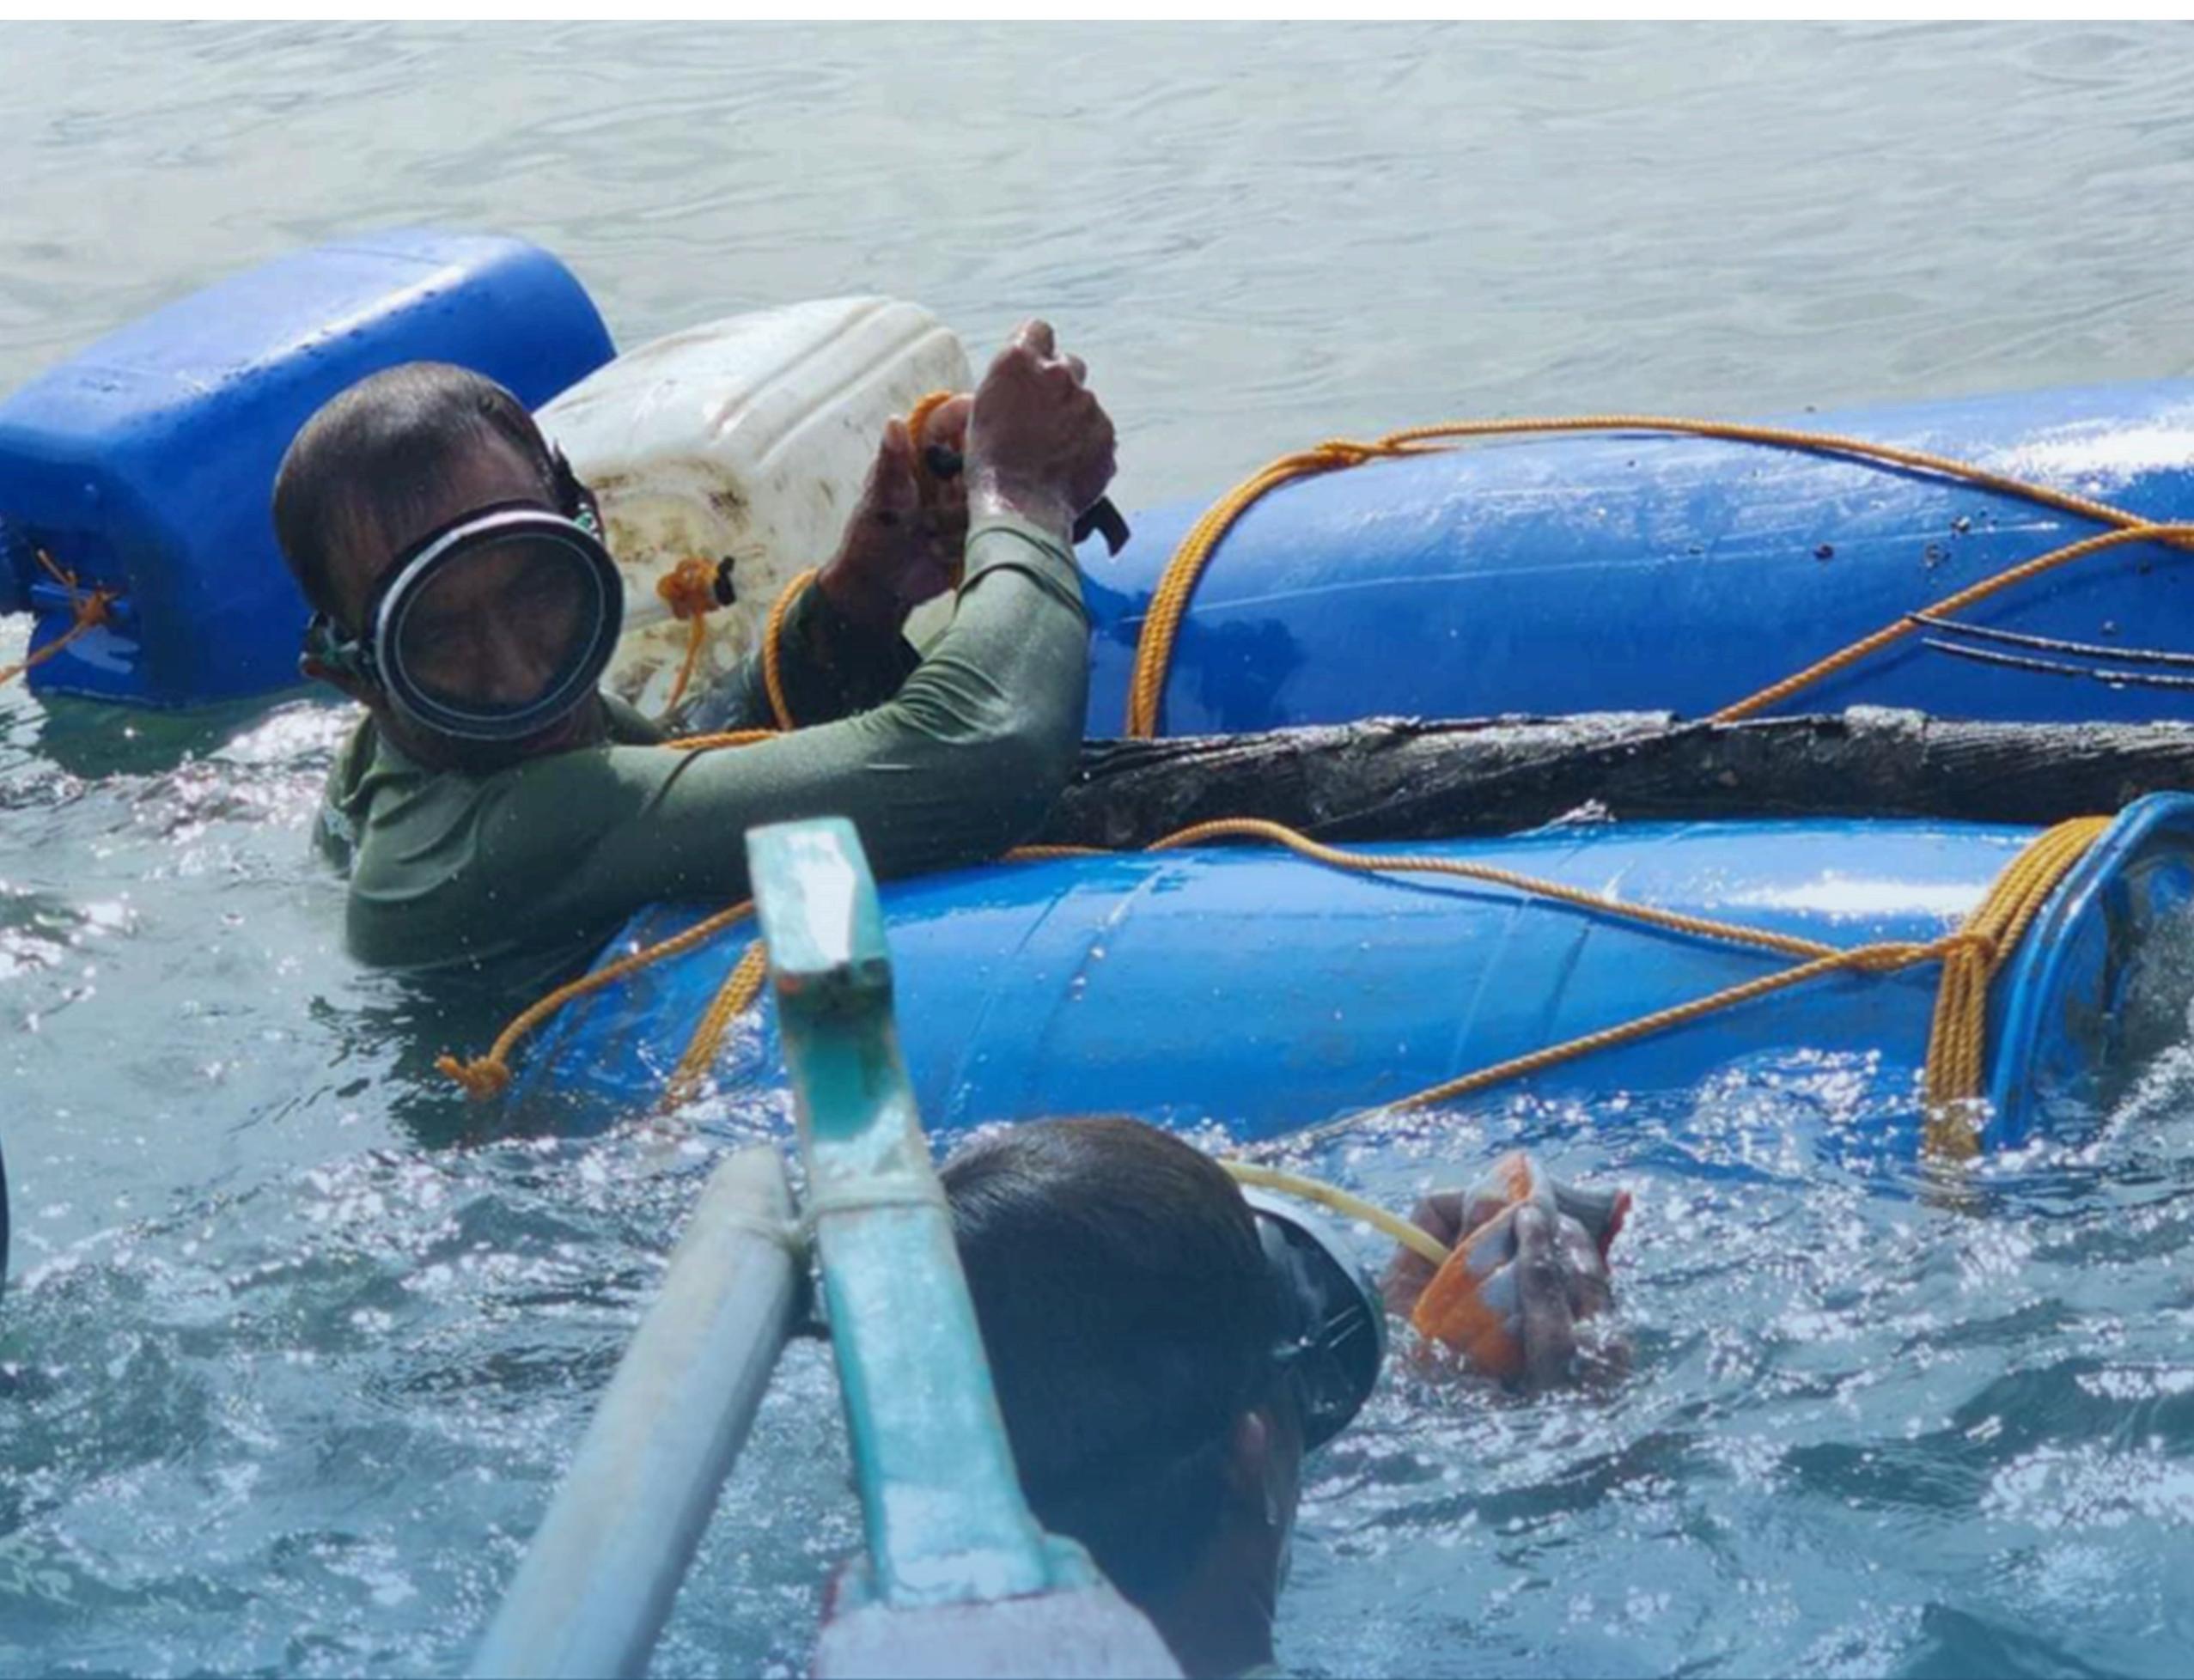
## The Impact

**Precision and Efficiency:** The use of the ICM method successfully converted a complex highly resistive fault into a manageable low-resistive one, providing an actionable location zone.

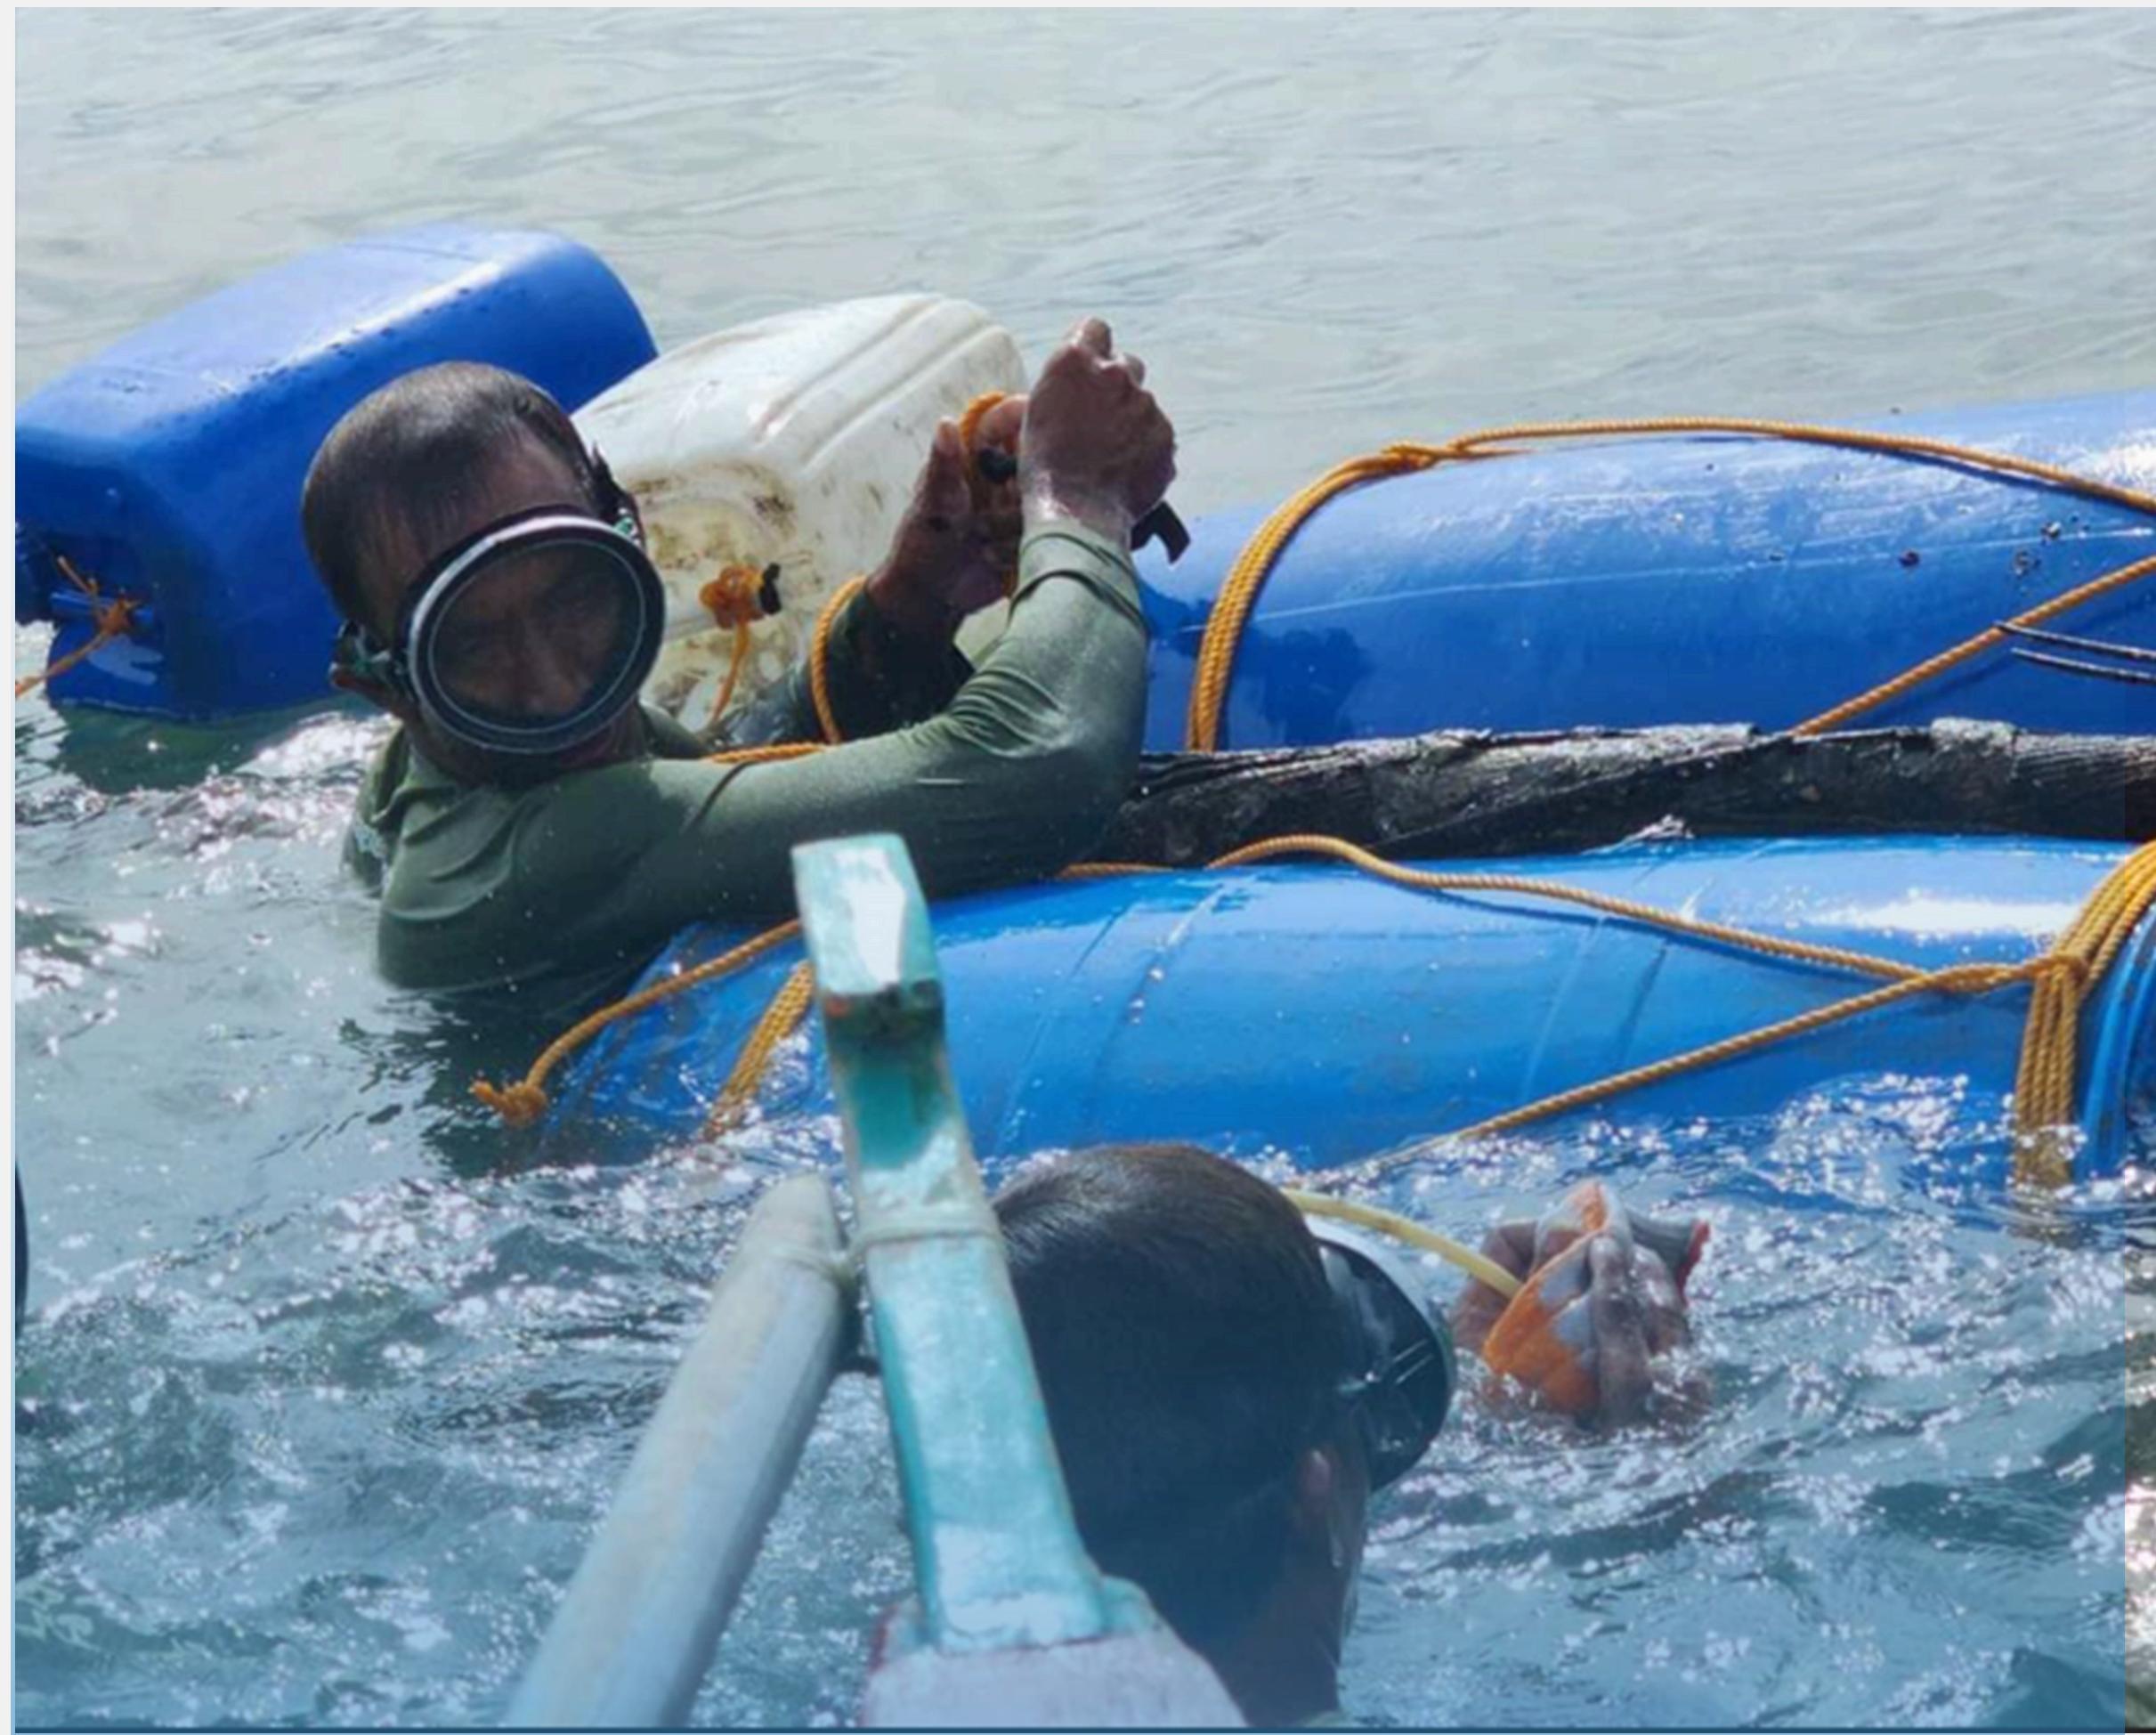
### The Impact

**Service Restoration:** The cable was successfully retrieved, repaired, and re-submerged. Power was restored to the island community before the New Year of 2024.
