# **EXHIBIT A**

## **The Public Trust Inspection Report**

# RECORD OF SURVEY NO. 13002

FOR PITKIN FAMILY PROPERTY TRUST LOCATED IN GOVT LOTS 4 AND 5 OF SECTION 13,  
TOWNSHIP 4 NORTH, RANGE 1 WEST, BOISE MERIDIAN, CITY OF EAGLE, ADA COUNTY, IDAHO

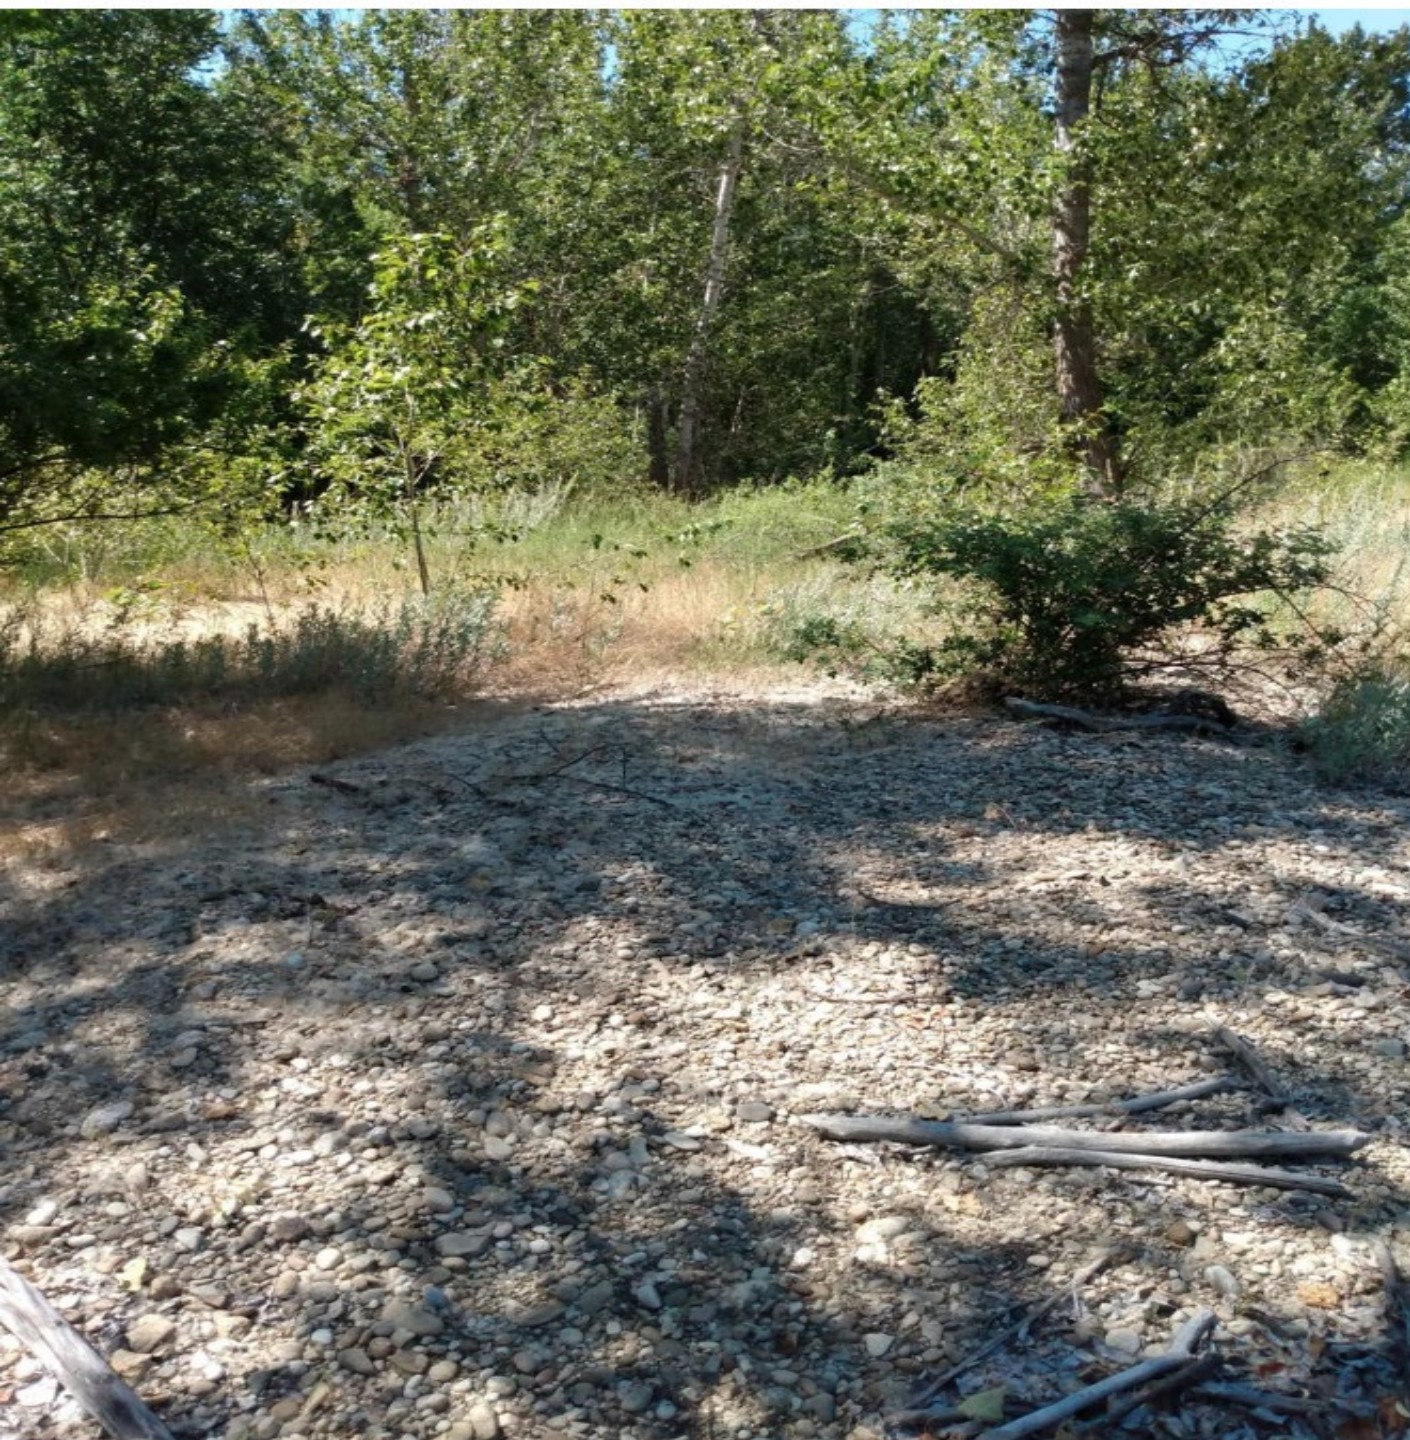
Photo #1: Looking south-southwest from gravel bar adjacent to flowing river. River is behind the viewer. Gravel is clean, up to 3 inches in diameter, and likely deposited last year or the year before. The green grass in the middle of the photo is the location of side channel #1. That channel bottom is two to three feet below the elevation of the gravel bar surface.

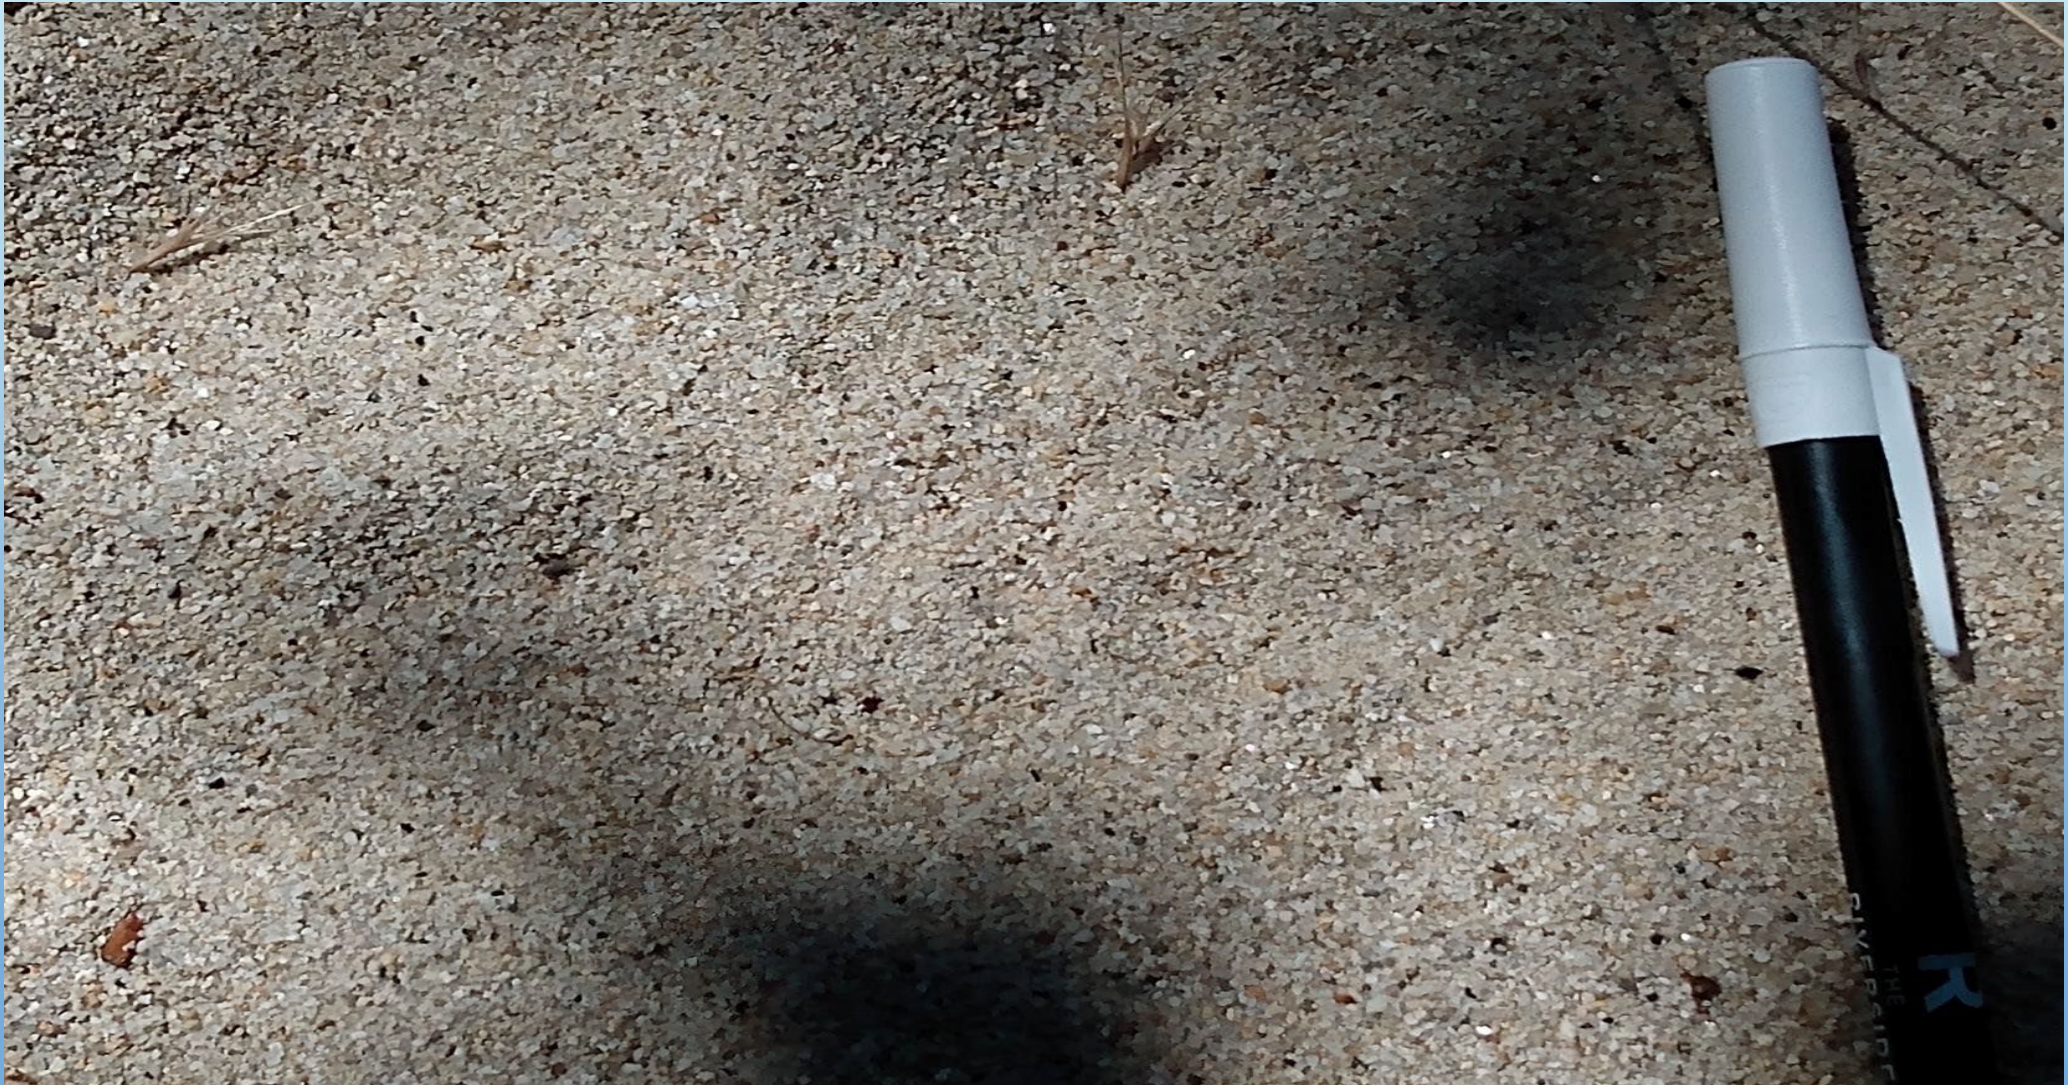
Photo #2: Coarse sand in bottom of side channel #1 just south of Photo #1 and flowing river. Ball point pen for scale. Sand is clean and likely deposited earlier this spring due to lack of dead vegetation covering it.

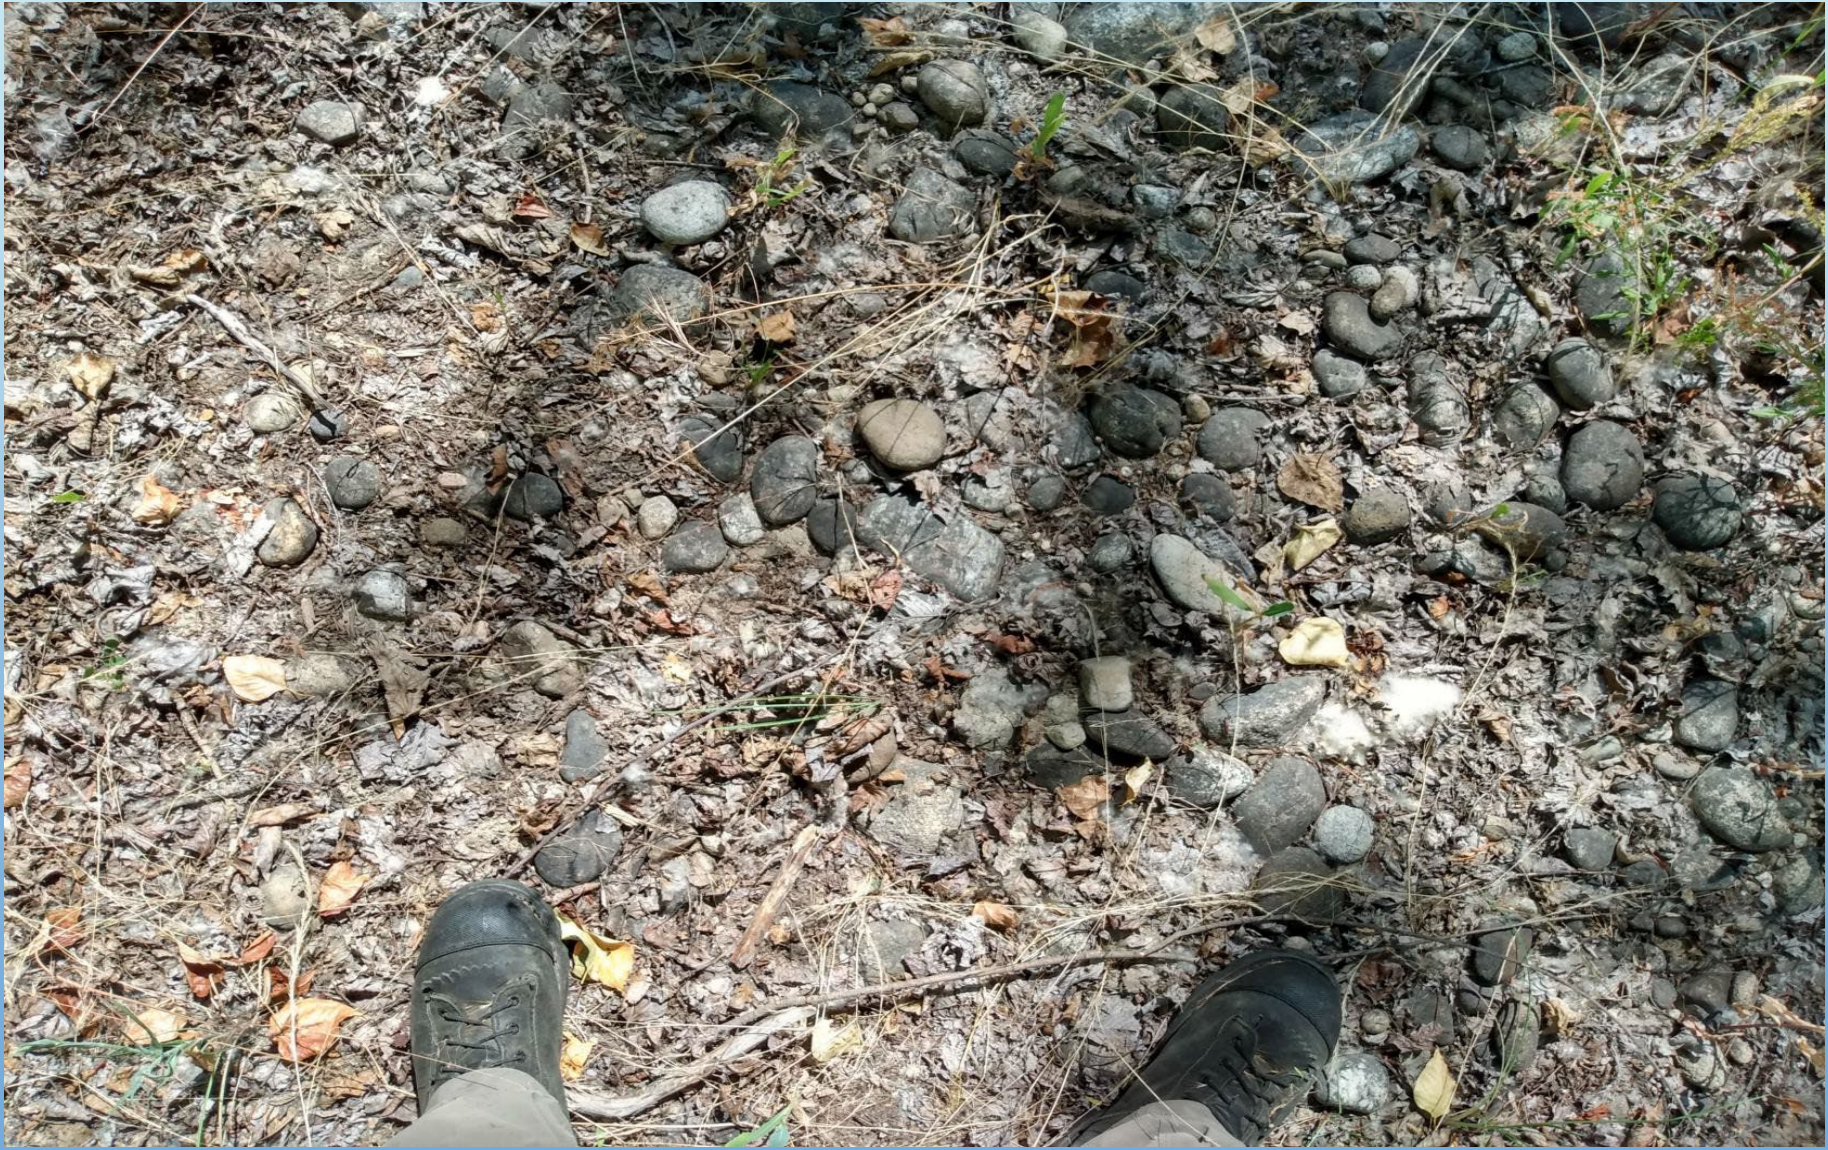
Photo #3: River gravel and cobbles in bottom of side channel #1 east of Photo #2. Size 11 boots for scale.

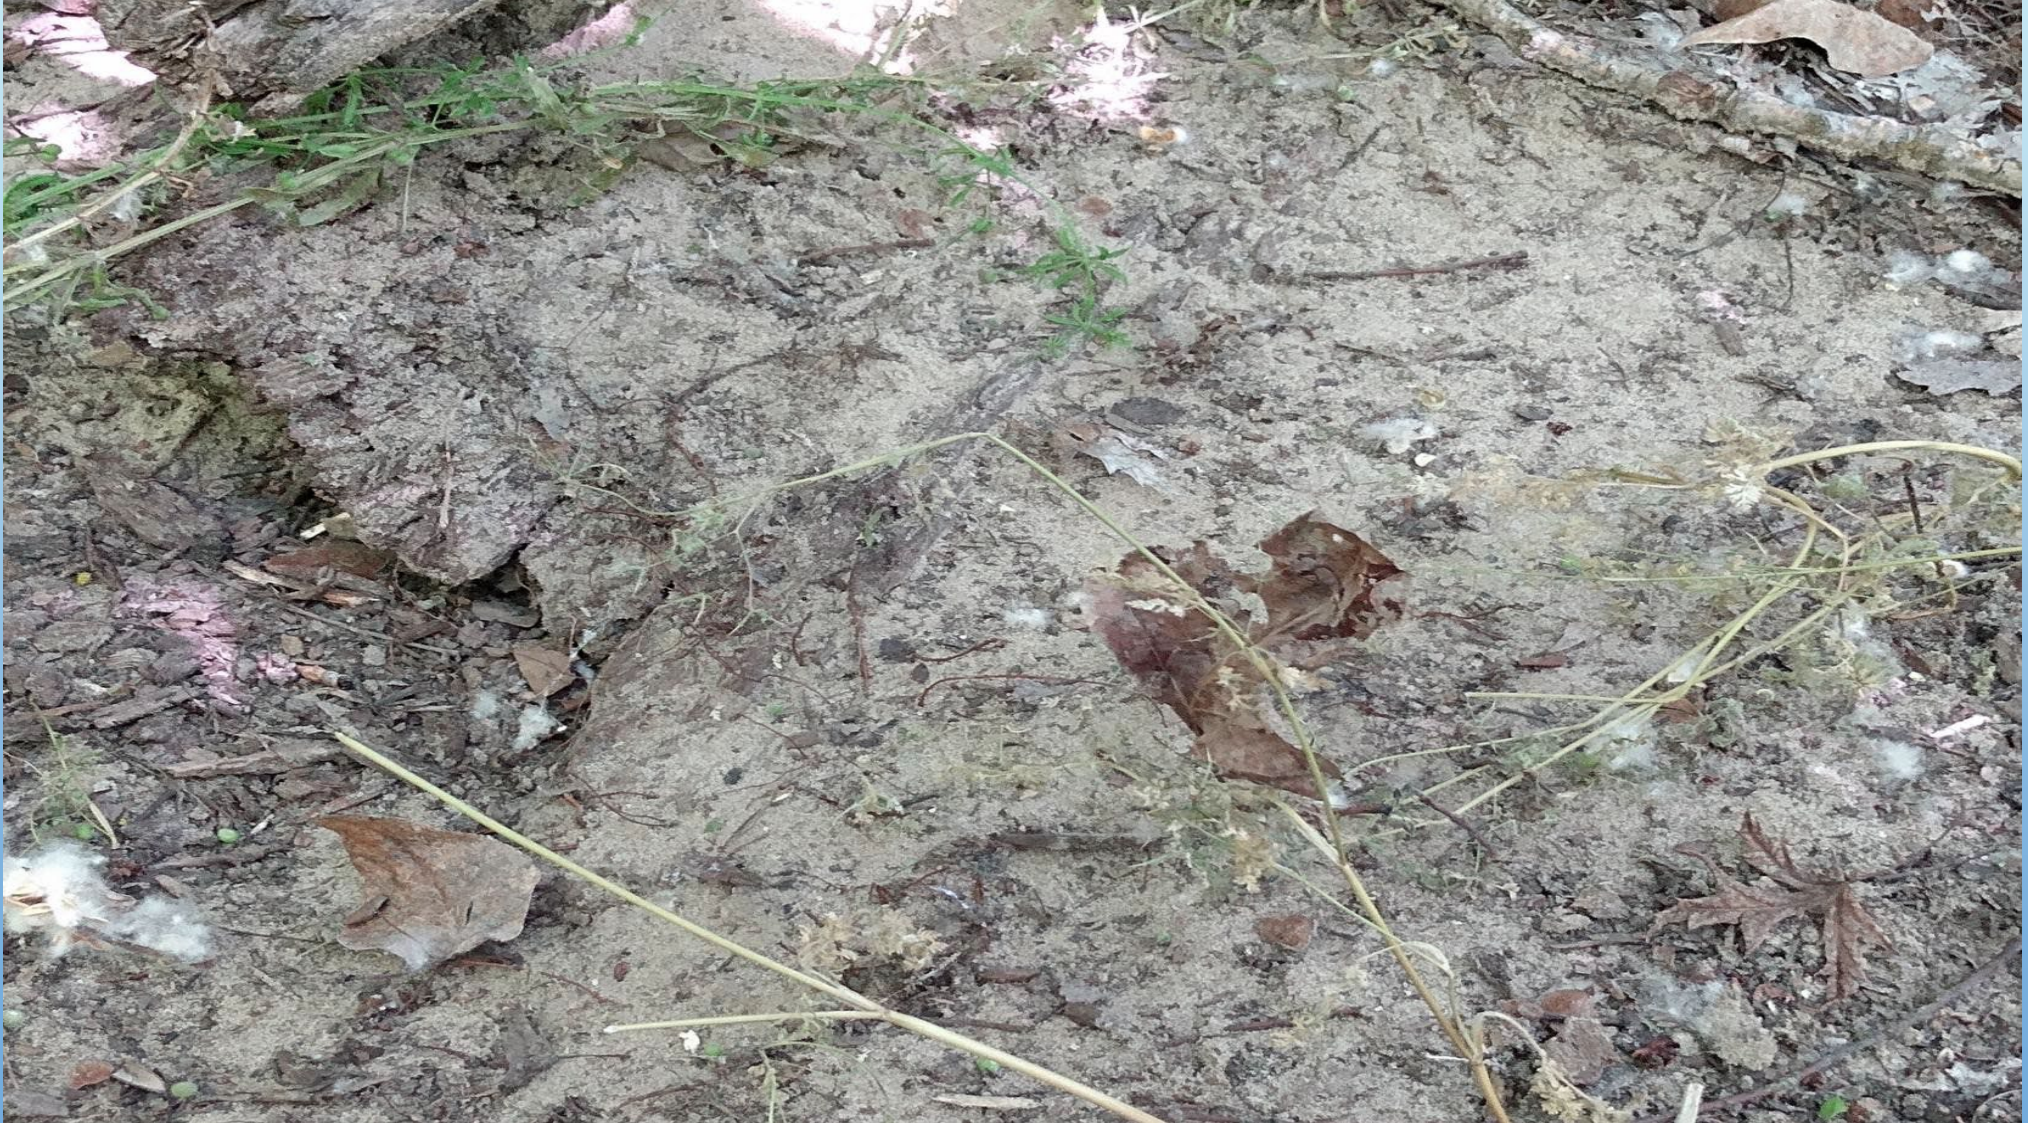
Photo #4: Gravel, sand, and silt in bottom of side channel #1 east of Photo #3. Water flowed from right to left. Note scour feature on left. Flow occurred earlier this spring due to the lack of dead vegetation over the deposited material.

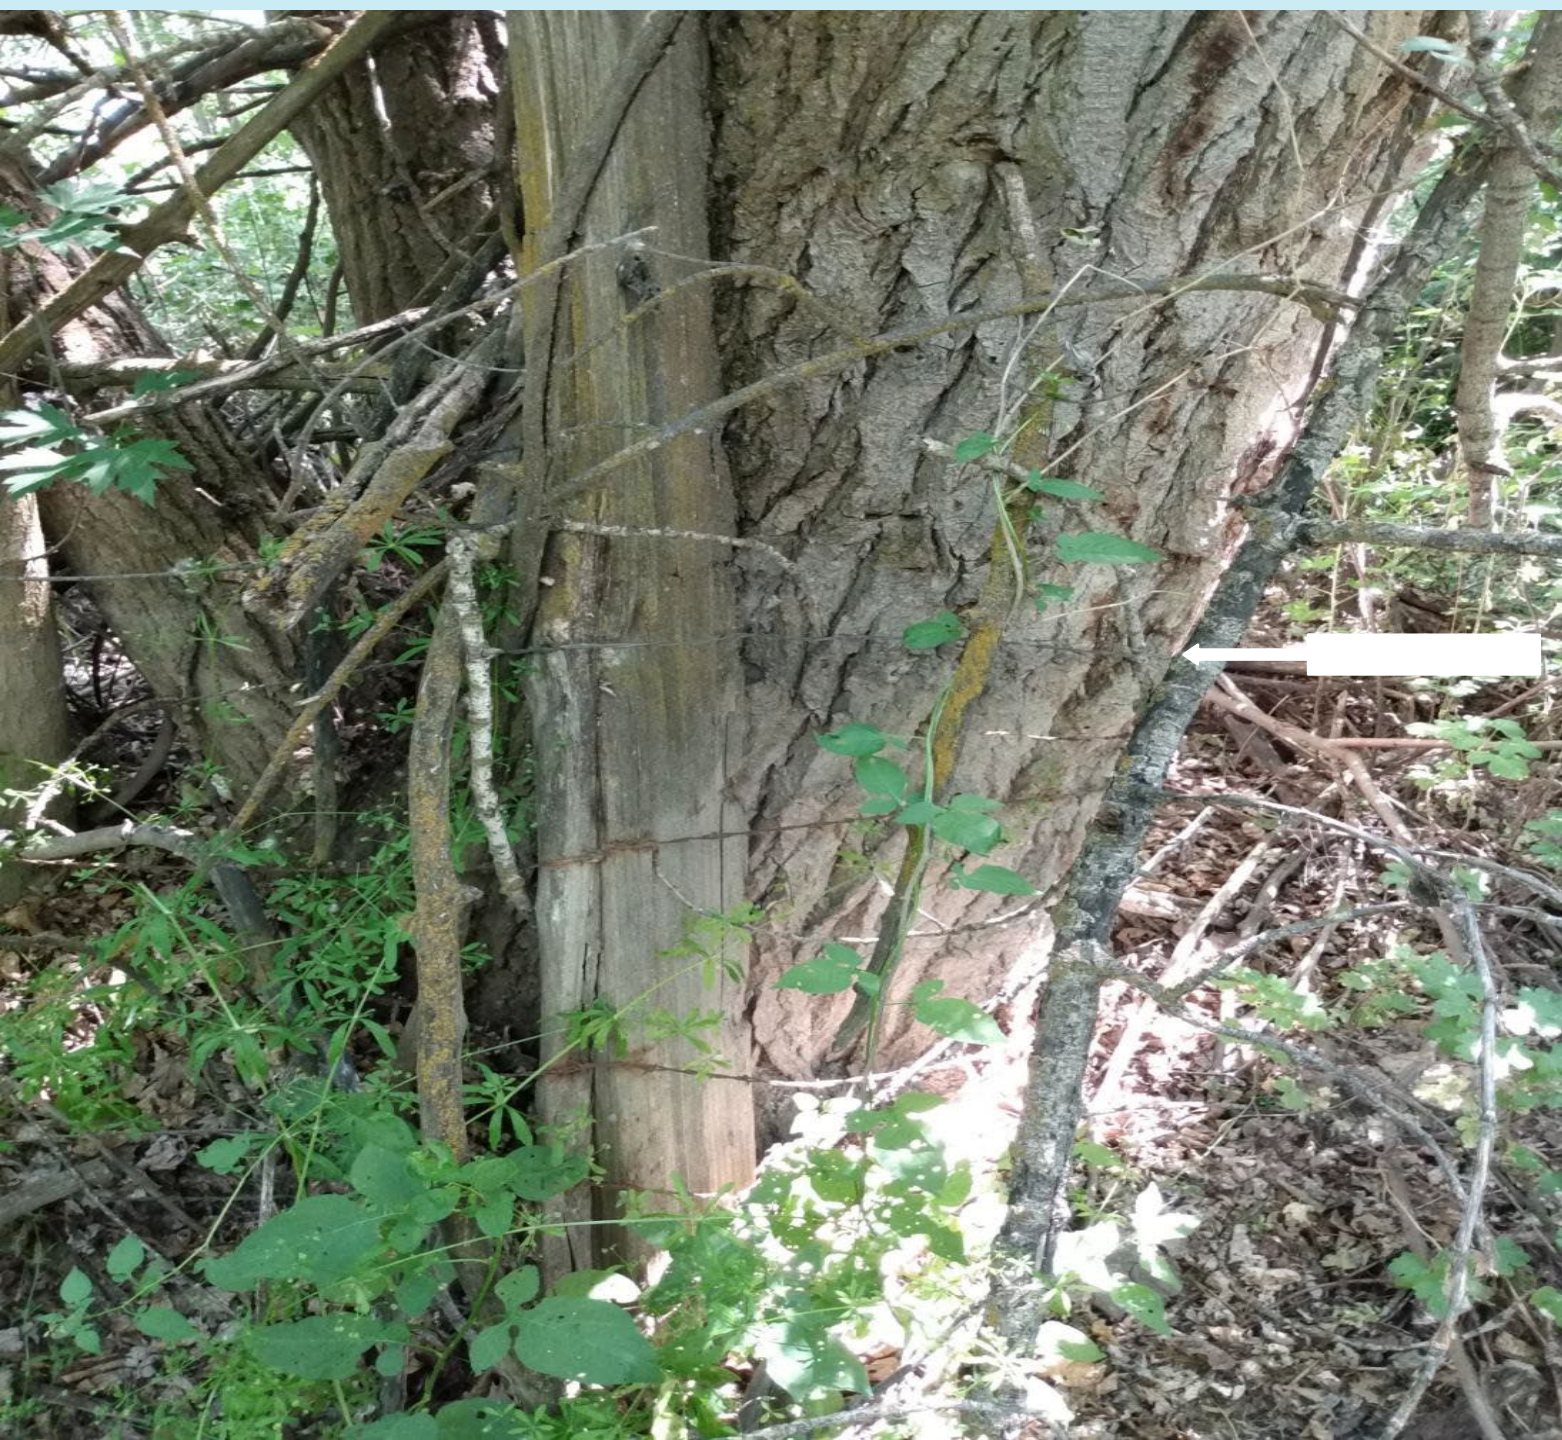
Photo #5: Old fence post on tree with barbed wire. Note top wire is not rusted and post at this level is covered in lichen. Bottom two wires are rusted and post lacks lichens on lower portion. The lichen and silt staining on the adjacent tree show similar changes. The rusted wires, lack of lichen, and silt stains indicate frequent and sustained flows about two to three feet off the ground.

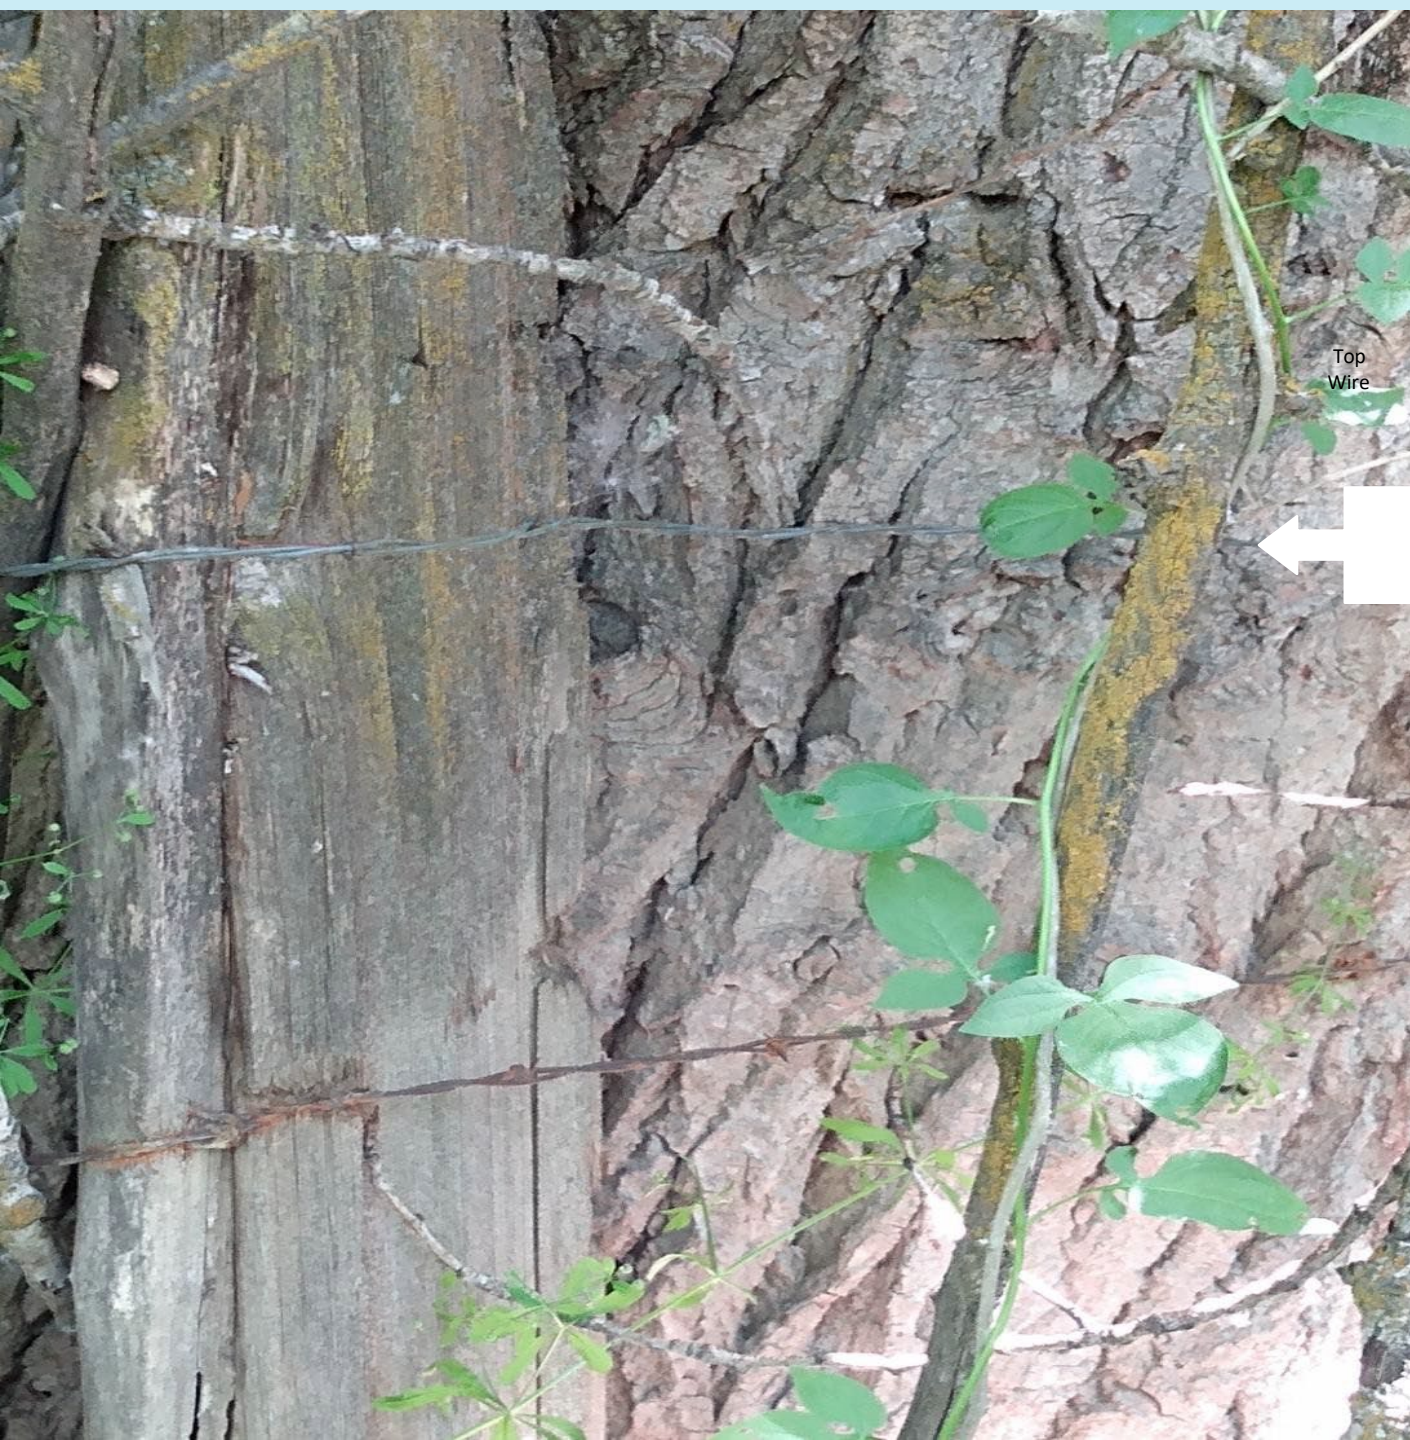
Photo #6: Same fence post shown in Photo #5. Close up of top two wires and color changes. Note top wire is not rusted and post at this level is covered in lichen. Bottom wire is rusted and post lacks lichens on lower half. The lichen and silt staining on the adjacent tree show similar changes. The rust, lack of lichen, and silt staining indicate frequent and sustained flows about two to three feet off the ground.

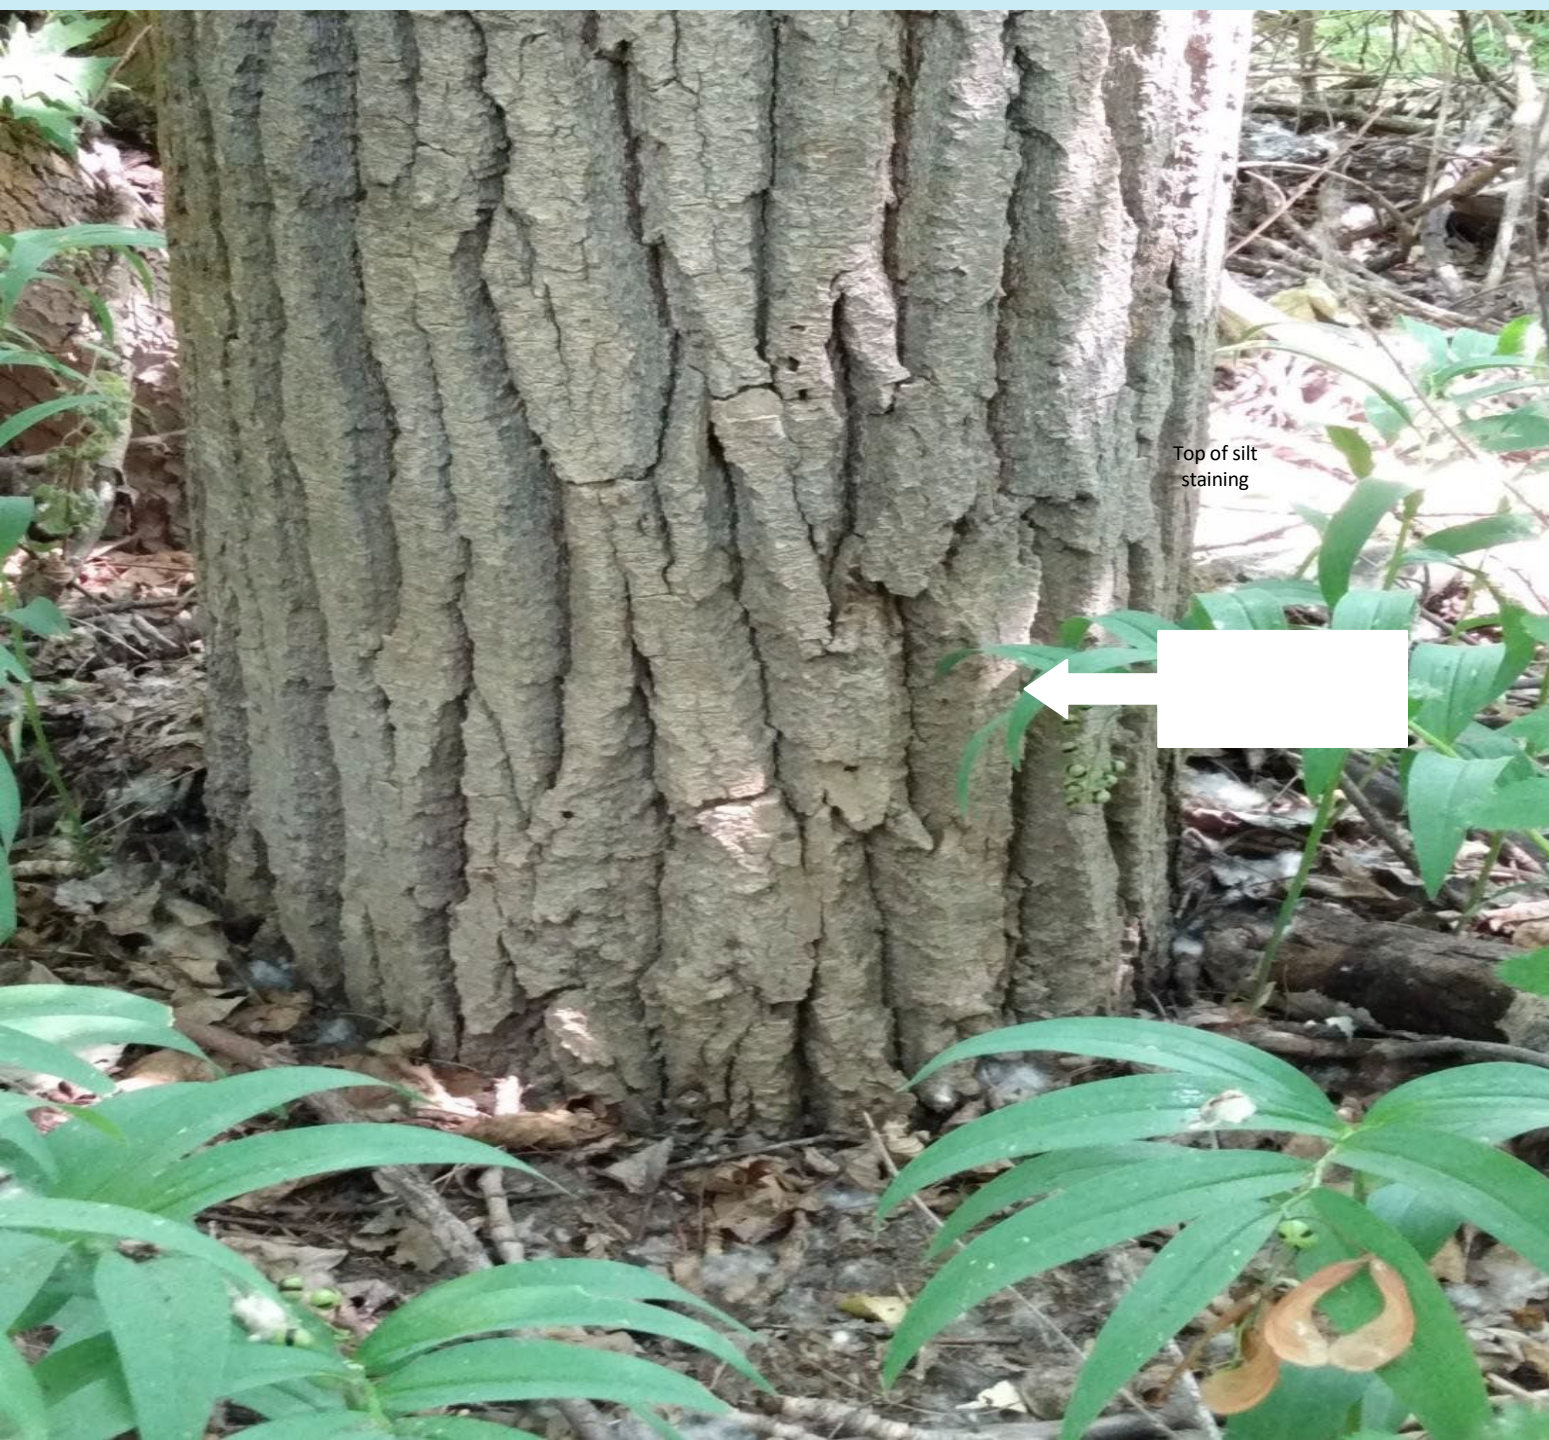
Photo #8: Cottonwood tree with silt staining on the trunk about 18 inches off the ground. This location is east of Photo #7 in side channel #1.

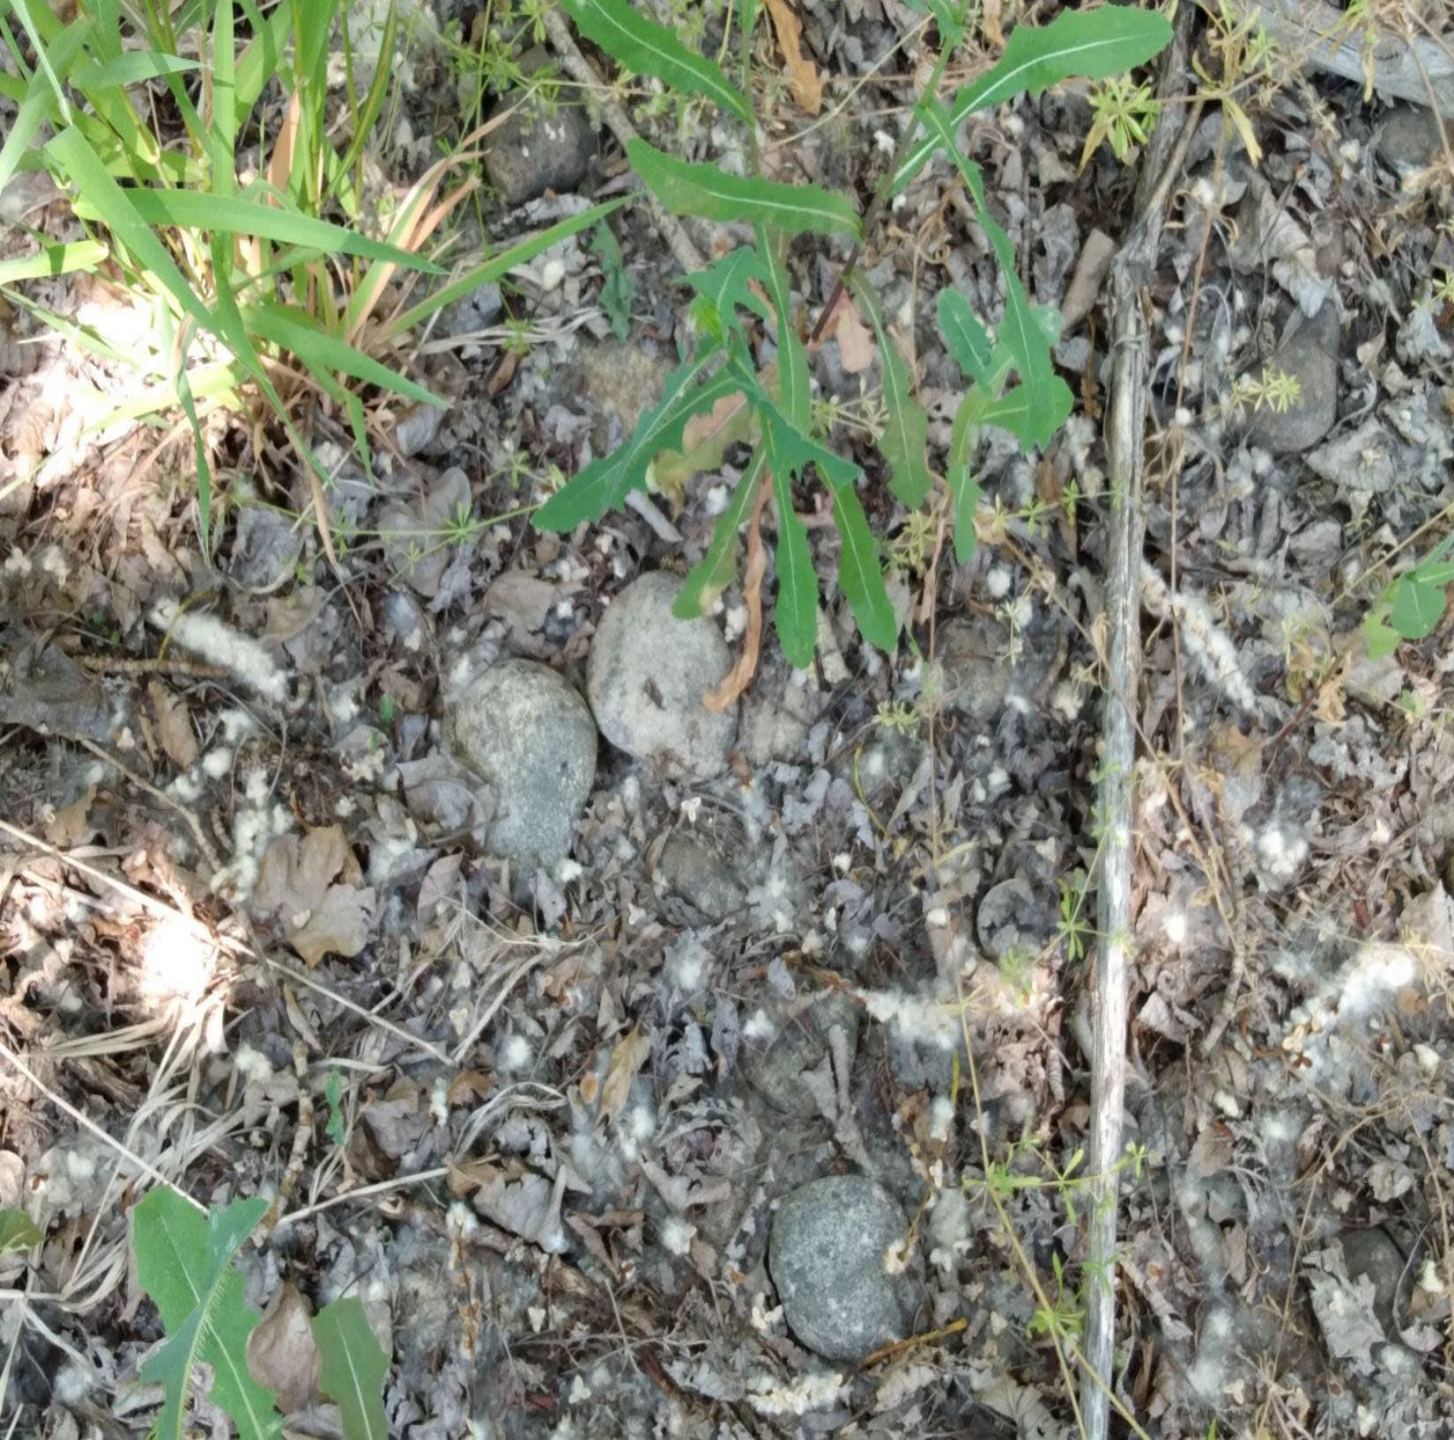
Photo #10: Gravel in bottom of side channel #1 east of Photo #9. Largest rock size is about 4 inches in diameter. As with other points within this channel, no soil formation is occurring.

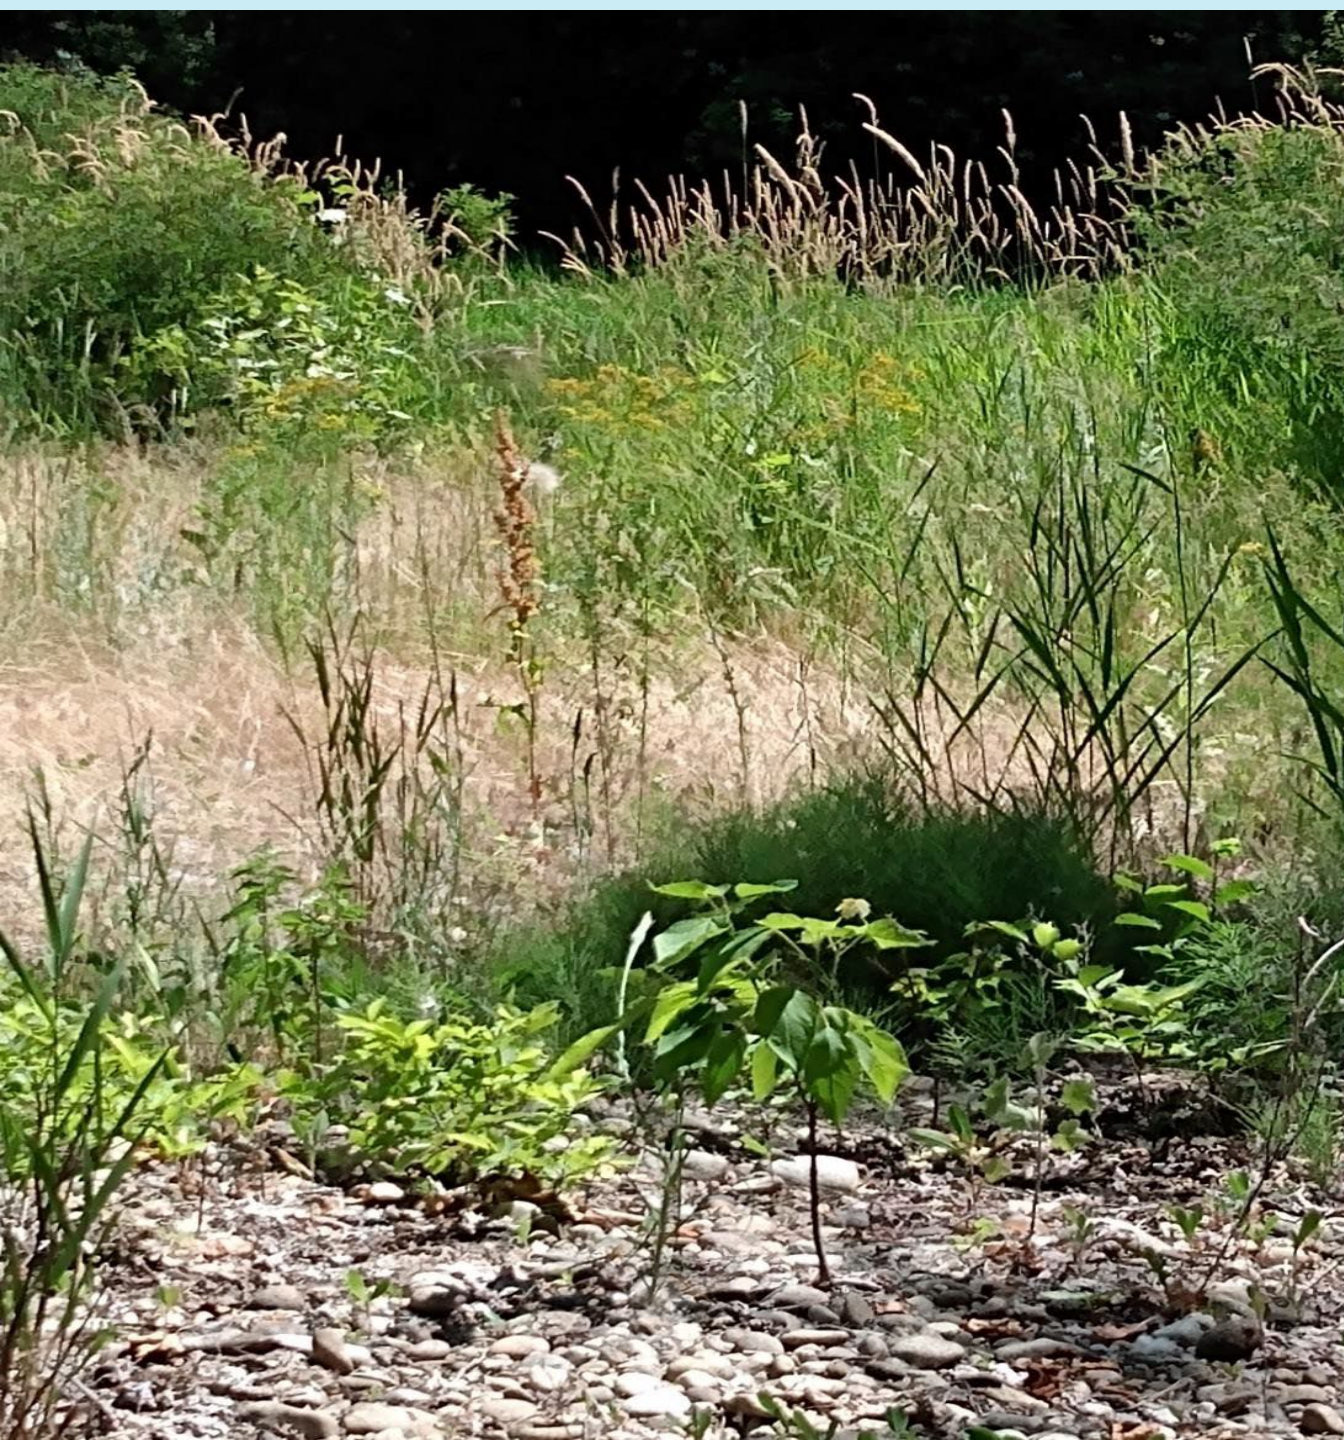
Photo #12: Head of side channel #1 as it exits the main channel. Looking northeastward to the main channel just past the tall grass. Note bare gravel and young cottonwood trees in foreground. Cottonwood trees require freshly scoured sand and gravel substrates for germination.

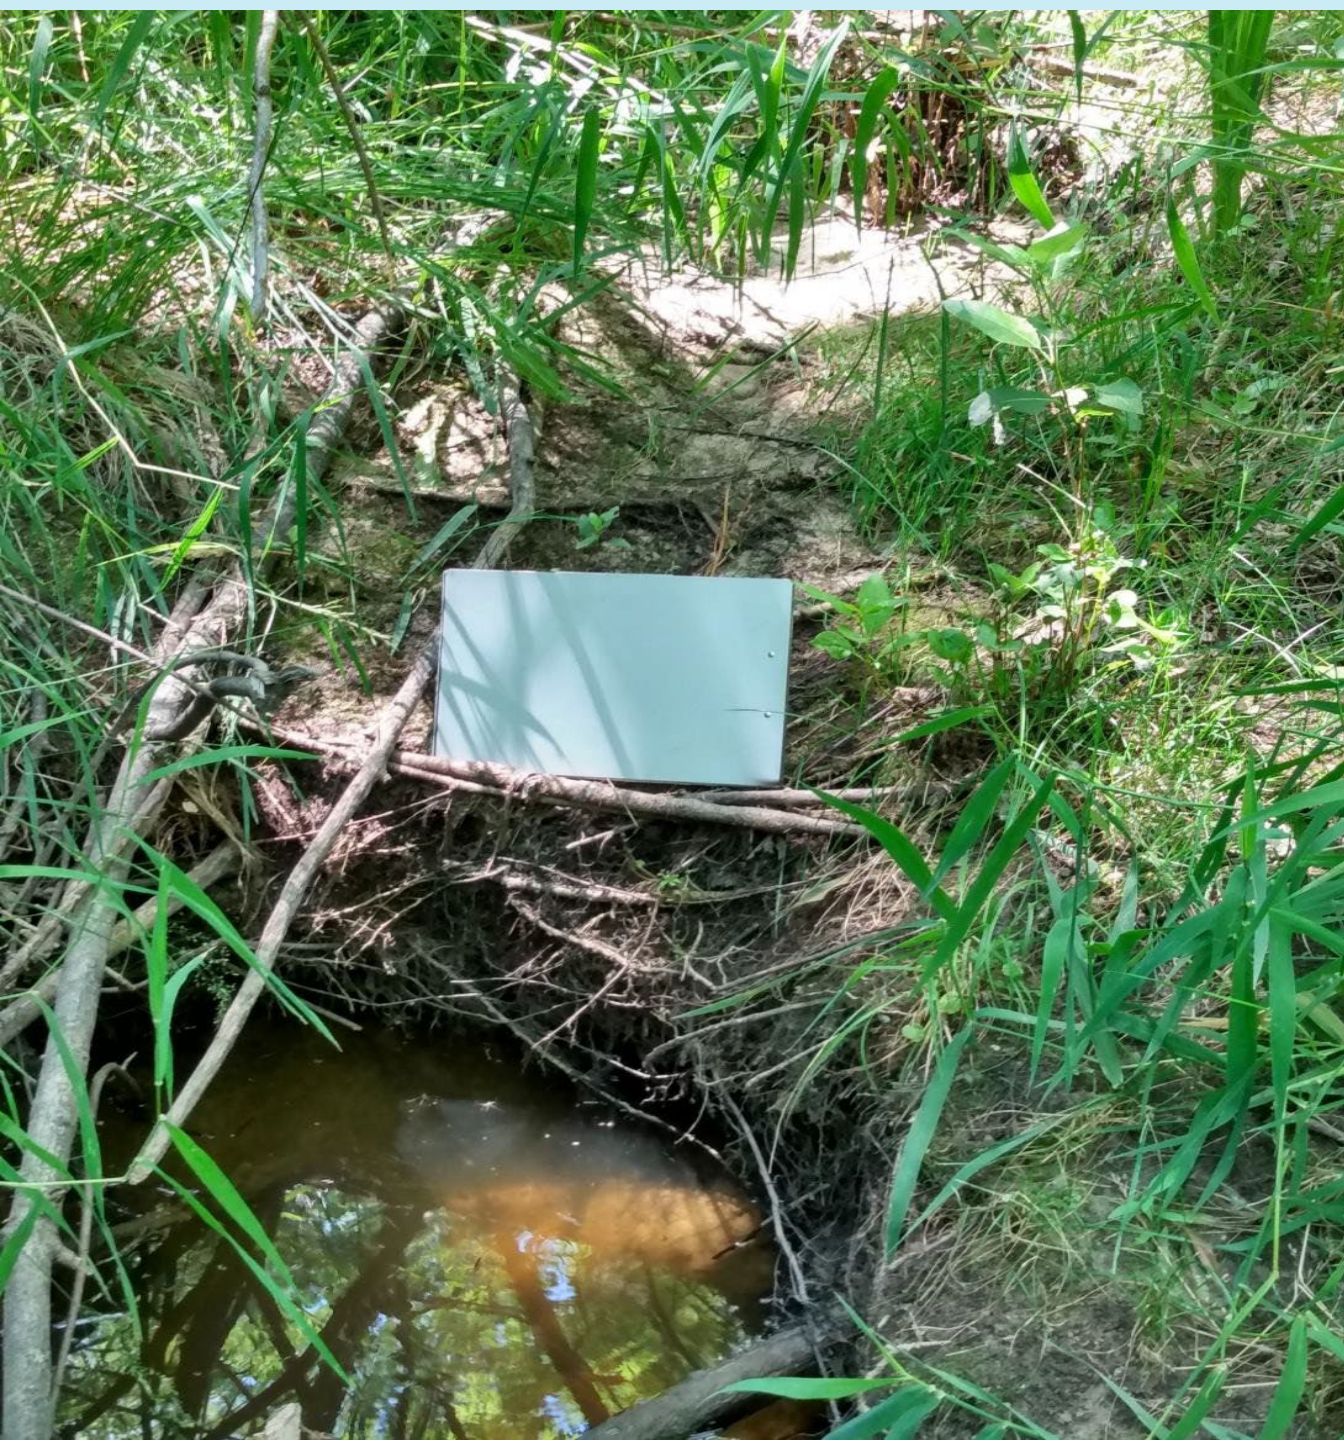
Photo #14: Close up of channel #2 and scour feature in Photo #13. Water flowed from top of photo to bottom this year. Clipboard measures about 9 inches by 12 inches.

Water may be from hyporheic flow. Just west of here the water is flowing and it grows large enough to be a barrier to easy foot traffic. Channel is dry above this point.
