# **EXHIBIT A**

## **The Public Trust Inspection Report**

# RECORD OF SURVEY NO. 13002

FOR PITKIN FAMILY PROPERTY TRUST LOCATED IN GOVT LOTS 4 AND 5 OF SECTION 13,  
TOWNSHIP 4 NORTH, RANGE 1 WEST, BOISE MERIDIAN, CITY OF EAGLE, ADA COUNTY, IDAHO

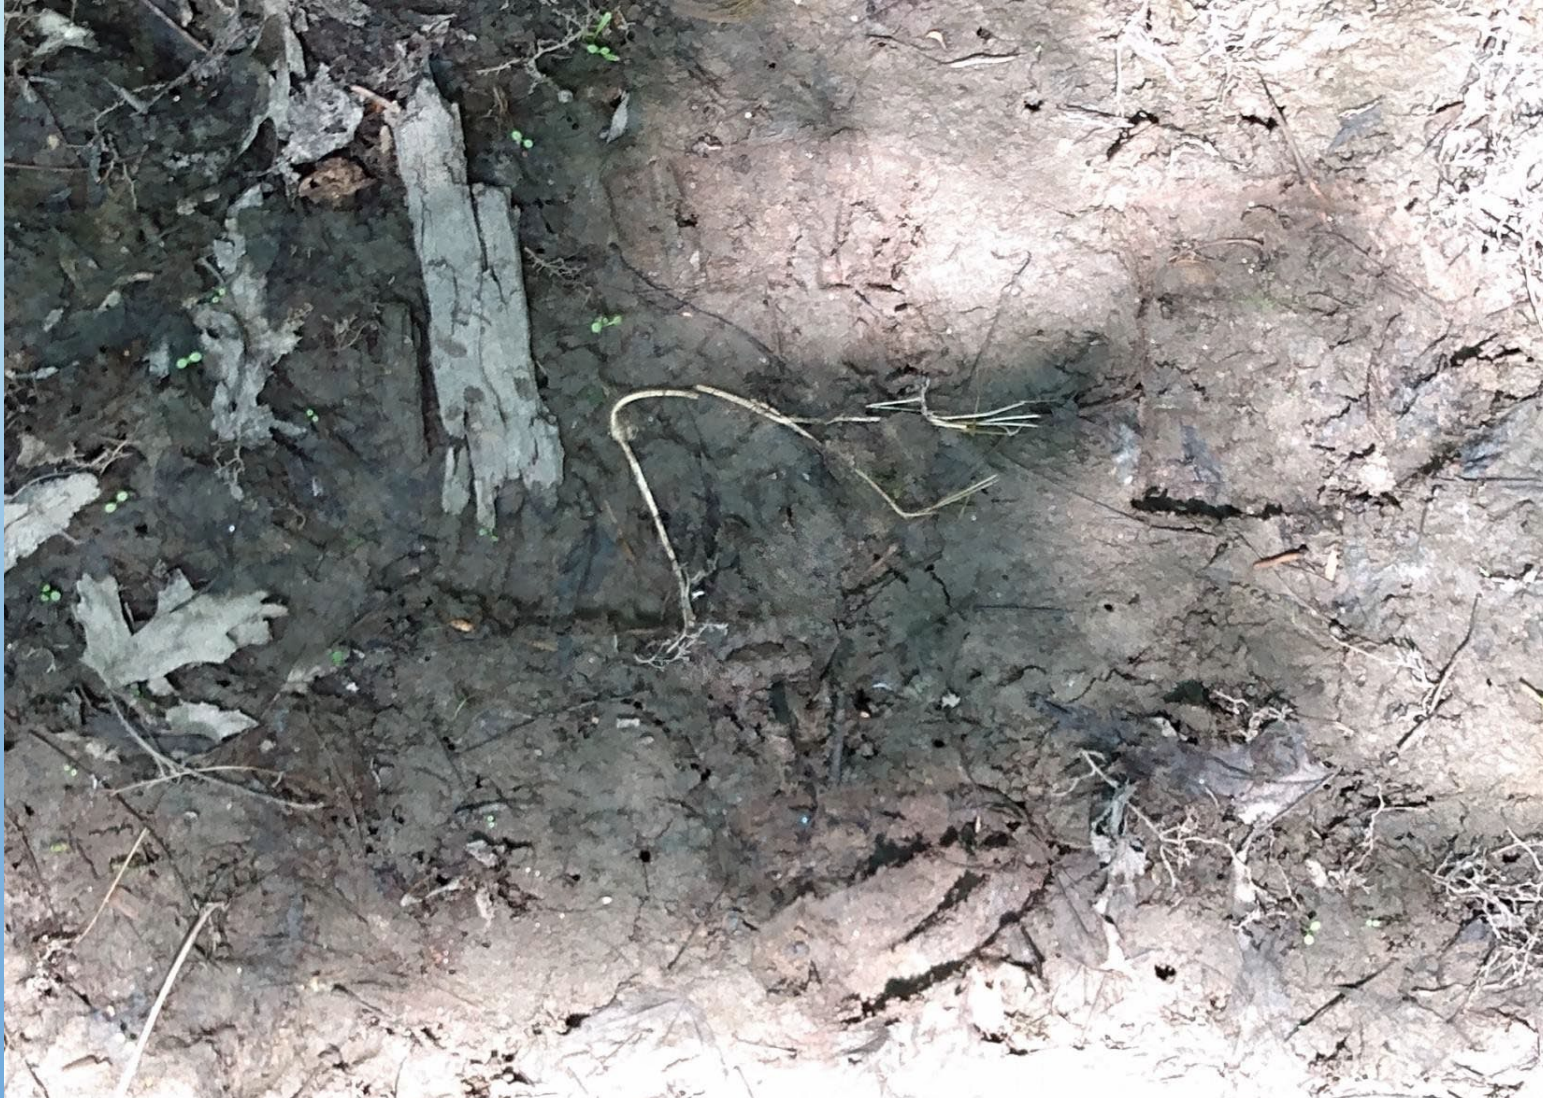
Photo #15: Silt from this spring and fresh deer tracks in side channel #2 south of previous side channel. Just past clipboard in Photos #13 and #14.

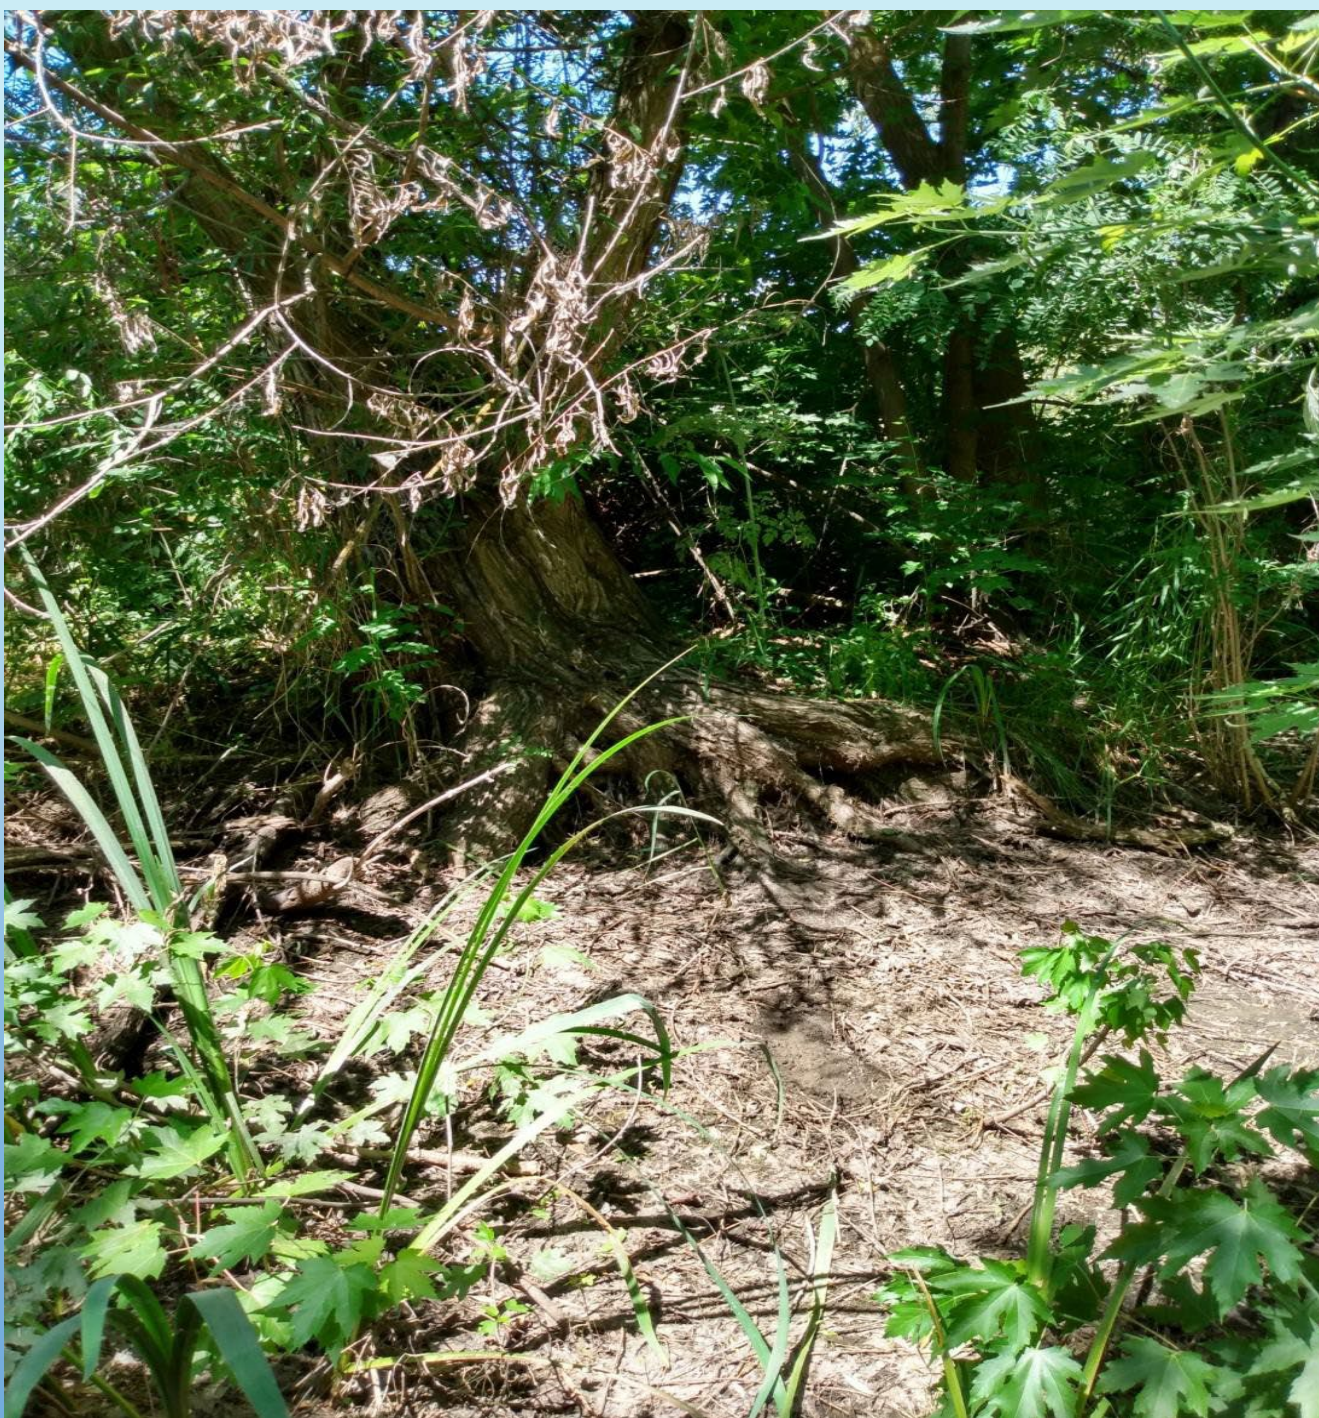
Photo #16: Looking southward up to the top of dike on the State Park land approximately 300 feet upstream of the property. Channel #2 is now at the base of the dike, and it flowed earlier this spring and deposited lots of silt. Cattails also growing in this area.

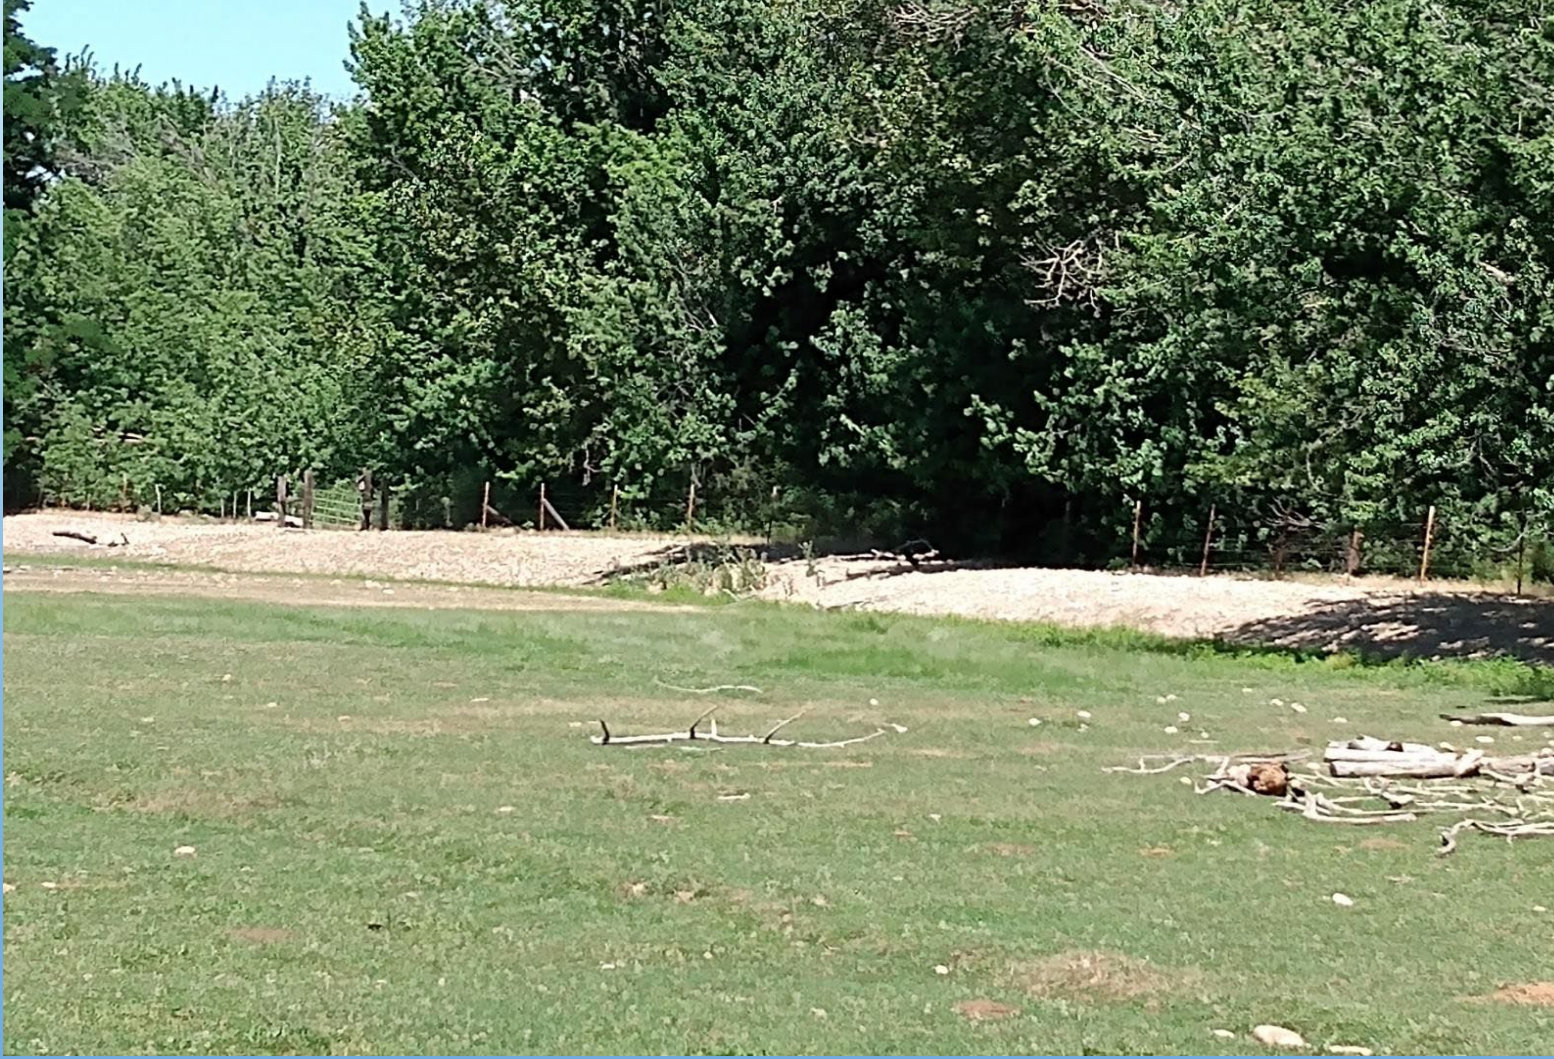
Photo #23: Looking northward at the property from the trail on State Parks property. The dike is two to three feet higher than adjacent pasture. The cottonwood forest just past the dike is the area claimed that is crossed by the side channels show in Photos #2 through #17.

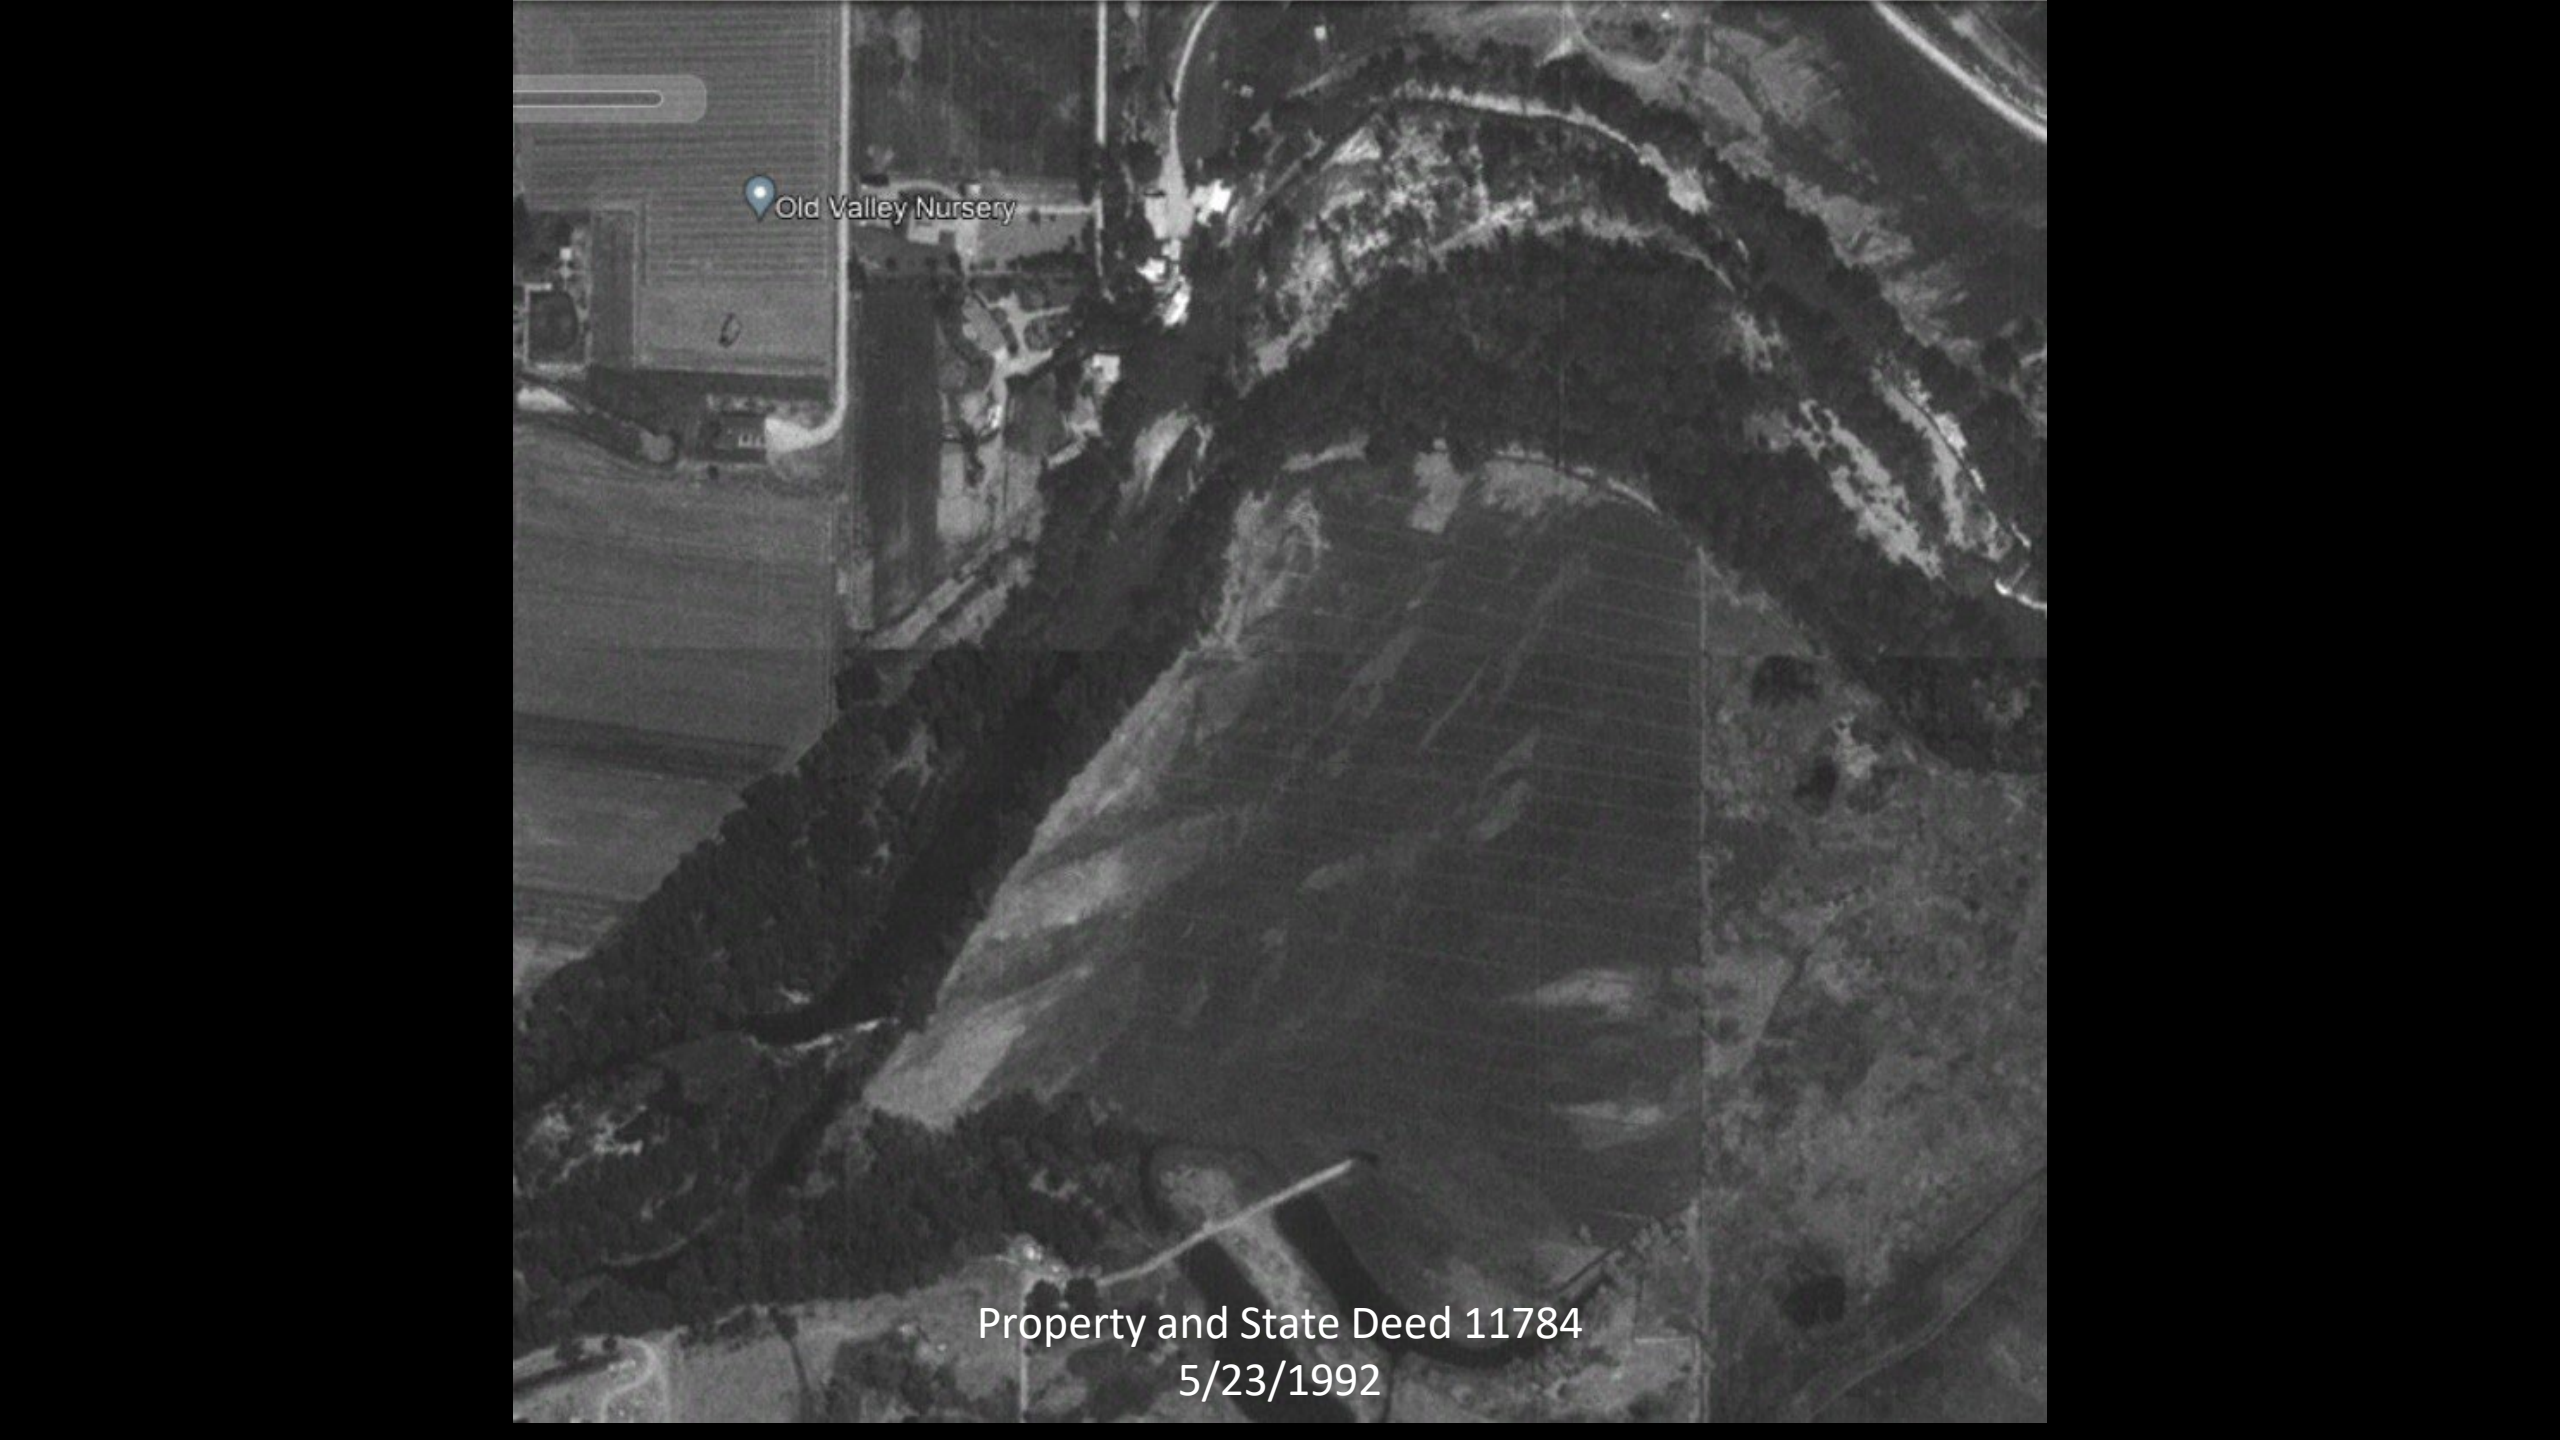
Property and State Deed 11784  
6/27/2003

An aerial photograph showing a rural landscape. In the upper left, there is a building complex labeled 'Old Valley Nursery'. The central and right portions of the image are dominated by a large, dark, textured area that appears to be a forest or a large field. To the left of this area, there are several rectangular fields, some of which are lighter in color, possibly indicating different crops or land use. A road or path runs vertically through the center of the image, separating the nursery area from the larger field. The overall tone is dark and grainy, typical of an aerial photograph.
