CTL Reservoir - Batch Maintenance clean

Industrial Tank Cleaning Case Study

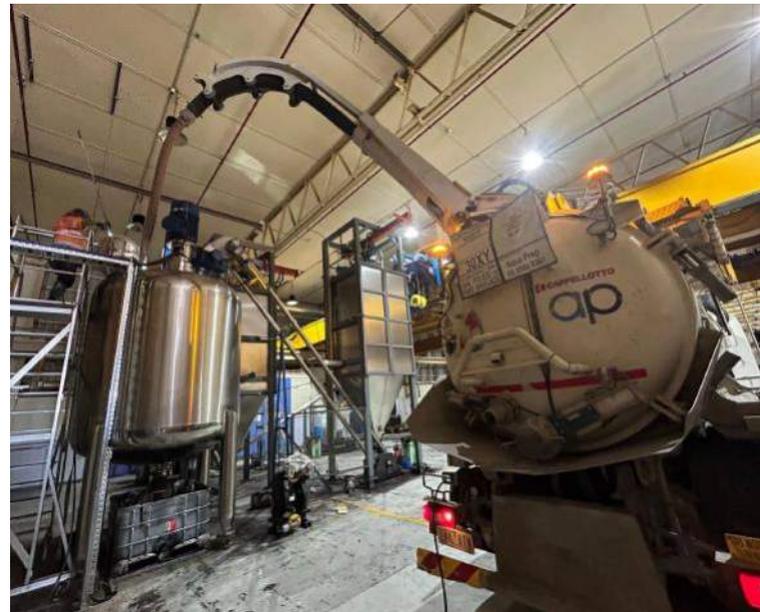
This was a specialised industrial cleaning project involving a 10KL stainless batch tank contaminated with solidified oil and toner powder residue. Using ultra-high-pressure hydro-lancing techniques, the hardened material and sludge were effectively broken down and removed. Waste material was continuously collected via an open IBC positioned beneath the tank's bottom valve, ensuring efficient containment and disposal throughout the operation.
