Preservation Suggestions for Grange Hall

Warren County, Tennessee

Tennessee Civil War National Heritage Area

Fall 2021

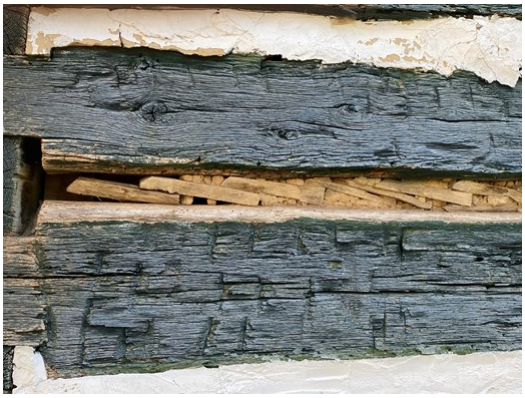
Grange Hall is built using "Chink Construction," the method of building walls with logs and leaving a gap between each log (Figure 11). It simplifies the build by allowing for discrepancies and adjustments as the walls are erected. Later, the spacing, or chinks, will be filled with board slats and a chinking mixture, or daubing. To achieve chink construction the corner notching must allow for spacing between logs. Corner notching can be accomplished through a variety of ways. Grange Hall represents square notching. Square notching is the crudest form of notching in log construction. It is mostly found as a traditional style of notching along the Gulf Coastal Plain.[9] Square notching likely originated in Central Sweden, but is found in Fenno-Scandian regions as well as German-Slavic Borderland regions.[10]

Figure 11: Chink construction showing the use of daubing.

There are several places that are missing chinking and daubing that should be repaired (Figure 22). Check and make sure that proper daubing material is used. The use of a mortar mixture as daubing can draw moisture into the wood and speed up the deterioration process.
