SITE INSPECTION REPORT

Wavepool Balance Tank

Darwin Wavepool

21/10/2025

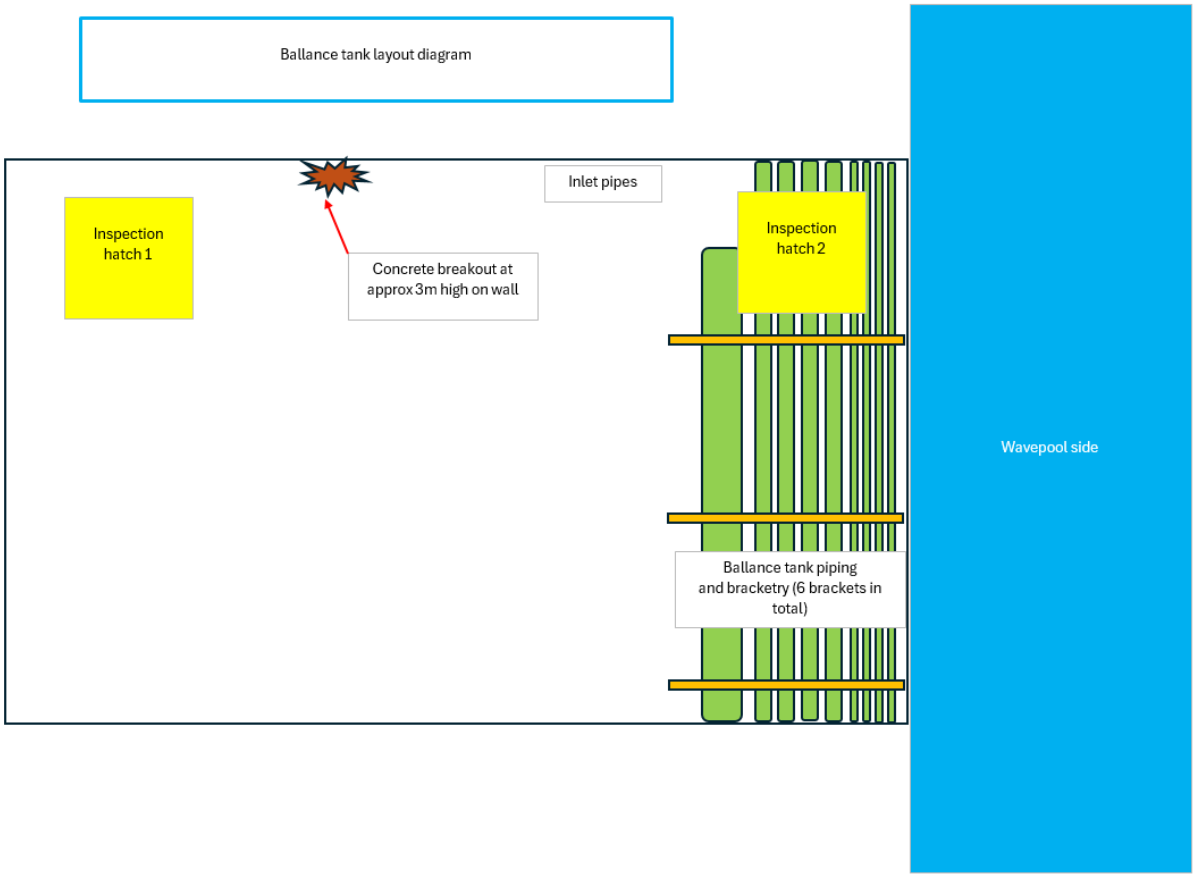
The overall condition of the tank was good. PVC piping is in good visual condition. 316 Stainless steel brackets are in good condition with signs of scaling built up and only minor signs of material corrosion. The concrete walls were in good overall condition with one area showing a small breakout approx. 30cm x 30cm. sand and silt was approx. 100mm – 150mm deep in places on the floor of the tank.

RAM recommend that the balance tank be inspected every 2 years to monitor condition of piping, bracketry and overall tank condition. Next inspection, the following areas would require effort.

- Remove all sand and silt with vac truck
- Addition of scaffold to further inspect bracketry, remove scaling and assess integrity, replace clamps/brackets as required.
