BUILDING SURVEY & INSPECTION REPORT

[REDACTED]

Building Survey & Inspection Report

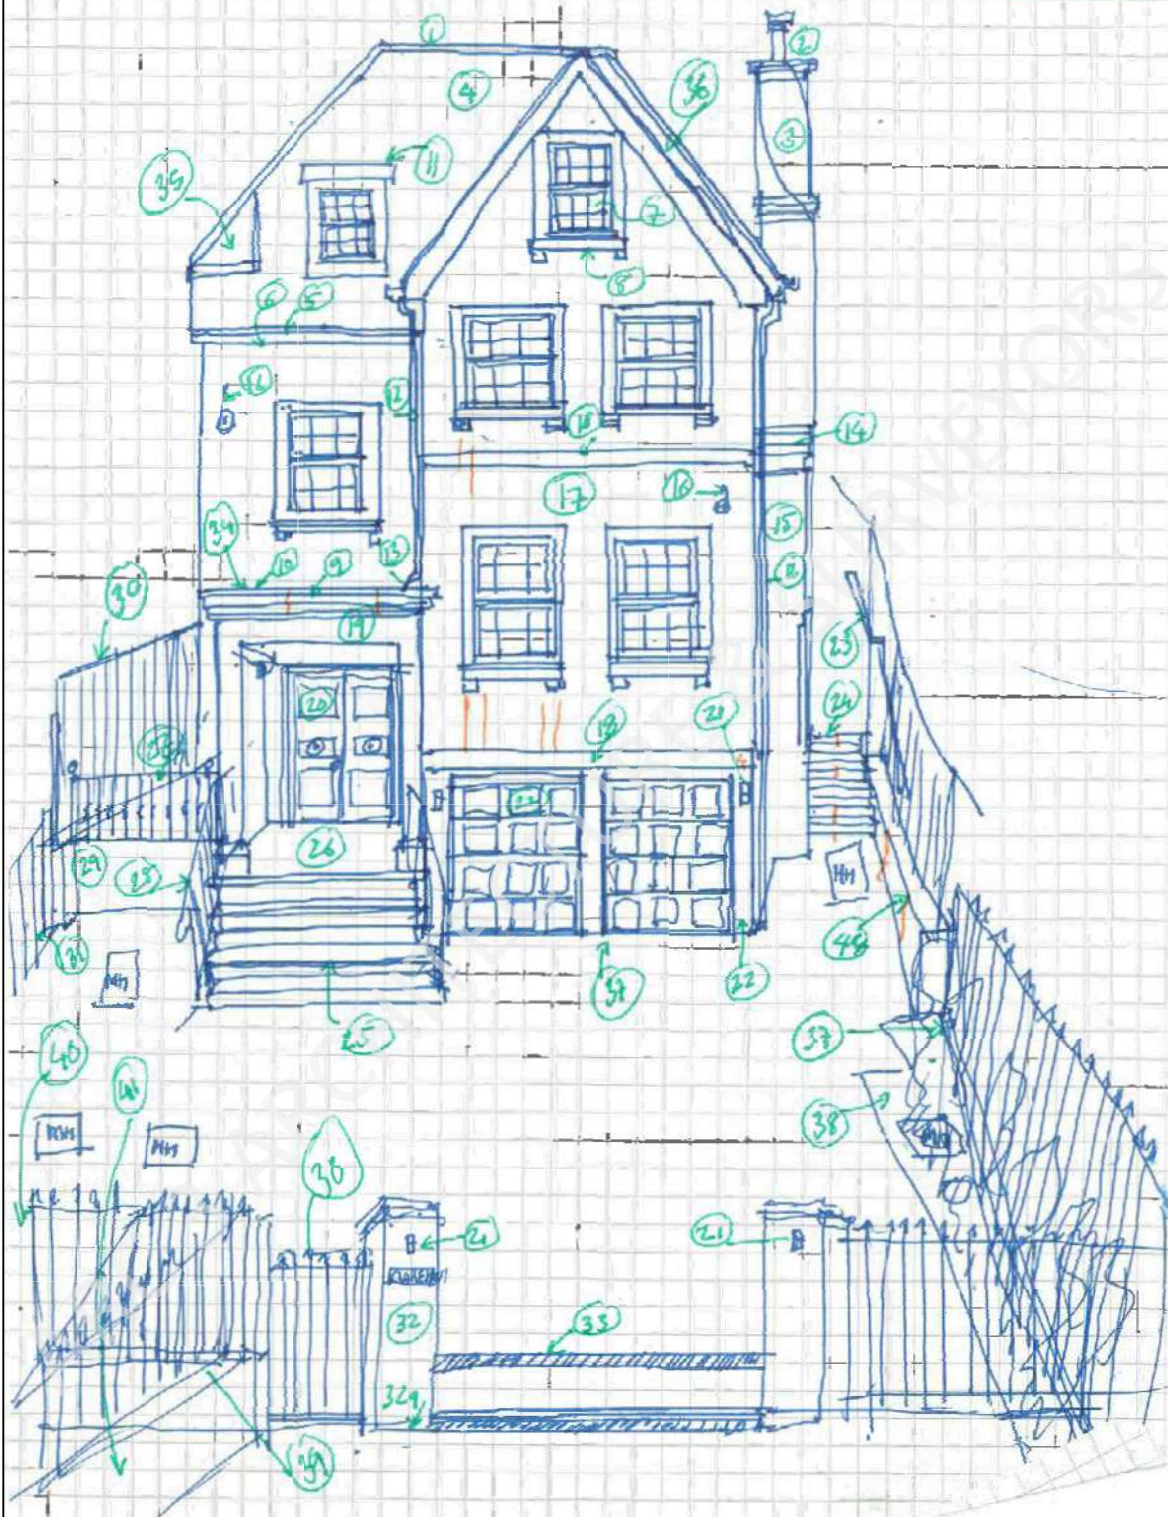
FRONT ELEV. → MAYUR

- 1 - RIDGE TILES - GOOD (3)
 - 2 - CHIMNEY FLOW - (3)
 - 3 - HIGH CHIMNEY - (3)
 - 4 - ROOF SPANISH NAT SLATE (2)
 - 5 - AL. GUTT (2/2)
 - 6 - SOFFIT (3/2)

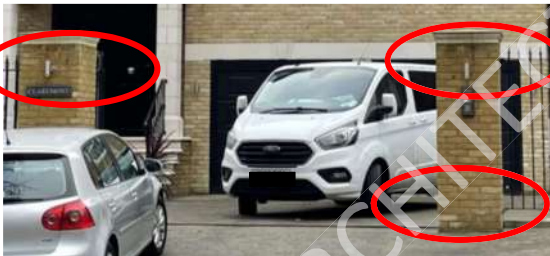
2.00	Front Main Building Façade	
2.1	Side Pedestrian Gate (Front Entrance Gate) Space is available but appears. not Installed. No ' <u>Pedestrian only</u> ' access.	This is only an observation: Whether this was intended or not is not known.
2.2	Walls (Dwelling) dampness was evident at the base.	Dampness to be prevented. Rendered plinth is recommended.
2.3	Brick wall - efflorescence stains & cobbling.	Observation only
2.4	Lintels above garages have mortar marks/splatter.	Some, making good, is necessary and recommended.
3.0	Garage	
3.1	Uneven floor finish.	Ideally should be a level sloping floor.

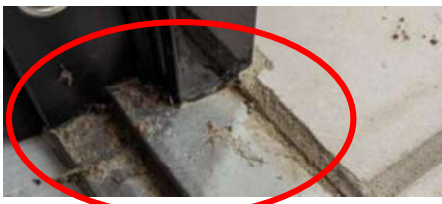
FRONT ENTRANCE		
9.2	9.3

INTERIOR	
9.0	Front Entrance	
9.1	No door stop.	Without a door stop wall will get damaged.
9.2	Triple switch - 3rd switch not connected. To be further investigated and action to be taken. Gap above the switch.	Observation Make good

9.3	Front entrance door threshold requires cleaning and regular maintenance.	To be cleaned and observation.
9.4	No window keylock.	None of the windows have key locks.

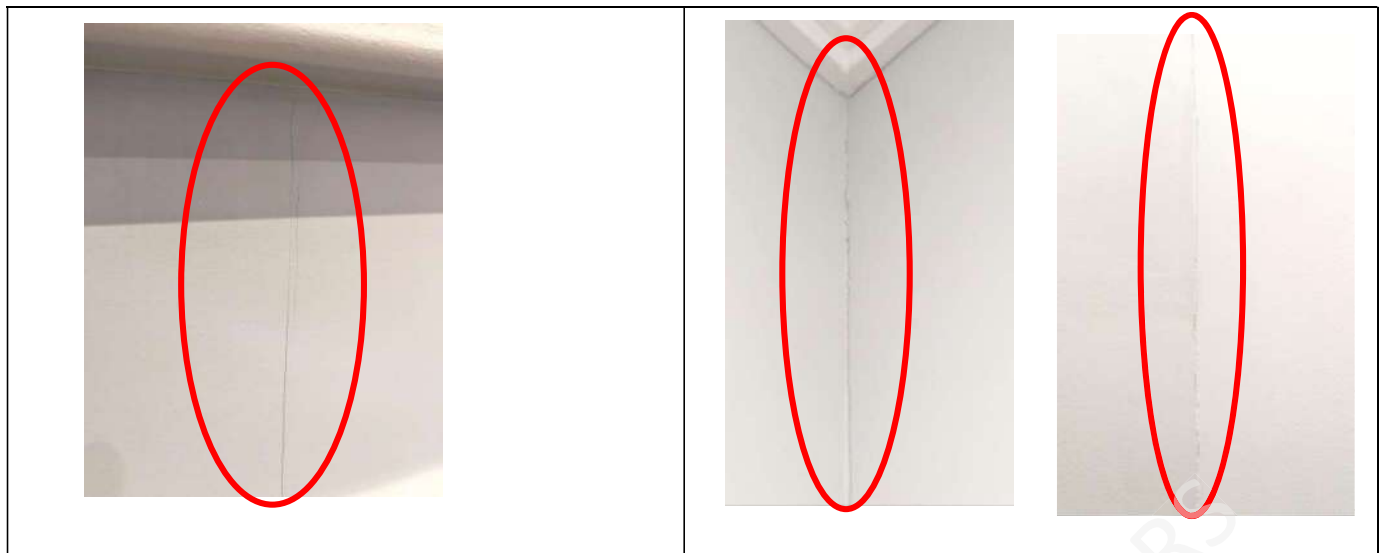
9.5	9.6

9.5	Hairline Crack under window sill.	Requires making good.
9.6	Hairline crack at the interface of wall and cupboard.	Requires making good.
9.7	No shoe rack.	Provision and installation recommended.

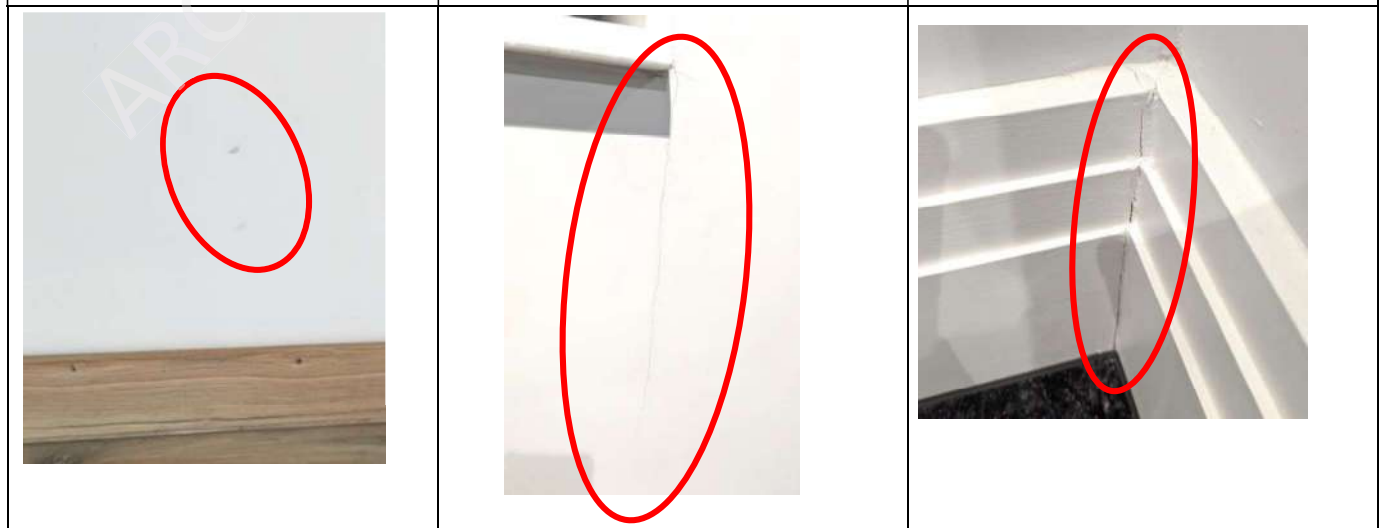
9.11	Scuff mark on the ceiling above stairs.	Make good.
9.12	Hairline crack on the wall - under first floor stairs opening (corner)	Make good.
9.13	Steps have a potential of becoming slippery.	Observation.

9.14	Skirting board do not have a uniform scribe and mitre joints.	Observation and possibly can be made good.

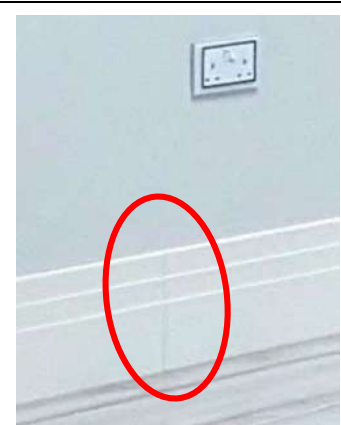
12.5	Living room skirting board interface presents visible gap.	Requires making good
12.6	3 panel bifold door - on exterior - vent grill broken. <i>(Also mentioned above in item 6.5)</i>	Requires making good

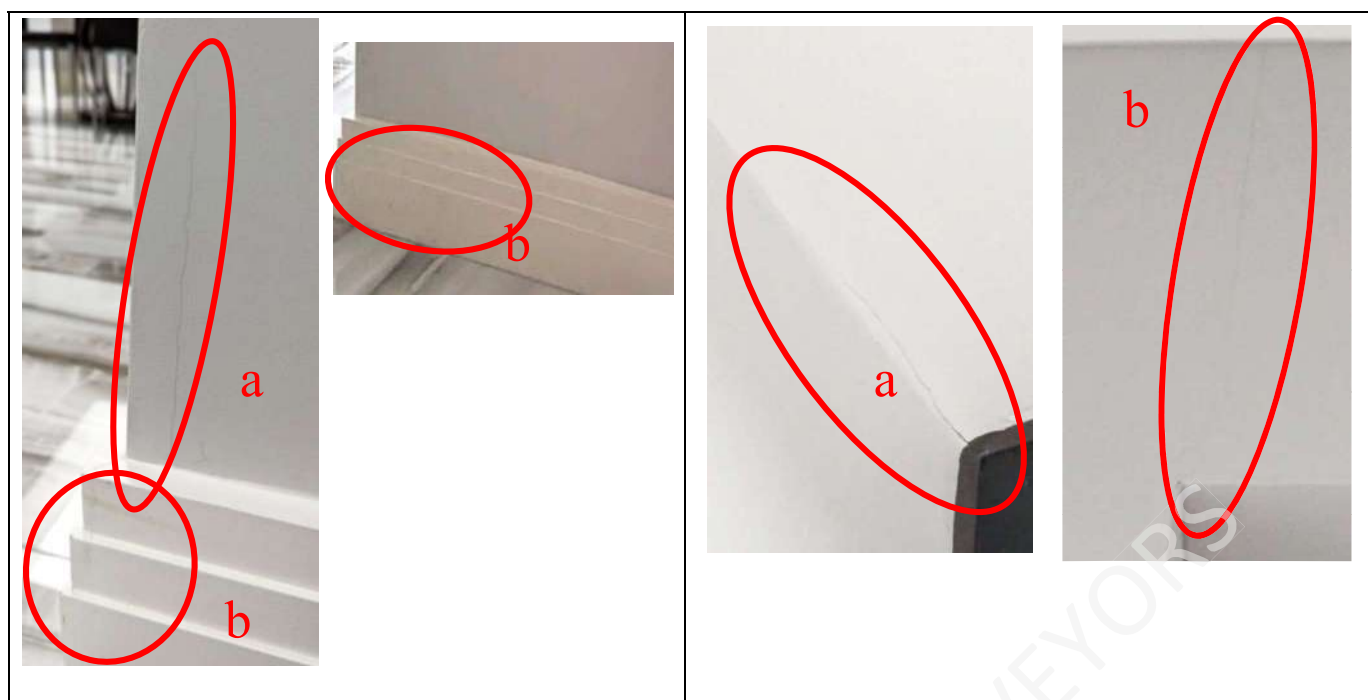
12.7	a. Hairline crack on column – next to the skirting board. b. Scuff Marks on columns skirting board.	Requires making good
12.8	a. Hairline crack at the interface of ceiling and wall within the 4-door panel bifold wall opening. b. At the exterior corner of the same bifold door, hairline crack on the outer side of middle wall (wall - in between bifold doors.)	Requires making good

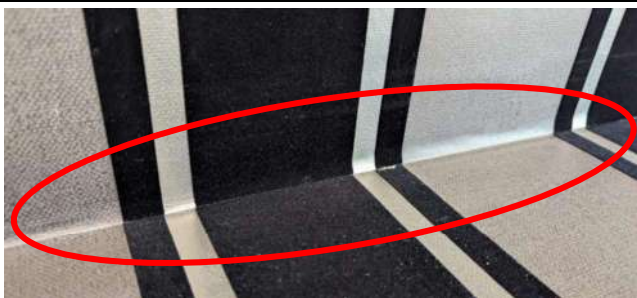
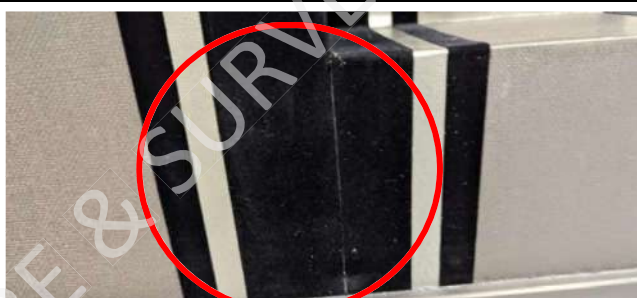
14.2	14.3

14.0	Formal Reception Room	
14.1	No door stop.	Wall will get damaged without one. Provision and installation recommended.
14.2	Wallpaper not cut and sealed evenly or properly. Inexpertly undertaken.	Requires making good
14.3	Scuff marks on wallpaper - right of fireplace.	Requires making good
14.4	Scuff mark under fireplace wall	Requires making good
14.5	Above fireplace, sockets to be installed for TV	Appeared to be on-going or in progress.

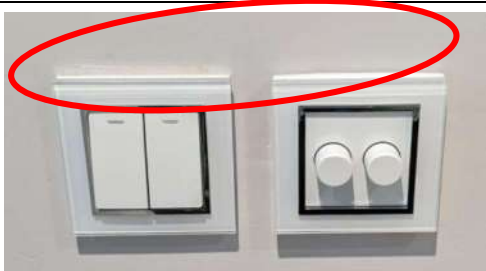
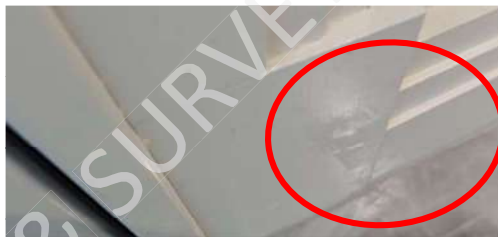
15.1	15.4

15.0	Hallway	
15.1	Scuff marks on wall next to light switches.	Requires making good
15.2	Uneven landing and stair interface. Loosely fit – slight movement of first step.	Requires making good - Threshold and Transition strip recommended.
15.3	Steps could become slippery.	Slip prevention system recommended.
15.4	Scuff marks or scratch on the skirting board next to the fire door, on the wall with the light switches.	Needs making good.

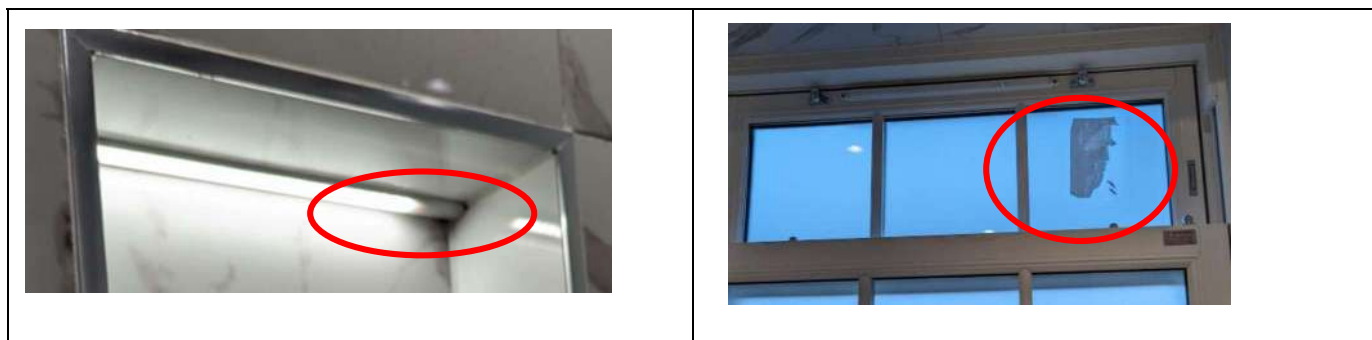
17.6	17.7

towel rail and so on.	recommended.
17.5	Toilet label to be removed.	Cleaning Recommended
17.6	Sticker to be removed from the window	Cleaning Recommended
17.7	LED in the shower not working on the ends, only middle of the strip..	Requires further investigation and /or service and action
17.8	No door stop.	Without one, wall will be damaged. Provision and installation recommended.
17.9	Door lock stiff	Requires making good

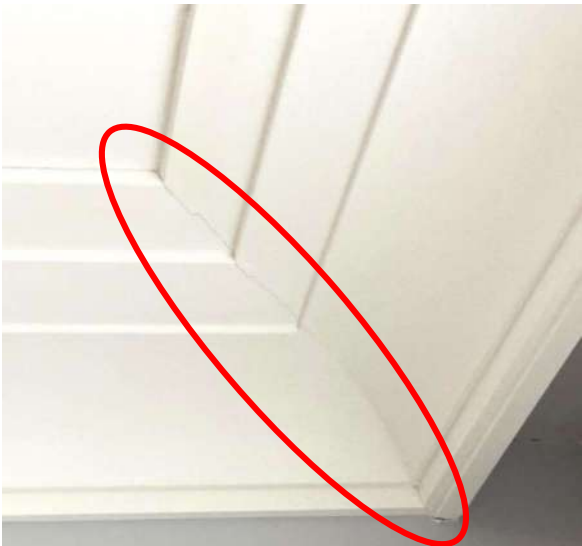
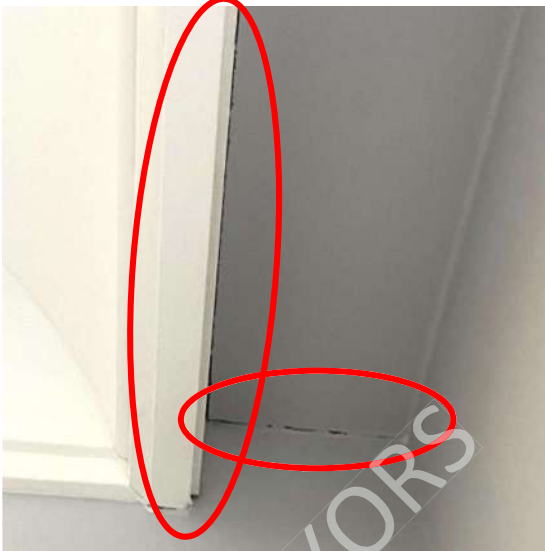
22.6	22.7

22.6	The cornice has a hairline crack.	Requires making good
22.7	a. No LED strip behind the cornice on the window wall (LED installed in bedrooms 1-3). b. Hairline cracks are observed behind the cornice at interfaces with wall/ceiling.	Noted. Requires making good

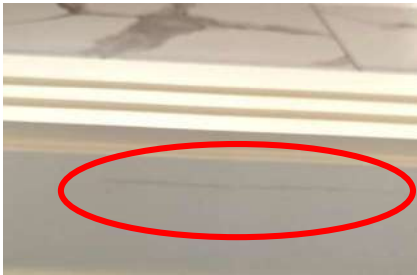
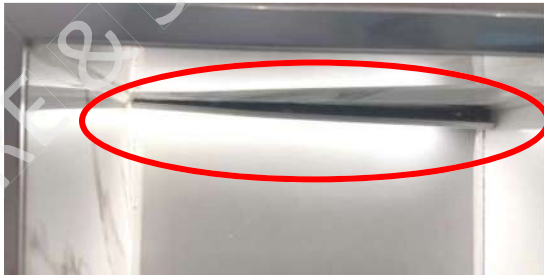
BEDROOM 4 ENSUITE	
23.11	23.12

23.12	LED Strip inside the shower is dislodged.	Requires making good
23.13	Shower door's label to be removed and cleaned.	Cleaning Recommended
23.14	Door handle to be fixed. Square ironmongery fixed to door is loose.	Requires making good

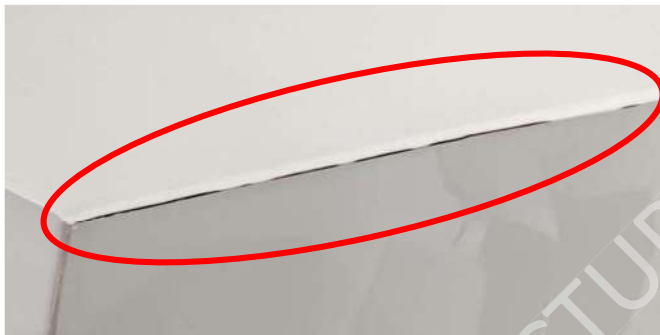
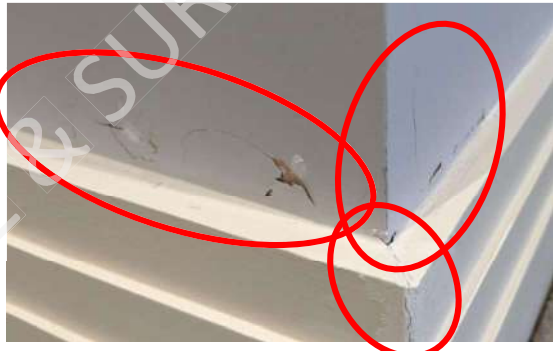
LOFT BEDROOM 5	
27.1	27.2

27.0	Loft Bedroom 5	
27.1	Sealant is cracked at the interface of wardrobe with ceiling. Wardrobe had ongoing works done inside at the time of the survey.	Requires making good

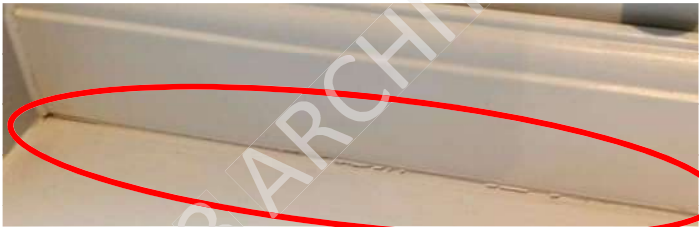
27.4	Window sill has a crack.	Requires making good
27.5	Skirting board is cracked.	Requires making good
27.6	Hairline crack above the loft storage access door	Requires making good

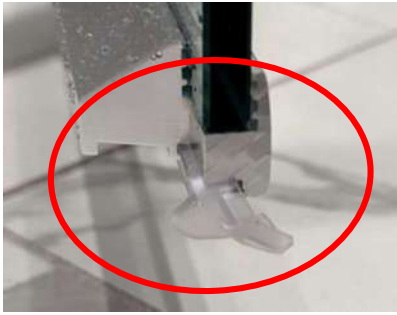
28.5	Shower door screen plastic screen not properly fitted. Loose and appears dislodged.	Requires making good and regularisation.

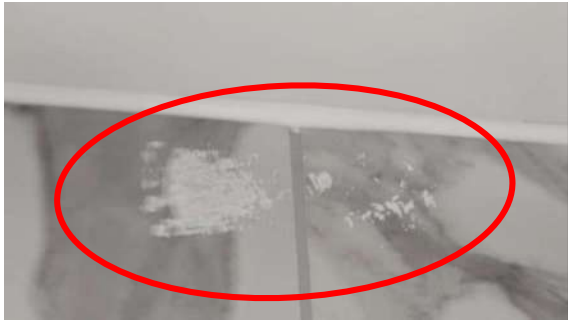
28.6	Shower tile has a paint/render/mortar splatter – upper tile behind above shower head	Requires making good and cleaning.
28.7	Ceiling fan startles. To be checked. Unusual noise.	Requires further investigation and/or service and/or action
28.8	Ceiling to wall sealant cracked at the interface of roof angled ceiling and bedroom wall.	Requires making good
28.9	Sink Drawer loosely fitted.	Appeared to be on-going or in progress.
28.10	Mirror Light not working.	Requires making good
