Inspection Report

Property Address:

1111

Brighton MI 48114

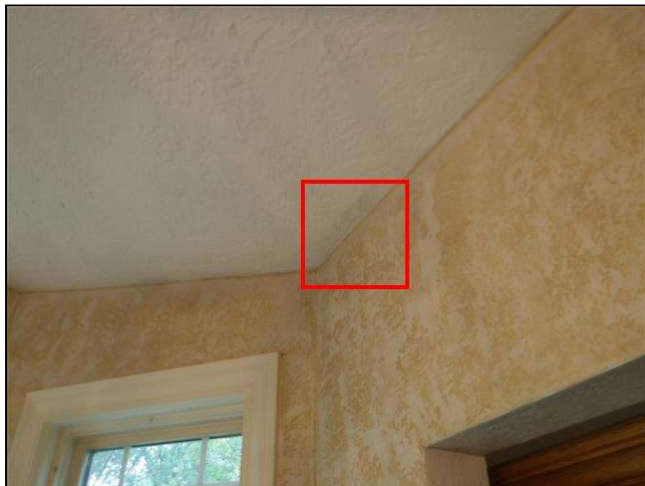
1.0 Item 1(Picture)

1.0 Rolled rubber is holding water, at indicated location. Current condition has resulted into moisture entry at indicated area of ceiling below. This was observed with a thermal imaging camera and confirmed with a moisture meter. Recommend repair as needed

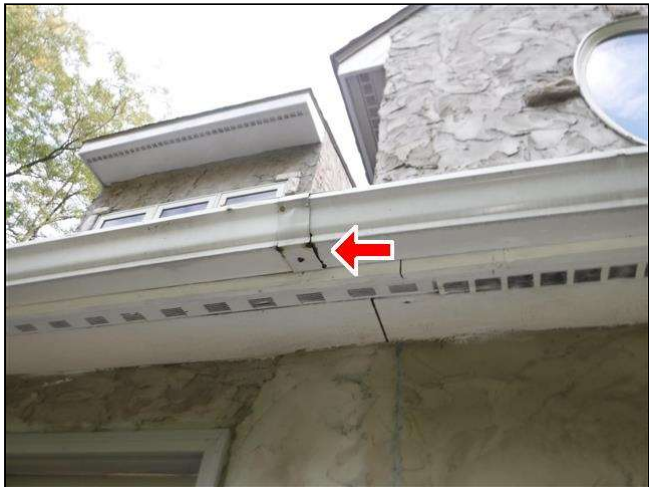
1.5 Item 2(Picture)

1.5 Gutters appear to be leaking/overflowing at multiple areas. Recommend repair as needed for improved water control.

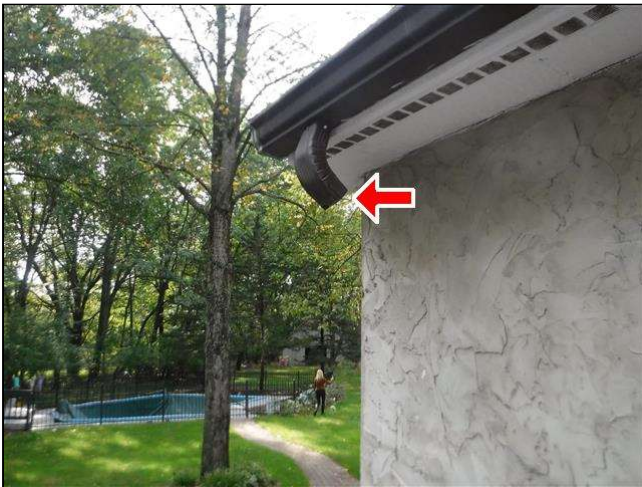
1.6 Item 2(Picture)

Recommend reconfiguring discharge location of extension indicated. Current configuration is resulting/contributing to elevated moisture levels at the adjacent area in the garage.

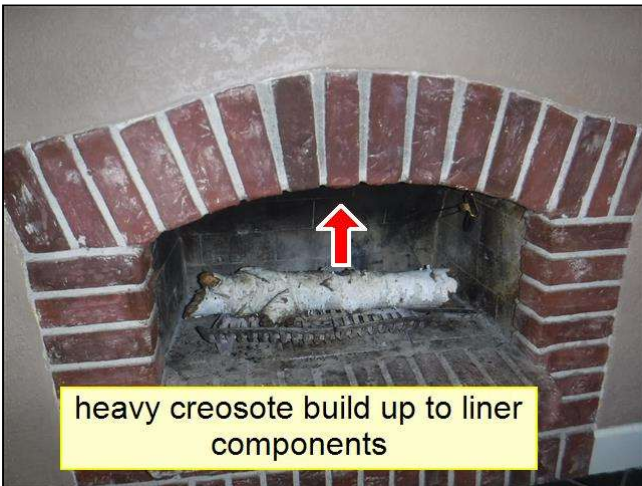
8.8 Item 2(Picture)

8.8 Creosote build up on liner/flue components to dining room fireplace. This condition presents a fire hazard, to the chimney, as creosote can be ignited by extreme heat from a fireplace. This condition can also conceal any potential defects to flue components. Recommend a full cleaning and inspection by a qualified contractor.

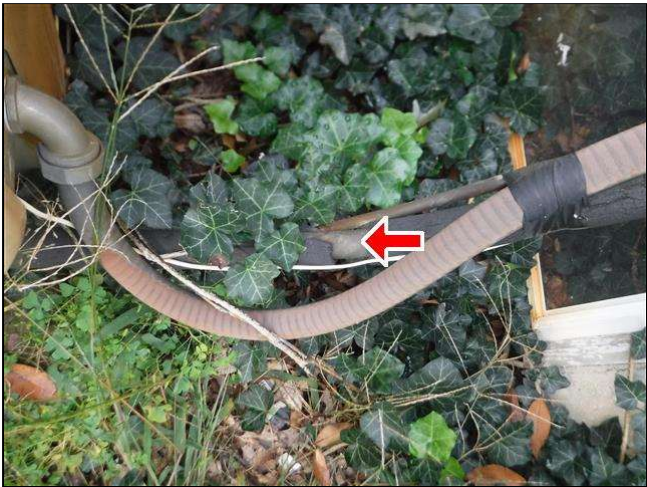
12.1 Item 1(Picture)

12.1 Add insulation to voids on low pressure freon line to increase efficiency.
