# Comprehensive Pre Purchase Building Report

**WA Buildinspect**

**Medina**

Report/Agreement #	2212250941091015
Inspection Date:	22 Dec 2025
Inspection Time:	09:30 AM

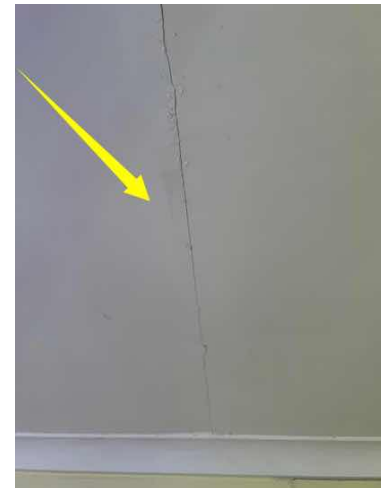
Settlement Cracks Noted . These are typical and generally patch and paint will suffice.

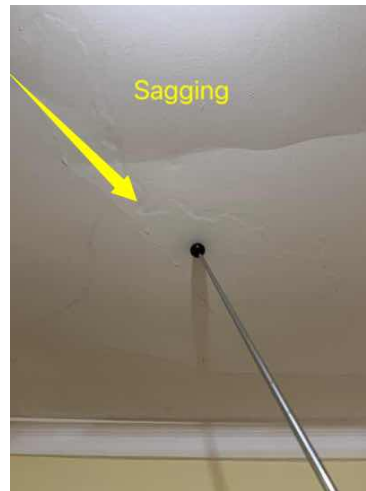
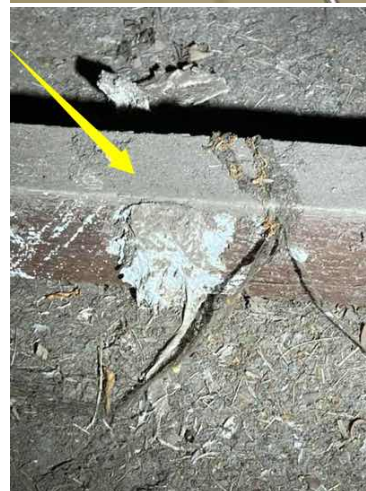
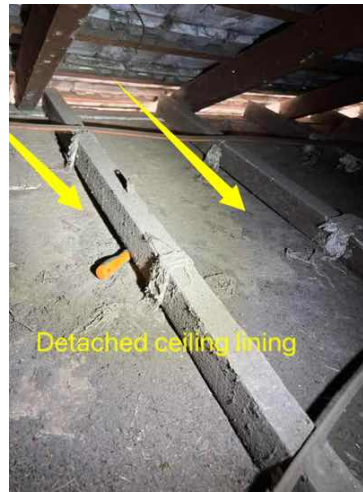
The ceiling lining is sagging in areas due to failure of fixings including plasterglass lagging. This has resulted in the ceiling lining detaching from the underside of the ceiling joists in areas. A ceiling contractor is to further assess all the ceiling lining in the roof void and repair where necessary.

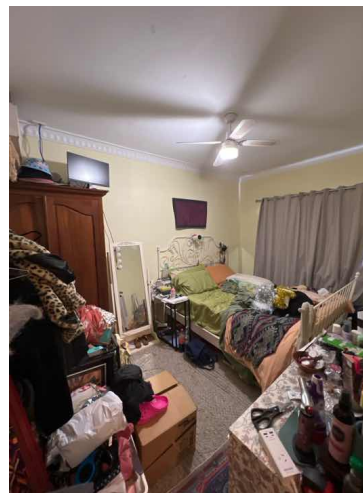
This Bedroom is in serviceable condition with no notable structural defects sighted. The ceiling fan is not working. Recommend electrician further assess.

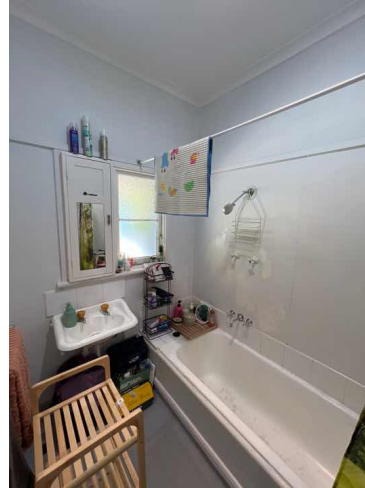
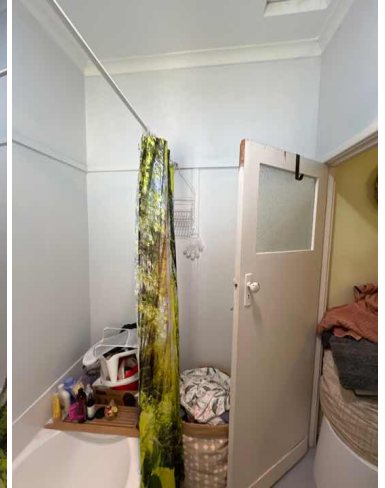
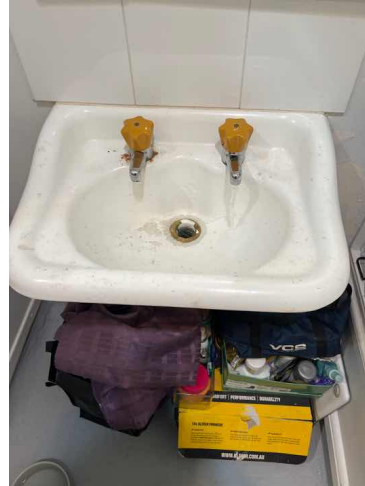
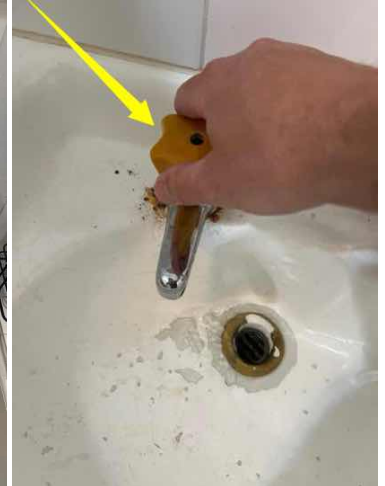
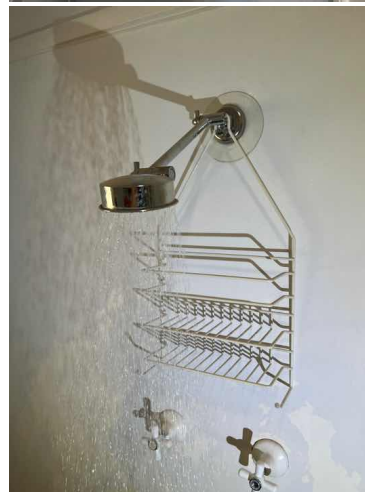
Sink - The hot water tap in the sink continues to rotate and does not flow any water. Recommend plumber repair.

One of the heat lamps is not working. Recommend change globe to ensure light fitting is in good working order.

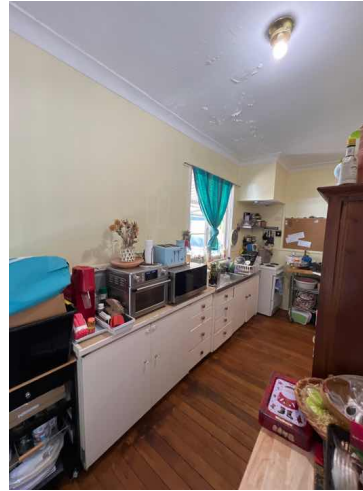
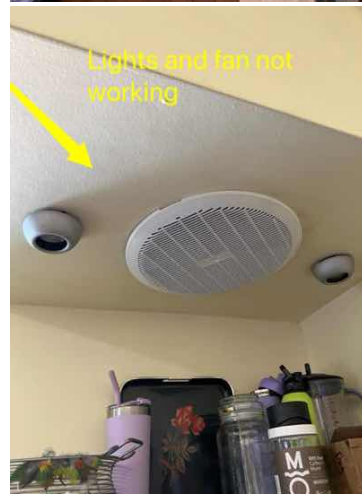
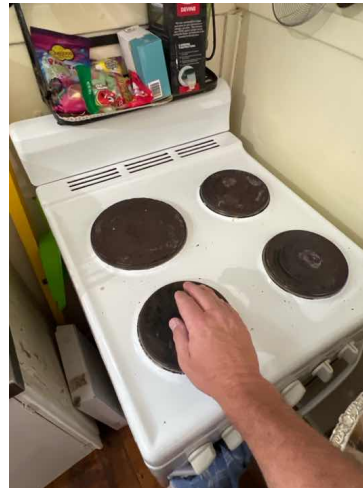
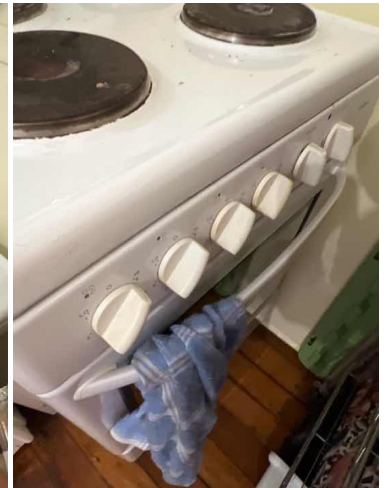
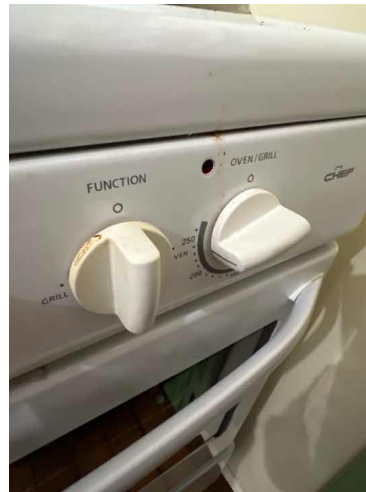
The fan and lights above the oven were not operating.

Recommend electrician further assess. Although the oven was operating there is excessive rust to areas of the appliance, including the cooktop burners. Recommend repair/replace oven.

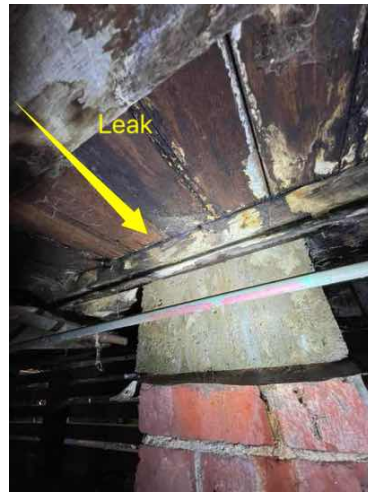
The cistern continues to leak water into the pan when the flush cycle is completed. In addition, there is cracking visible to bottom section of ceramic pan. There is also a drip/leak below the Wc/laundry area visible in the subfloor. Recommend plumber further assess and repair.

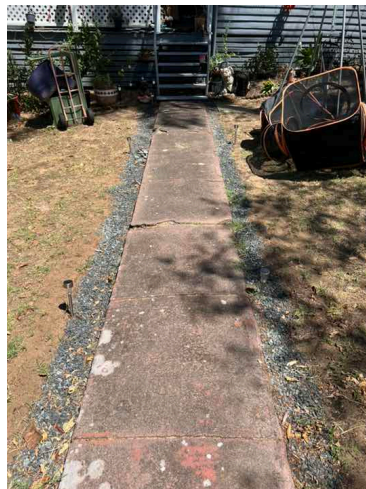
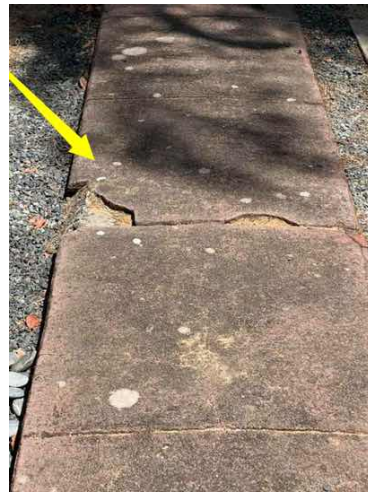
Common cracks/damage were observed on paths. Recommend repair where required.

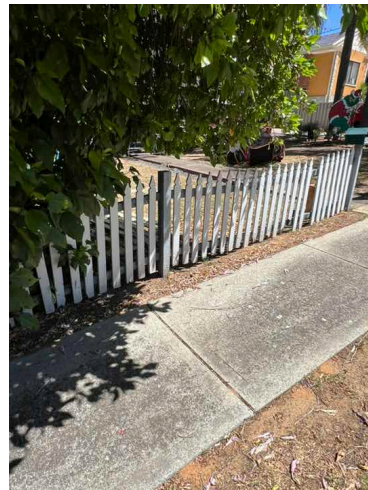
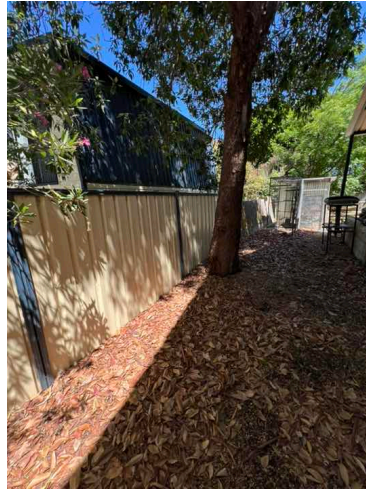
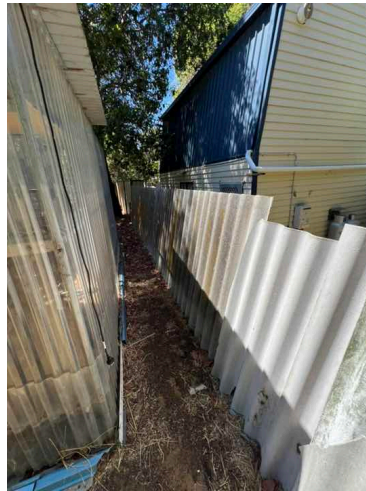
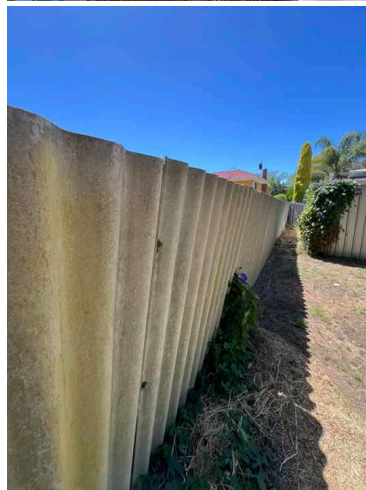
There are sections of the fencing that may contain asbestos fibrous cement sheeting. It is also cracking and leaning in areas. Recommend a fencing contractor further asses.

The front timber fence has timber rot and is damaged in areas. Recommend carpenter repair/replace fence.

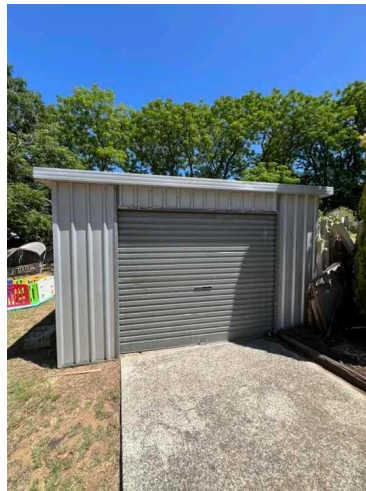
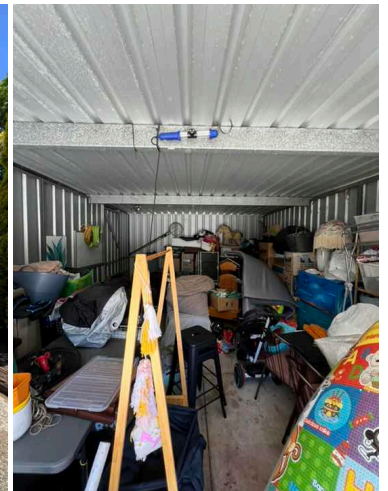
The shed is in fair usable condition.

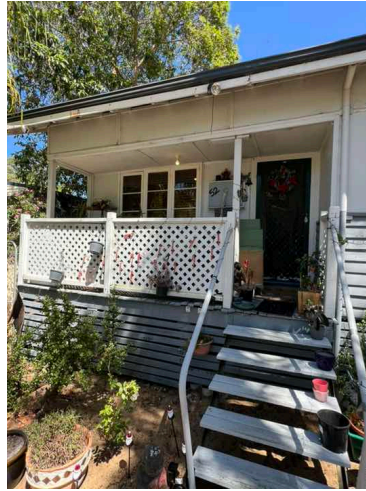
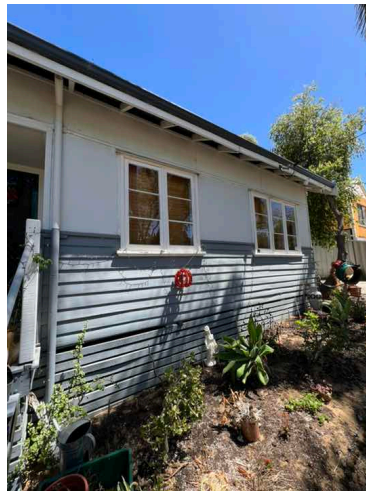
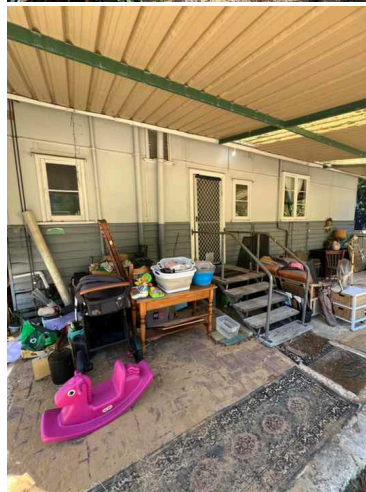
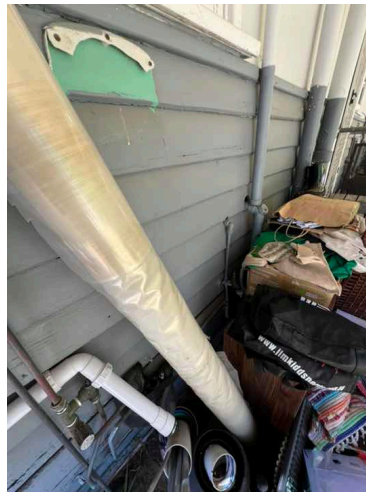
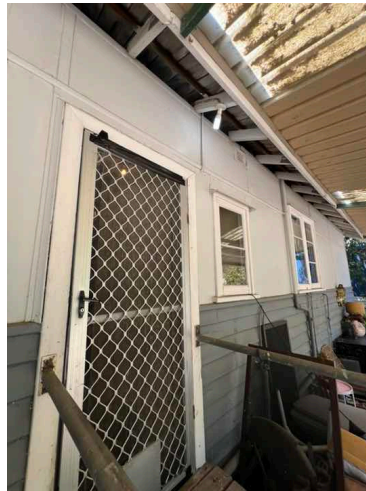
Minor damage and cracking visible to areas of the external cladding. Recommend repair where required.

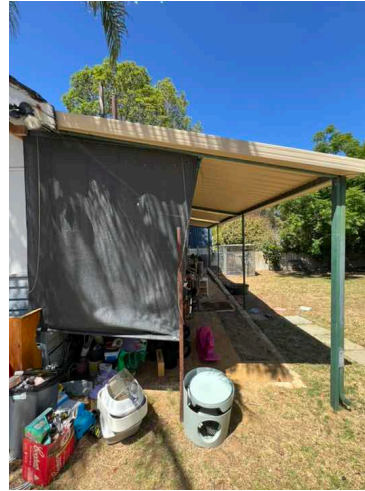
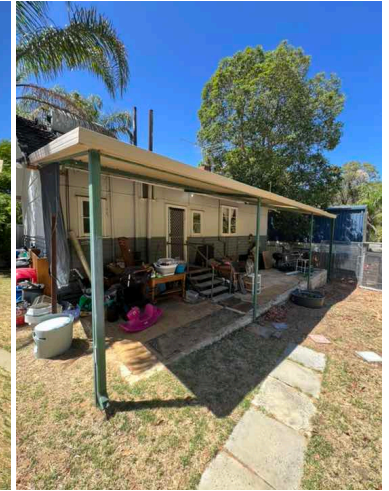
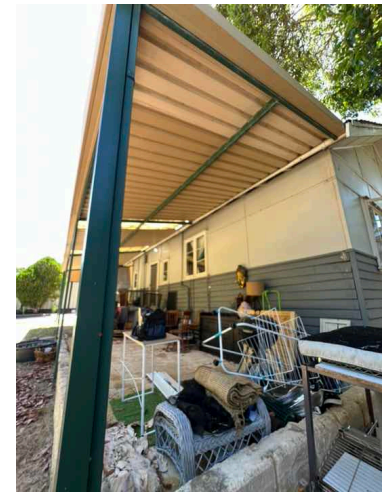
The Pergola is in a serviceable condition with no notable defects sighted.

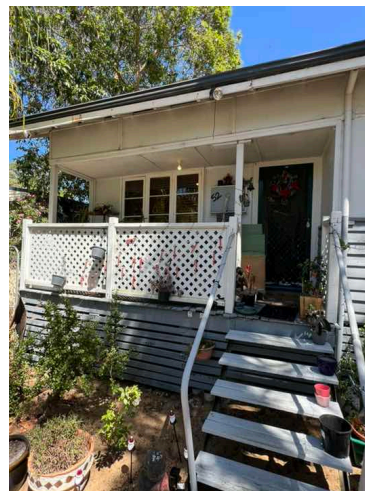
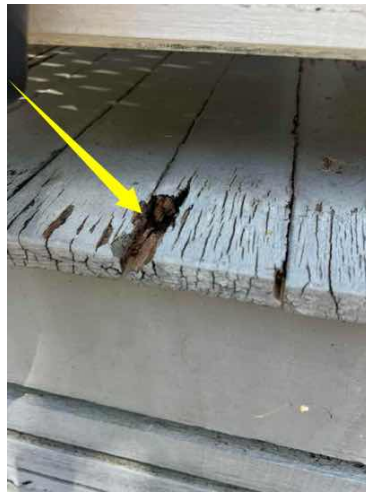
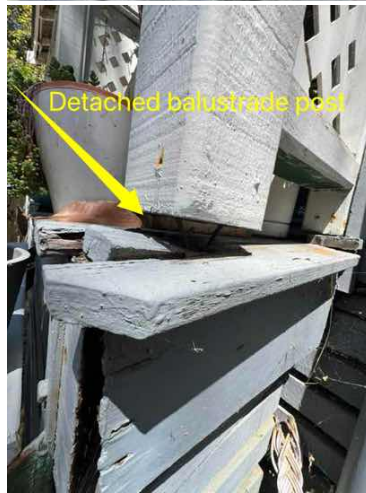
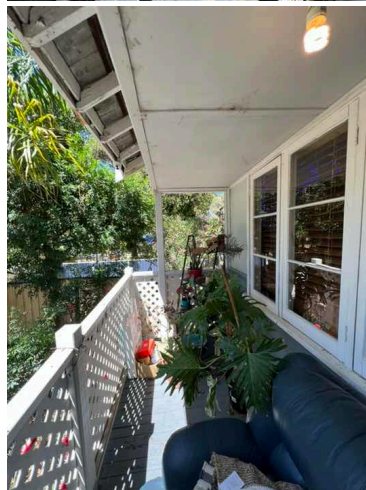
The floor boards to the verandah are loose/damaged in areas with timber rot visible. The balustrade is also loose in areas. Recommend carpenter further assess and repair where required.

Major Structural Defect - The verandah post in front of the meter box is loose at ceiling level. This post is a structural component and requires refixing to verandah ceiling framing by a carpenter.

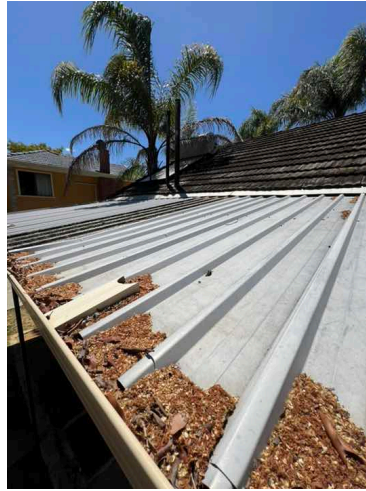
Recommend maintenance be undertaken to roof cover including repair minor timber rot visible to ends of barge boards and remove debris from guttering to prevent blockages.  
 Excessive undulation/sagging visible to roof cover. See roof void defects for further comments and repairs.

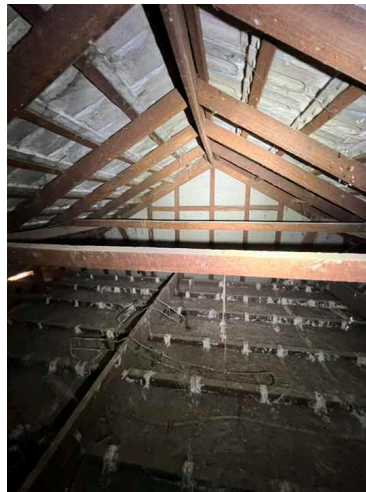
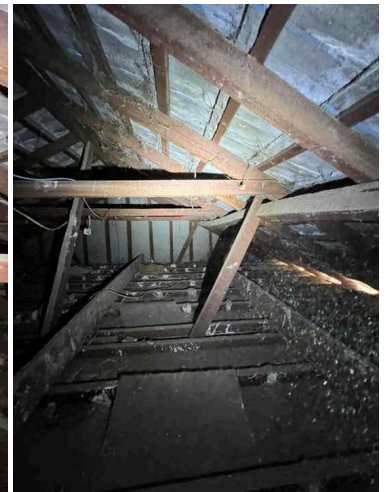
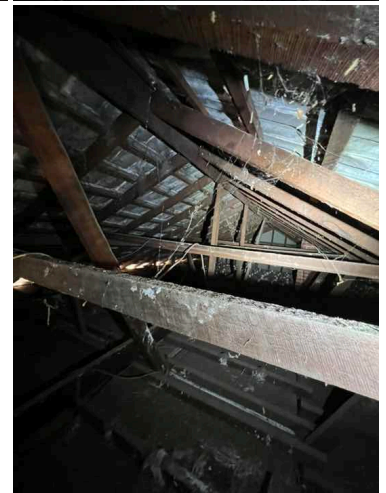
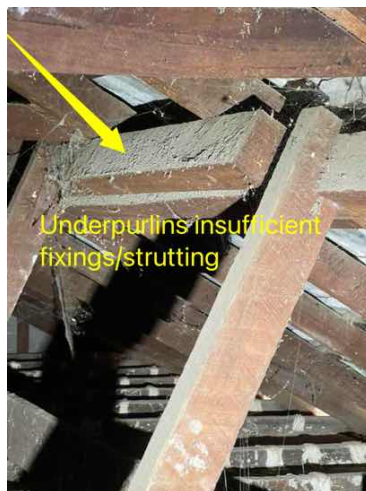
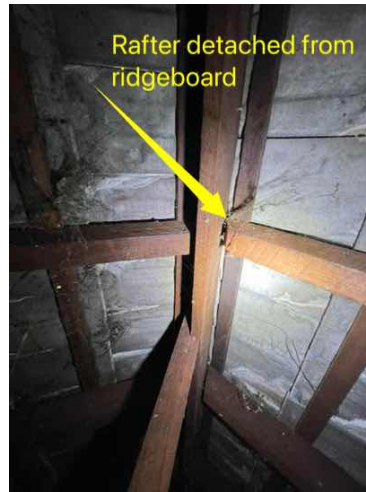
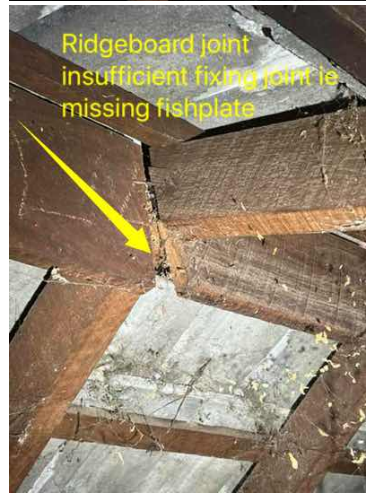
## Roof Framing Defects

Major Structural Defects - A roof carpenter is required to further assess and repair structural defects visible in the roof void area and prevent further sagging. Although some undulation can be typical of a property of this age, Major undulation is visible to the roof cover in areas as a result of failed/insufficient strutting to rafters/underpurlins. The underpurlin joint laps are insufficiently bolted/strutted. Other structural defects that require repair include a detached rafter at ridgeboard connection, loose collar ties that require retightening of bolts and a ridgeboard connection that requires refixing such as adding a fishplate.

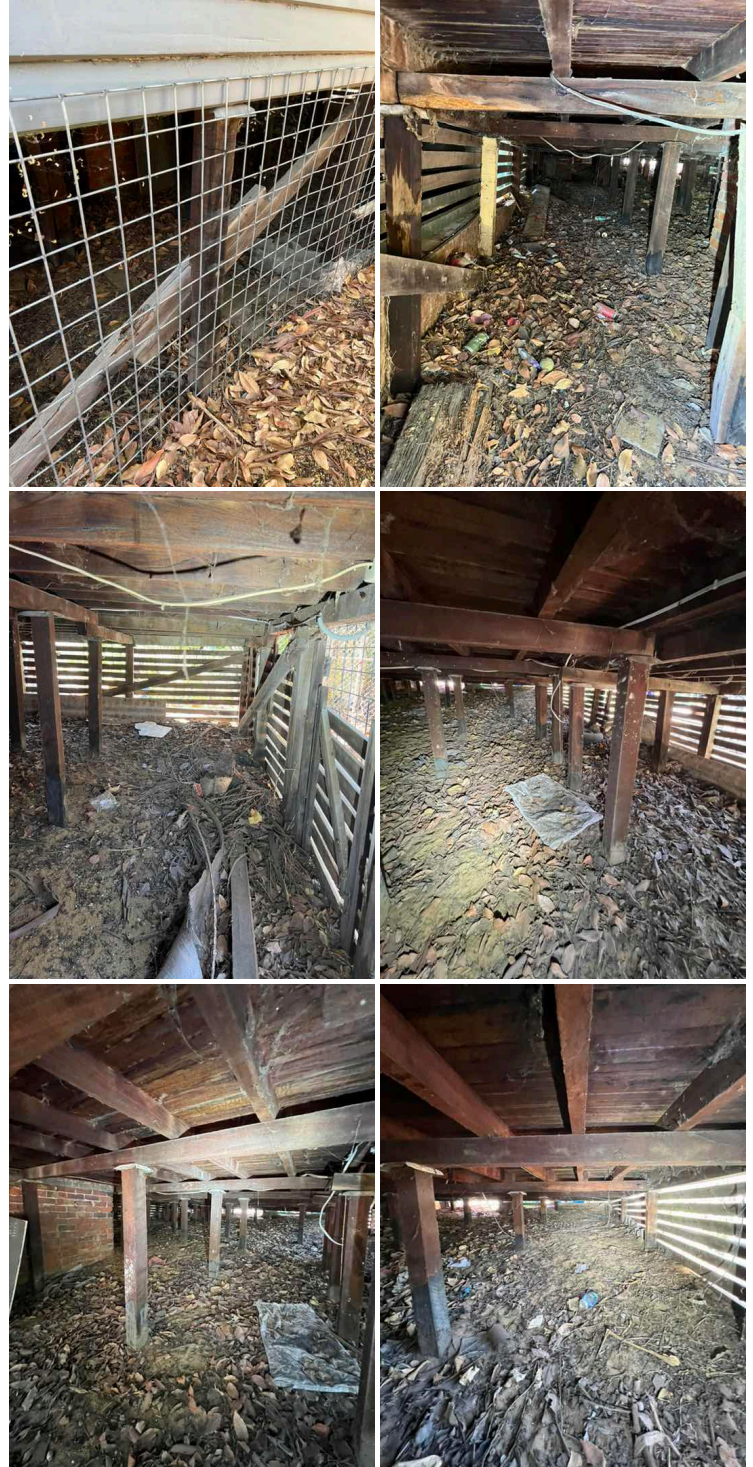
On inspection, defects were present that will require further assessing and recommendations by qualified contractors as described below.

The house floor boards are out of level upto approx 40 mm in areas. Undulation of floor boards can be typical of properties of this age, however subsidence of stumps is a possible cause. See subfloor comments for further details.

Major Structural Defects - Major structural defects visible to subfloor in areas and require further assessment and repair by a stumping contractor/ carpenter. These structural defects include timber rot visible to Several stumps and floor boards (under bathroom/laundry areas), termite damage to stump under bathroom area/bracing timber to subfloor entry, possible subsidence of several posts (particularly around perimeter) due to floors being out of level upto approx 40 mm and detached verandah outer beam at corner joint location.
