**REPORT**

**Potential Dam-barrier  
objects for  
removal/mitigation  
to support wild Baltic  
salmonid populations  
in Estonia**

**March 2021**

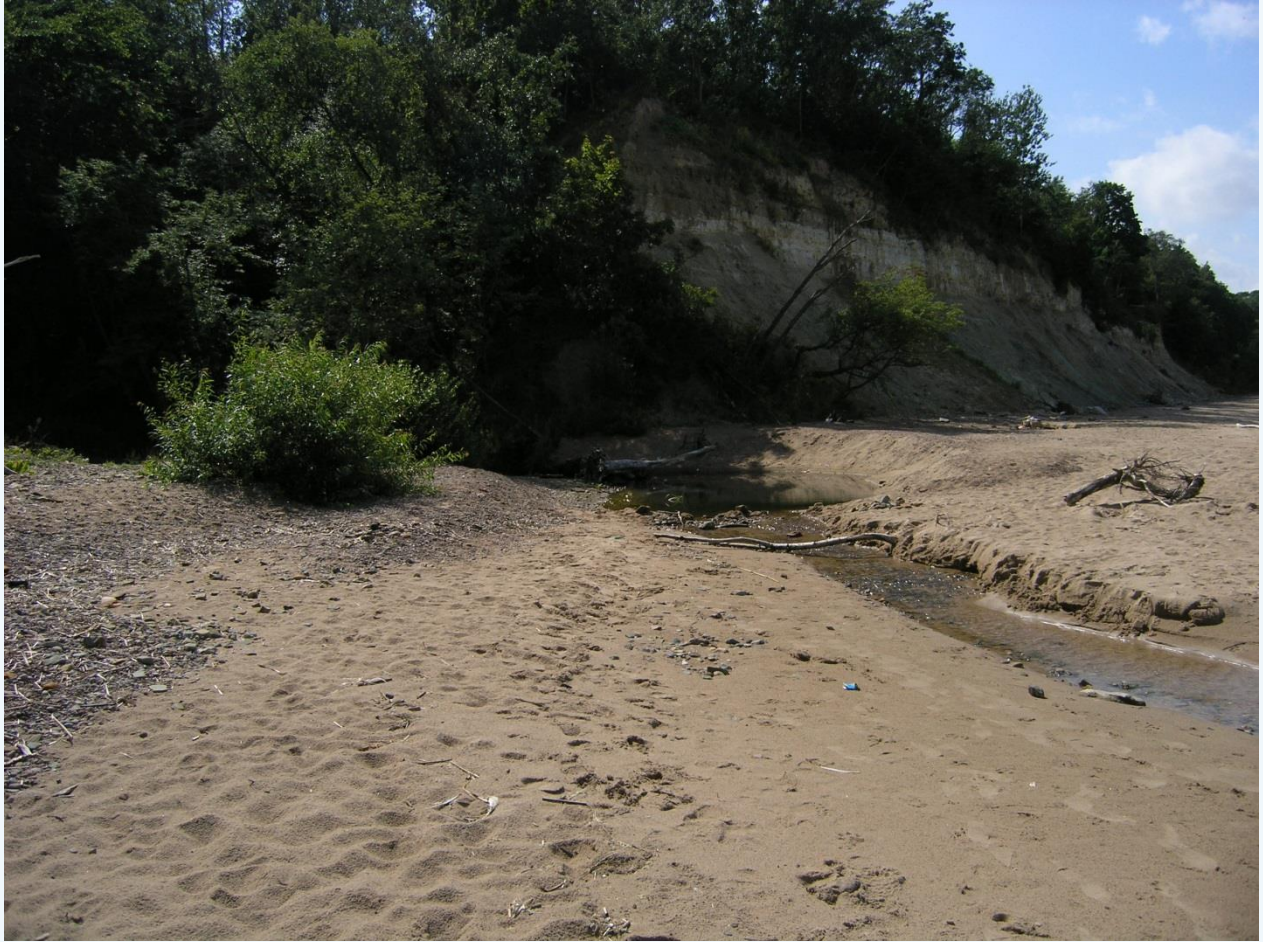
summer base flow due to many springs. The lower 1.4 km long part of the brook is very suitable for sea trout spawning and parr rearing (Photo 6 and 7). The brook has a dam 320 m from the sea, it is 1.9 m high and unpassable for all fish (Photo 8). In 2006, the trout parr density below the dam was 59 parr/100 m<sup>2</sup> and no trout was found upstream from the dam. River lamprey, three-spined stickleback, nine-spined stickleback and minnow also inhabit the river. Based on the size of the habitat in the brook, it was estimated that the part downstream from the dam could potentially produce 150 sea trout smolts annually and the upstream part could produce about 500 smolts annually. The dam has no water permit or any use, therefore removing it is best option and easy to do.

Photo 6. Outlet of the Udria book.

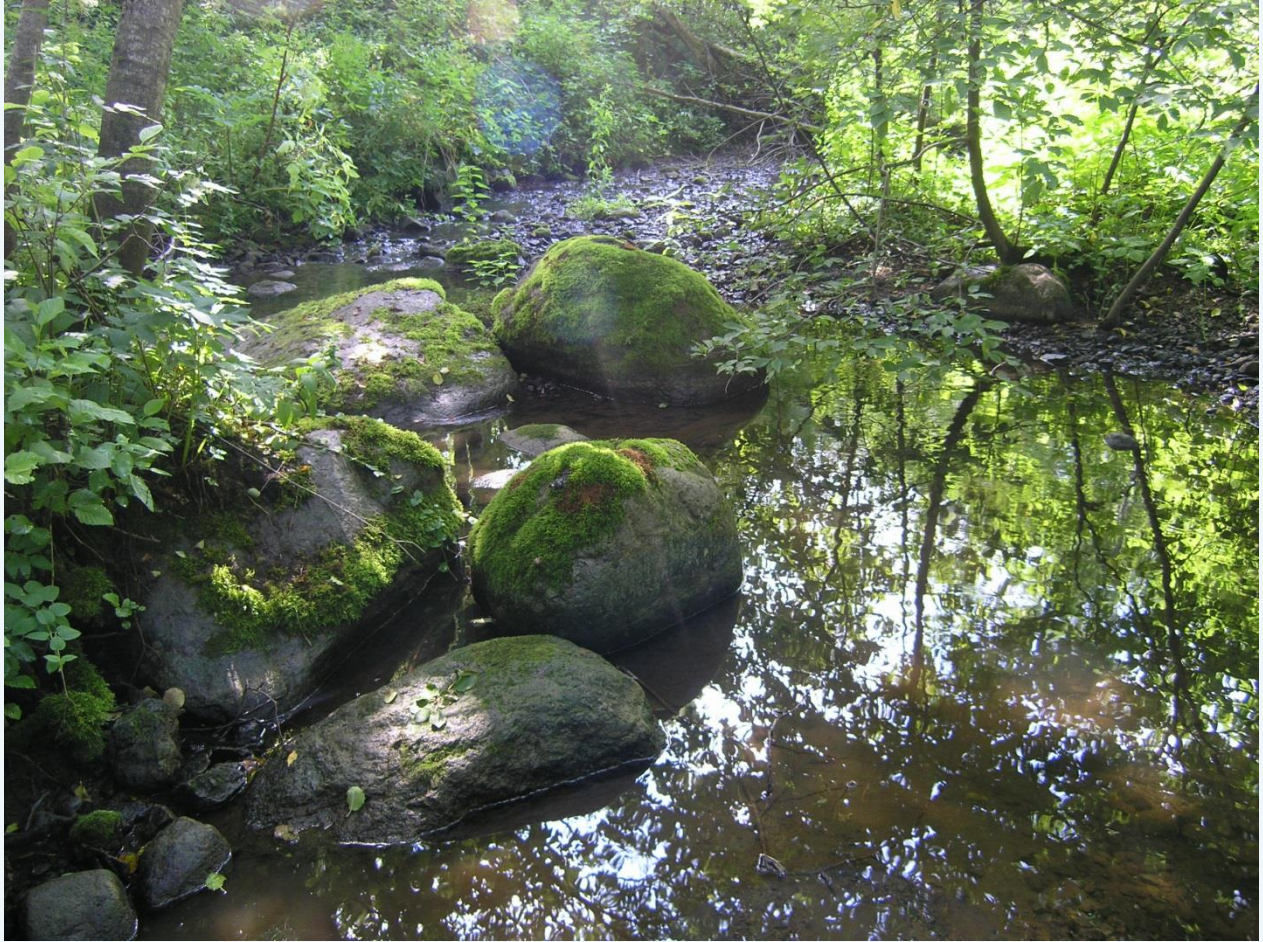
Photo 7. Typical habitat of the Udria brook. Bottom is naturally dominated by gravel that is suitable for sea trout spawning.
