**Accredited Snagging**

1 Sample Street  
Sample Town  
SA1 2BC

January 15th 2024

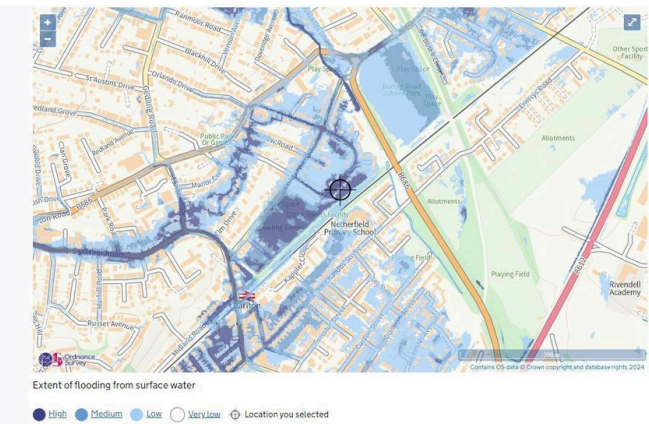
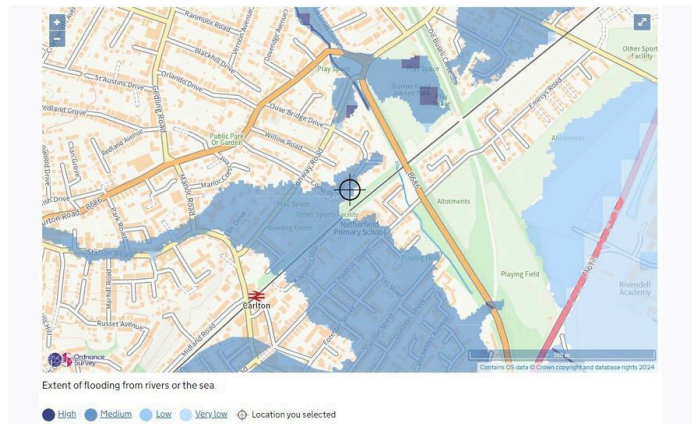
Ref # 9.1

Ref	Name	Answer	Comments
9.1	Any issues evident from the GOV.UK Long Term Flood Risk database?	Yes	The GOV.UK flood risk database shows a high risk of surface water flooding and a medium risk of river water flooding to the area. This could have implications for the cost of your property insurance and you should consult with your conveyancing solicitor and insurance provider.

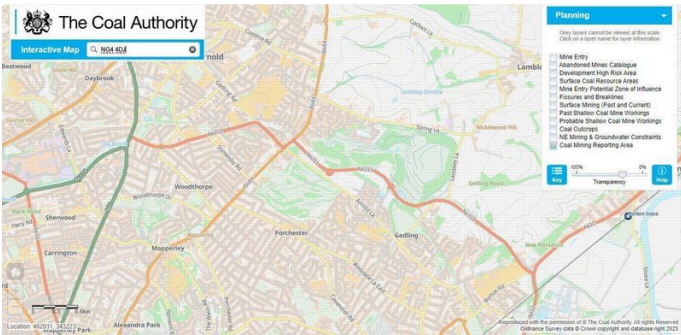
Ref # 9.4

The Coal Authority database shows the property is within the coal mining reporting area. Your conveyancing solicitor should request a CON29M report to investigate any risks associated with this property.

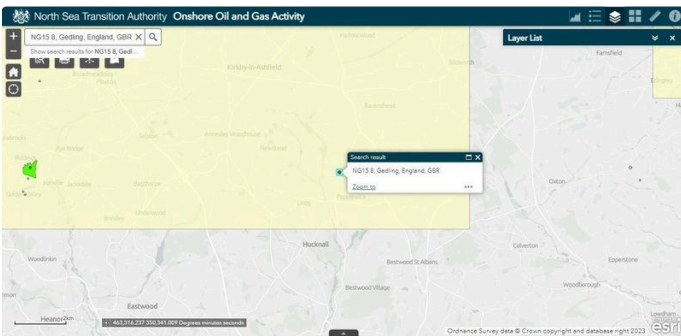
Ref # 9.5

9.5 Any issues evident from the NSTA Onshore Oil & Gas Activity database?

The property is located within an area that falls within a block of land offered by the Oil & Gas Authority (OGA) for applications to obtain a Petroleum Exploration and Development Licence (PEDL). Such licences may include permission to carry out fracking. Your conveyancing solicitor should enquire for more details and any potential impact on the property.

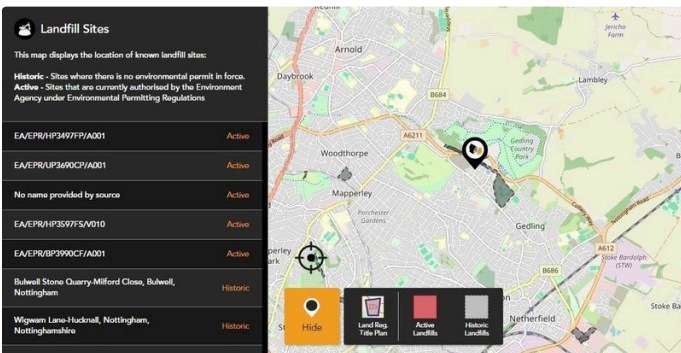
Ref # 9.6

9.6 Any issues evident from the GOV.UK Active and Historic Landfill database?

The property was found to be constructed upon an historic landfill site. This is usually taken into consideration at the planning stage to ensure no contaminated ground is still present on the site. Please consult the builder and/or your conveyancing solicitor if you have any concerns.

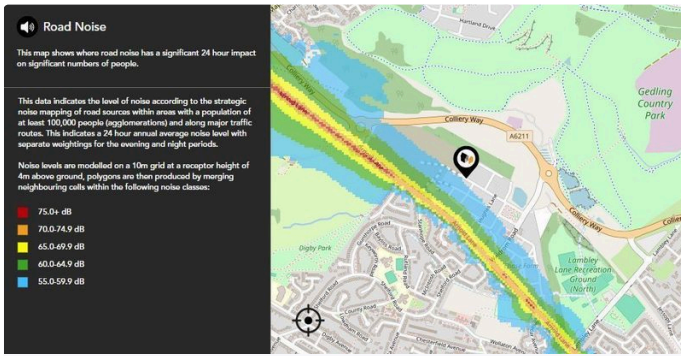
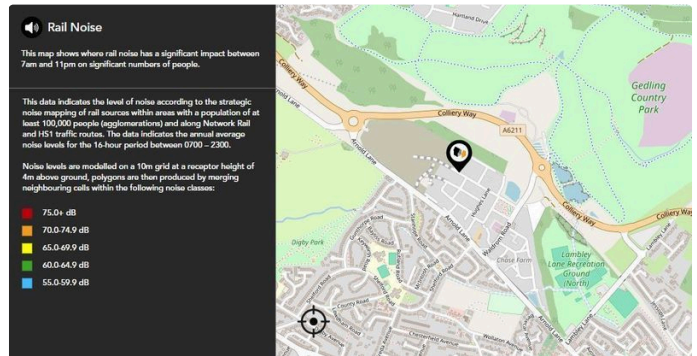
Ref # 9.7

Noise levels from nearby infrastructure (road and rail) are not seen to be likely to require additional measures to the building design.
