# RICS Home Survey Level 2 (Survey Only)

12 Sample Street, London, SE11  
1AA, United Kingdom

July 11th 2023

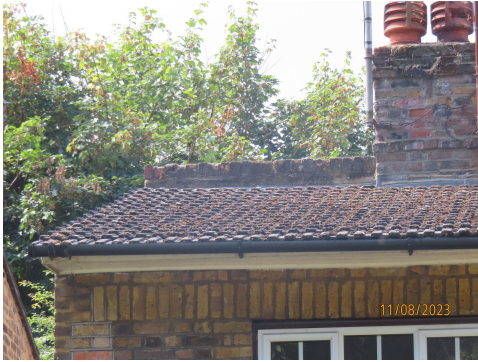
The roof coverings and ridge tiles are constructed of concrete. The verges at each gable are made up of mortar. General unevenness to some tiles was noted which is common in a property of this age. Some moss and lichen growth was noted on the roof but is not considered to be excessive. The parapet wall section to the left elevation requires some repair with spalling to the brickwork and worn mortar joints. Some light cracking was noted around the mortared verges which may require attention in the short to medium term. The roof was likely recovered when the property was rebuilt around 1947. This means the coverings could be around 75 years old. Typically concrete roof tiles have a lifespan of around 60 years and although no obvious signs of defect were seen you should be aware that defects may develop.

*View of parapet section.*

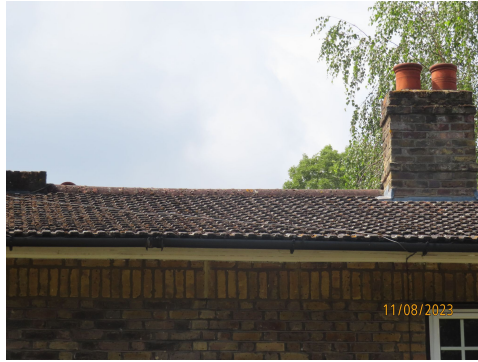
*View of roof coverings*

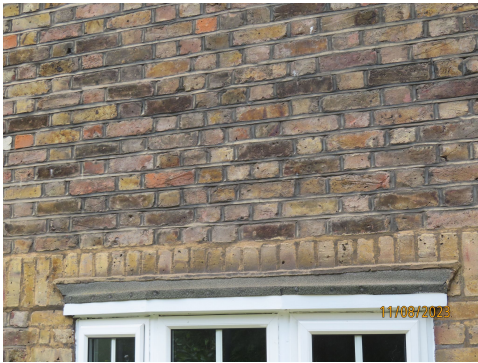
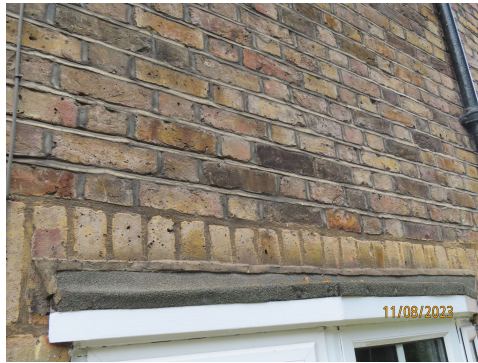
All windows operated as expected and there were no signs of failure noted. There was no evidence of blown double glazing but the external seals around the frames appear worn. This is also the case with the timber framing which will require ongoing maintenance. FENSA certificates were found for the replacement of the windows between 2003 and 2008. Without a copy of the FENSA certificate, there is no way to date the individual windows but typically PVC windows have a lifespan of around 20 years so the ones replaced in 2003 will be approaching the end of their expected lifespan. The two front bay windows have been fitted with mineral felt to the top sections whilst there is currently no indication of failure these sections will have a significantly reduced lifespan (typically 10 years) than that of a lead roof which would be a recommended improvement. Historical images show the bay windows with mineral felt roofs back in 2008 so assuming they have not been replaced then the roofs are likely to require repair or maintenance in the short to medium term. Low-level windows were noted on the first floor to the Landing, Bedroom 1, Bedroom 3 and the Main Bathroom. These windows pose a significant risk of falling and you should consider installing a suitable restrictor prior to occupation. The applied condition rating reflects this potential safety hazard.;

*Front bay window*

Advice: Be aware that previous owners may have distributed multiple sets of keys for the windows to individuals not known to you. When purchasing a property, you should consider the cost of replacing all of the window locks as soon as possible after you take up occupation. When doing this you should consult your insurers to ensure that you meet their requirements for security, and obtain any discounts that may be available by improving the security of the property.

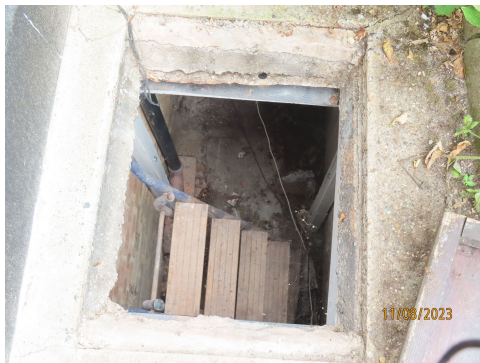
Timber supports have been used as shuttering to support the walls of the basement. These are showing signs of bowing and may be inadequate to hold the ground behind. Furthermore, significant cracking was noted in the retained wall close to the entrance hatch. I recommend a structural engineer is consulted to advise if the timber supports are adequate to hold the weight of the retained ground. The chimney breasts and old fireplaces within the basement are also in poor condition. Deterioration of the brickwork and cracked lintels above the fireplace is evidence of instability which is likely to develop into instability further up the chimney breast unless repair works are carried out. I was also able to use this vantage point to inspect the condition of the ground-floor joists. Moisture meter readings were taken which indicated a high level of dampness within the timbers at between 21 and 70%. Timber is susceptible to deterioration, woodworm and mold growth at around 18%. The floor joists were found to be unstable with rot and mold growth noted. In places, an attempt has been made to reinforce the floor joists with the addition of timber supports. These have failed and are not adequate to support the floor above. Significant repair work will need to be carried out to repair and replace the affected timbers.

*Access to basement*

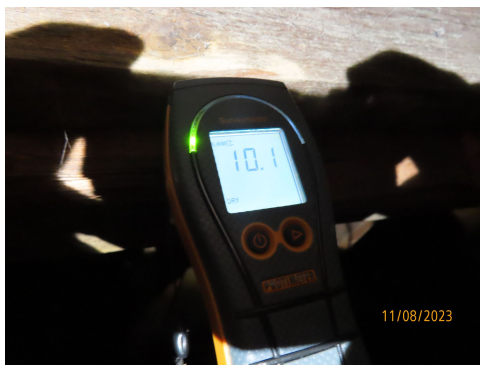
The roof space is not adequately ventilated and I recommend suitable ventilation is added as soon as possible to avoid a build up of condensation which can lead to dampness and rot of the timbers. The timbers tested were found to be dry with no signs of rot or defect but it is important that you are aware of the risks associated with an unventilated roof space which can lead to significant defects in the structure of the roof.

*Moisture meter reading within normal range.*

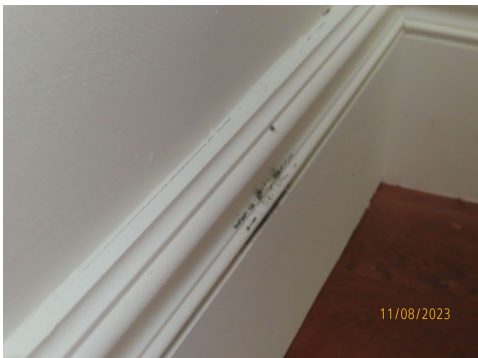
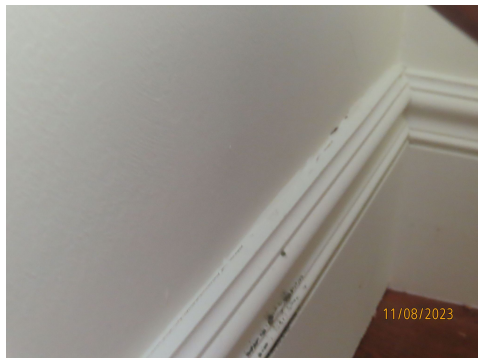
The internal walls were found to be in good condition with no obvious signs of defect noted. Some elevated moisture meter readings were taken around the property and these have been listed below. It is important to consider that none of the damp readings were confirmed with visible signs of dampness aside from some light mold growth within reception 2 (dining) although due to the recent renovation, the effects of any damp may be concealed behind the recent decorations. Moisture meter readings can only provide a guide as to the presence of dampness and the recording of high readings can be affected by other factors, for example, metallised wall finishes, chemical salts within internal plaster, or reactive materials below the plaster surface. A definitive and complete diagnosis for the presence of dampness, and the cause, will involve further testing requiring invasive methods that will cause some damage to the wall surfaces.

- Either side of all chimney breasts. Most likely due to the failure of the mortar joints and lack of ventilation to the capped chimneys as discussed in section D1.
- Reception 2 (dining). The left corner of the front elevation (some light mold growth was noted in this area.)
- Hallway. The left side of the side entrance
- WC. The corner of the rear elevation wall and the right side of the window reveal.
- Bedroom Front left. As discussed within section D4 and likely a result of poor pointing which has now been repaired.

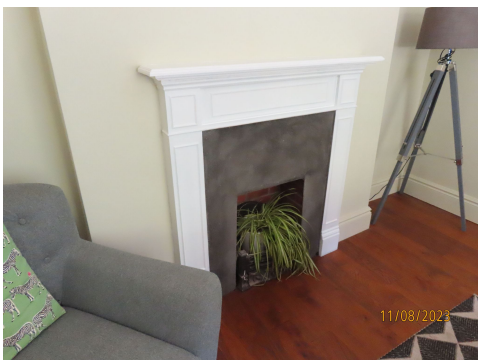
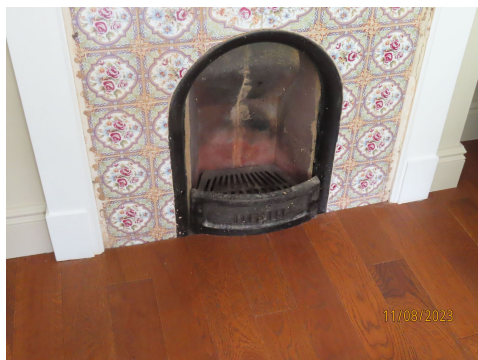
The chimney breasts and fireplaces throughout the property do not appear to have been used for some time and are for decorative purposes only. Some chimney pots have been capped off and the cowls used are not suitable for use with an active fire. See section D1. Louvre-type cowls are fitted to the right chimney stack and could be used for an open fire. Should you consider reinstating any of the chimney breasts, work would be required to ensure their safety such as the creation of a suitable hearth, ensuring the suitability of the chimney pot type and possibly relining of the chimney flue. I would also like to highlight that the property is within a smoke control area and there are restrictions on how much smoke can be released and what fuel type can be used (See section 8).

As referred to in section D9 other, the fireplaces in the basement are in a poor state of repair with signs of deterioration to the brickwork and structure at their base. This will impact the structure above and it is likely that some rebuilding and supporting work will be required. You should ensure that a competent contractor is used and any structural calculations have been made by an appropriately qualified structural engineer.

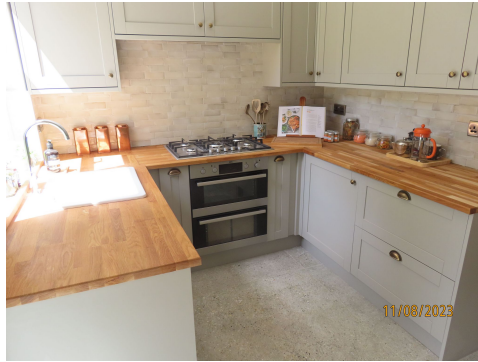
*View of Kitchen.*

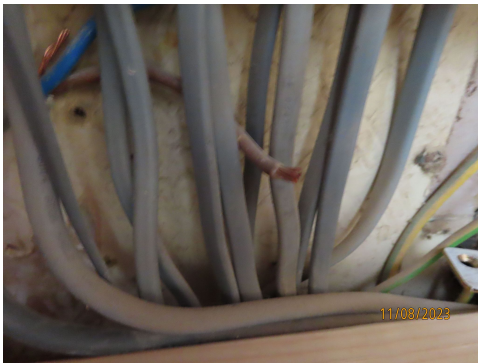
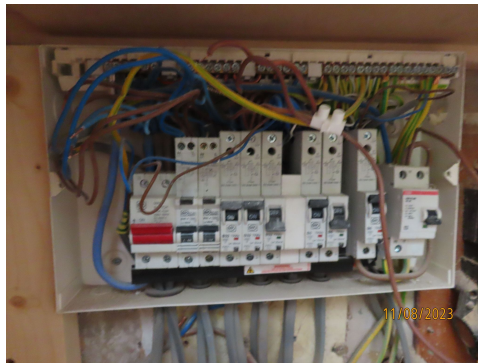
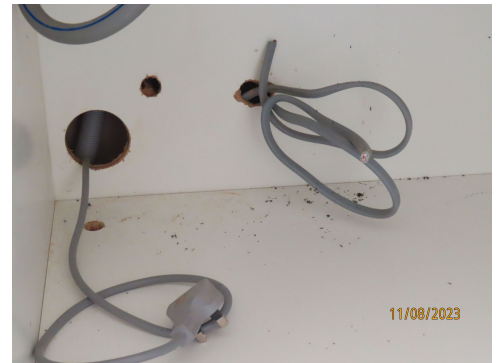
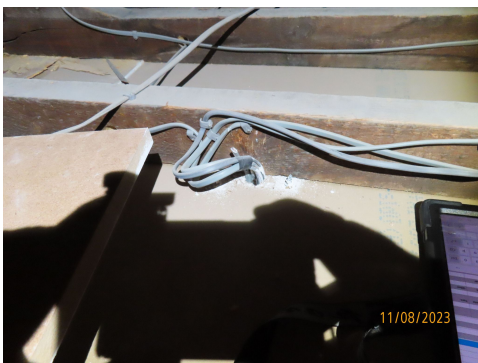
In its current condition, the electrical system is dangerous and you should not exchange it until a suitably competent electrician has inspected, tested and commissioned the system and produced an electrical certificate to confirm the installation is safe to use. Evidence of this can be seen throughout the property where potentially live exposed cables can be found. Furthermore, the consumer unit located in the cabinet in the hallway has had its cover removed exposing live wires. There is also some evidence of DIY electricians within this cabinet where wires have been joined. As part of the refurbishment, any electrical works carried out should have been completed by a Registered Competent Person (Electrical) and, as such, would have provided a Minor Electrical Installation Works Certificate, or an Electrical Installation Certificate, and in addition a Building Regulation Compliance Certificate where required.

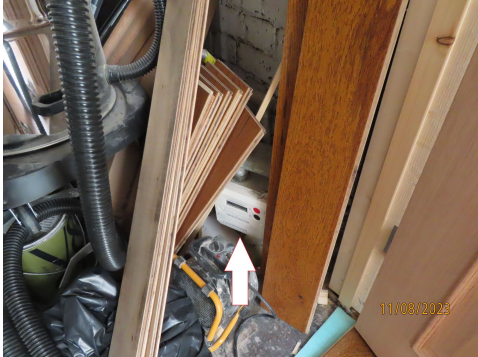
The mains gas supply runs through the basement, underneath the flooring and terminates at the meter which is located inside the cupboard under the stairs. The system was inspected for any obvious signs of damage or leakage although was largely concealed underneath the floor.

Furthermore, the gas hob within the kitchen was not connected. This will require installation by an appropriately qualified gas safe engineer and periodic testing as part of the entire gas system.

*Gas meter*

Gas Safe recommends that all gas appliances are inspected and serviced according to manufacturer's guidance, but at least once a year. A gas installation can look to be in a safe condition, but serious defects may be hidden, some of which can kill. It is therefore considered to be essential that you commission an inspection of the gas/heating installation prior to purchase of the property, unless you are provided with verifiable evidence that such an inspection has recently been carried out by a competent person. You can get more information, or find a Gas Safe registered engineer <https://www.gassaferegister.co.uk/>;

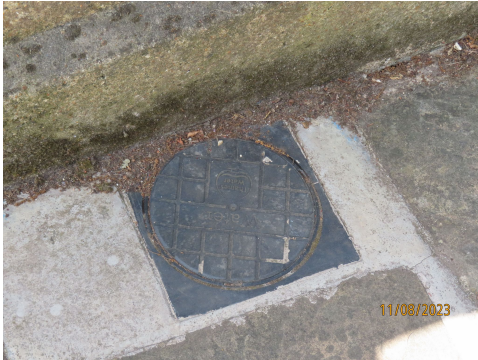
There were no visible signs of defect to the water paperwork. It is advised to check the installation for evidence of leaks or other defects on a regular basis i.e. approximately every 6 months, or sooner. Leaks most often occur at pipe joints and where pipes are subject to movement or physical damage, such as airing cupboards, roof spaces and under sinks.

*External stop tap*

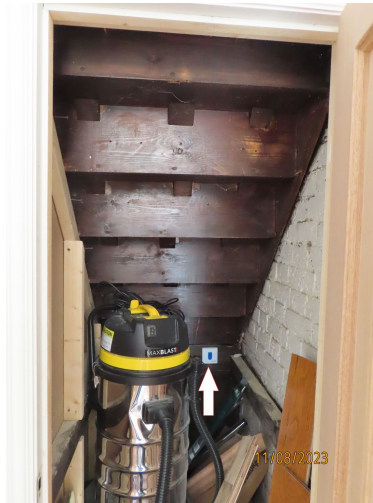
*Internal stop tap*

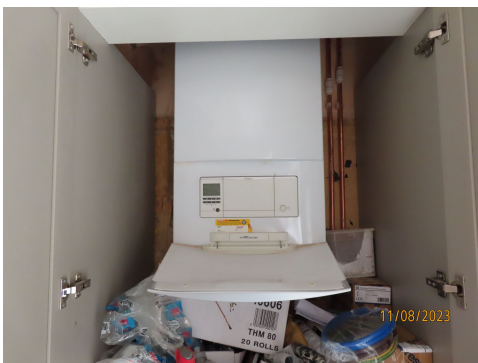
It is not possible to fully assess the condition and safety of a gas installation on the basis of a visual inspection only. A visual inspection was carried out of the radiators, pipework and boiler to detect leaks, corrosion and other common defects. The heating is provided by a gas-fired boiler which is located in the kitchen. As it is a combi system it provides both heating and hot water. The boiler and radiator system were not in operation during the survey and the boiler was switched off at its source.;

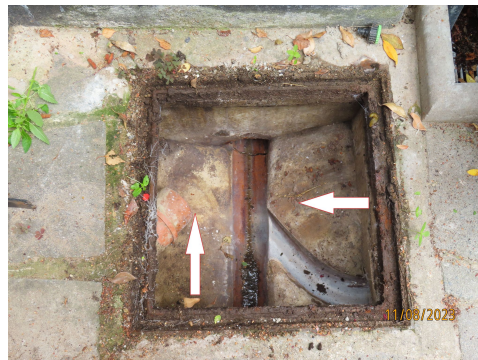
Rear inspection chamber. Arrows indicate direction of flow.

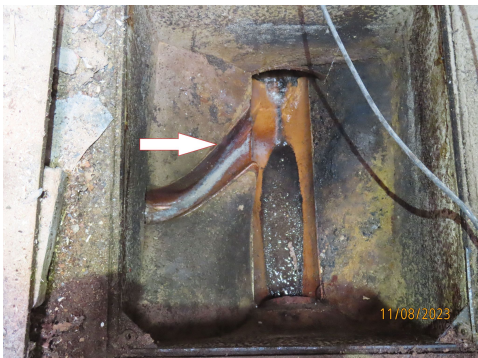
Front inspection chamber. Arrows indicate direction of flow.

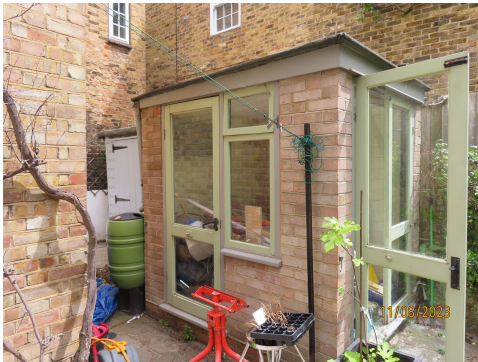
The outbuildings appear to be in a serviceable condition for their purpose although maintenance to the timber shed is required to preserve the integrity of the timber. The brick built outbuilding was also in a serviceable condition with no signs of dampness to the ceiling which is an indication of failure of the flat roof.;

*Garden room*

Advice: Compared to traditional coverings such as tiles and slates, most bitumen felt roofs have a typical life of 10-25 years. They are also prone to sudden failure and leakage. Periodic re-covering will therefore be necessary. When this is undertaken, the supporting structure may also need some attention.

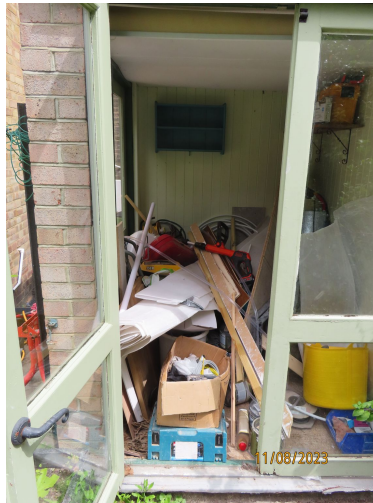
*Garden room internal*

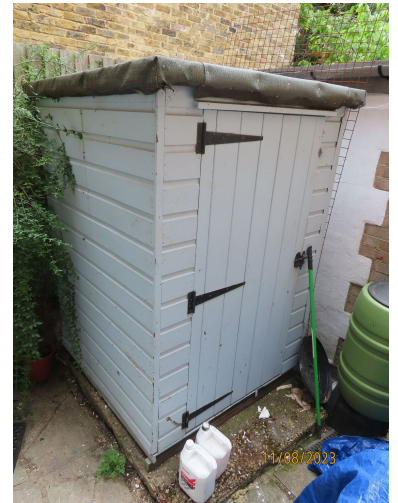
*Timber shed*

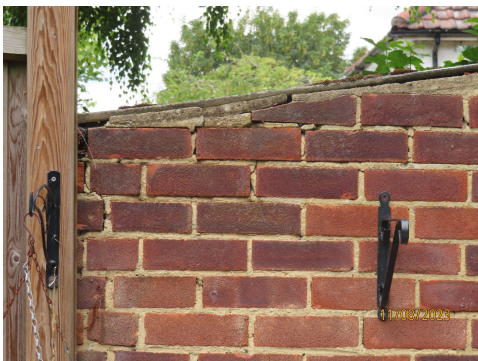
*Neighbouring garage wall.*

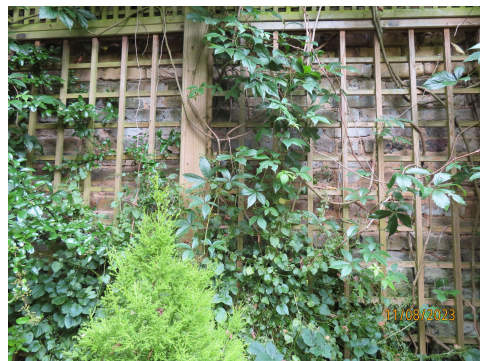
The property benefits from a mature rear garden with multiple trees and hedges some of which are within the neighbouring property. To the rear, there is a retaining wall structure.

*View of retaining wall to rear.*
