PROPERTY INSPECTION REPORT

<u>Mr. and Mrs. Happy Homeowner</u> Name of Client	<u>March 02, 2022</u> Date of Inspection
<u>1234 Happy Trail, Happy Town, TX, 76179</u> Address of Inspection Property	
<u>Bryan Garrett</u> Name of Inspector	<u>21568</u> TREC License #
<u>N/A</u> Name of Sponsor (if applicable)	<u>N/A</u> TREC License #

Prepared exclusively for Mr. and Mrs. Happy Homeowner • Inspected Address: 1234 Happy Trail, Happy Town, USA
By Bryan Garrett TREC #21568 • Hearthstone Professional Inspections PLLC
Mobile: (630) 743-1009 • Email: Bryang@hearthstonepllc.com

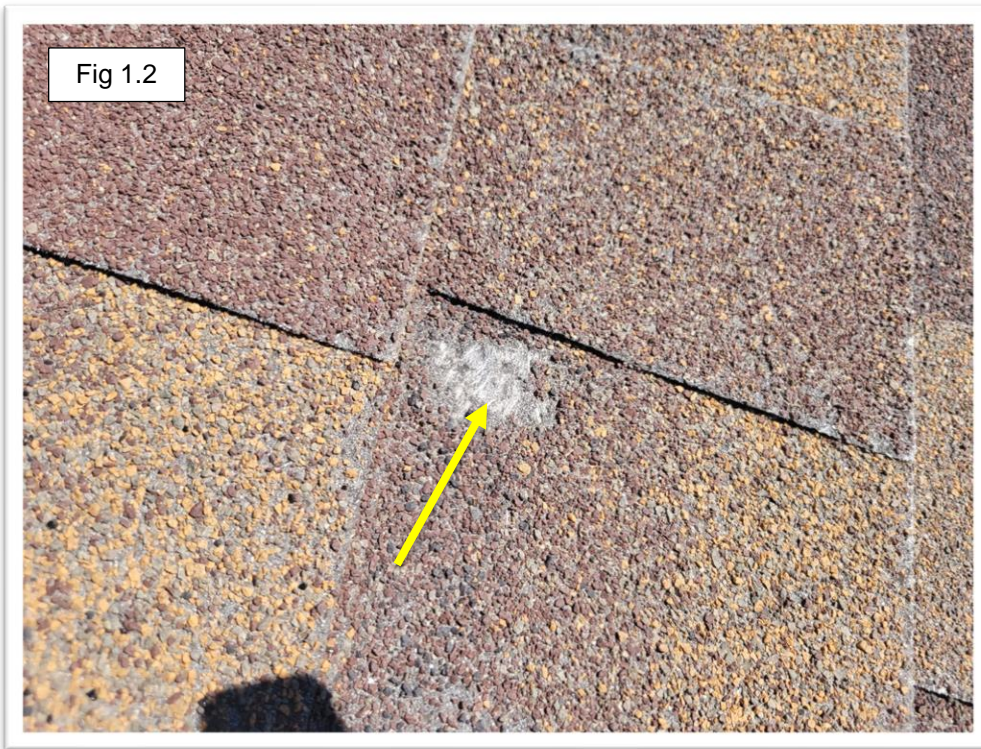
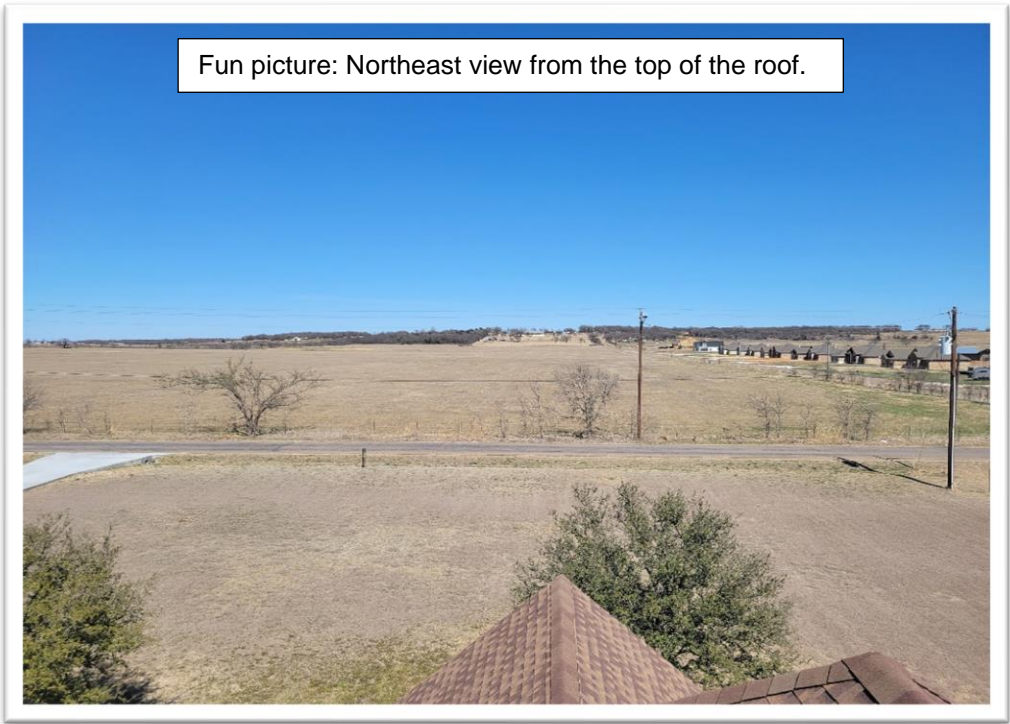
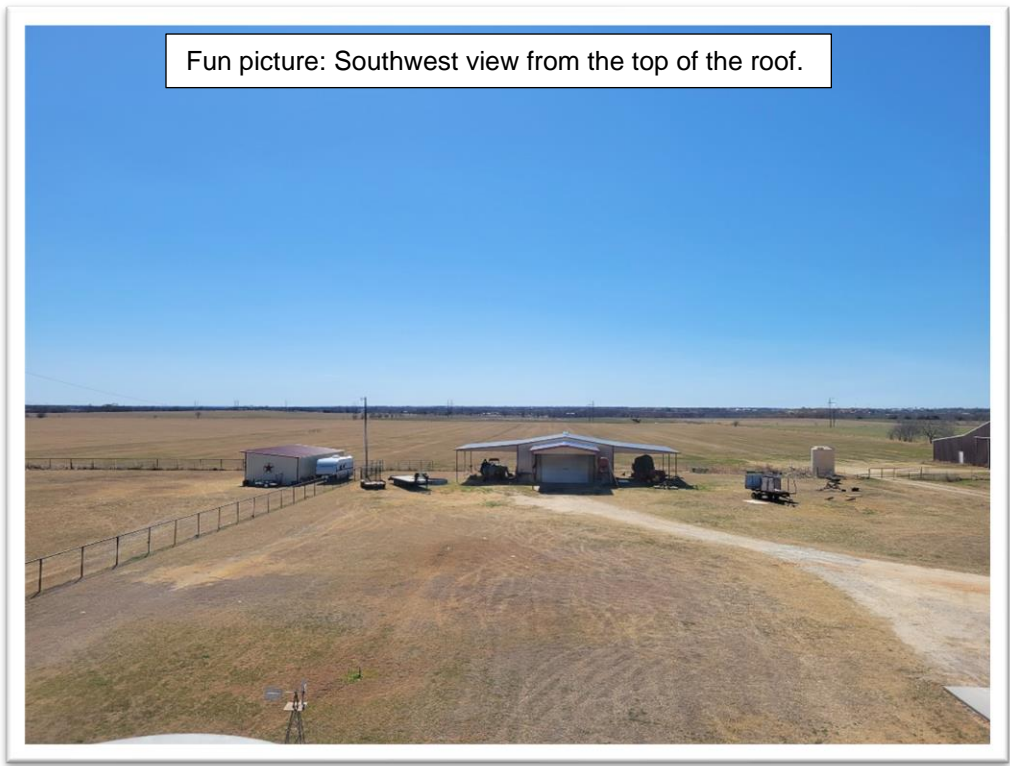
- Some of the shingles edges were showing. This can cause the shingles to prematurely deteriorate. See Fig 1.1 on page 8.
- There was evidence of hail damage on the southwest side of the roof. See Fig 1.2 on page 8.
- The roofing trim, eaves, and fascia board needed painting.
- The PVC vent pipes on the roof had missing paint which can cause them to prematurely deteriorate rapidly, recommend painting them for protection against the sun's UV rays.
- The felt paper was installed under the drip edge which can prevent water from draining.

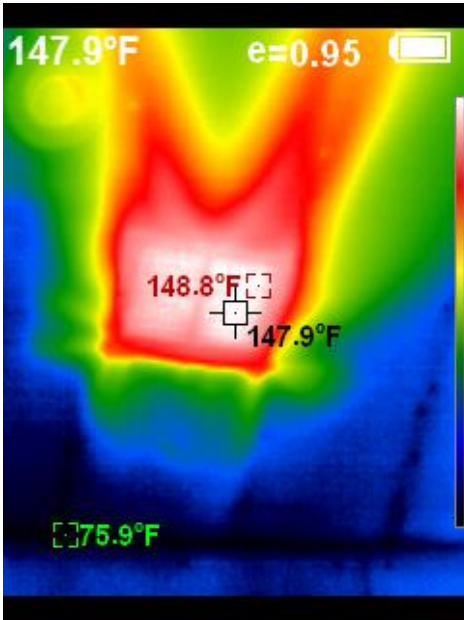
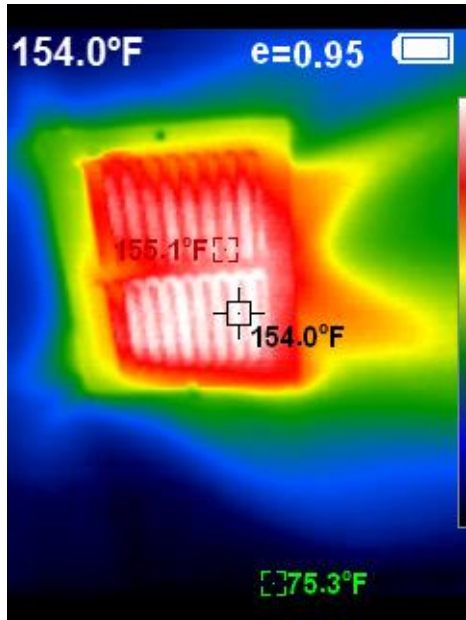
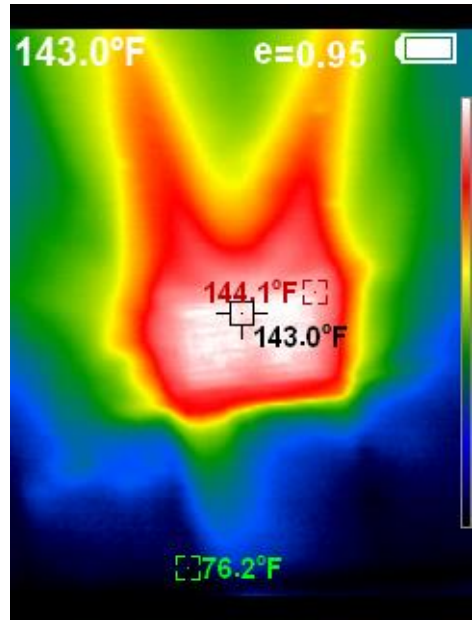
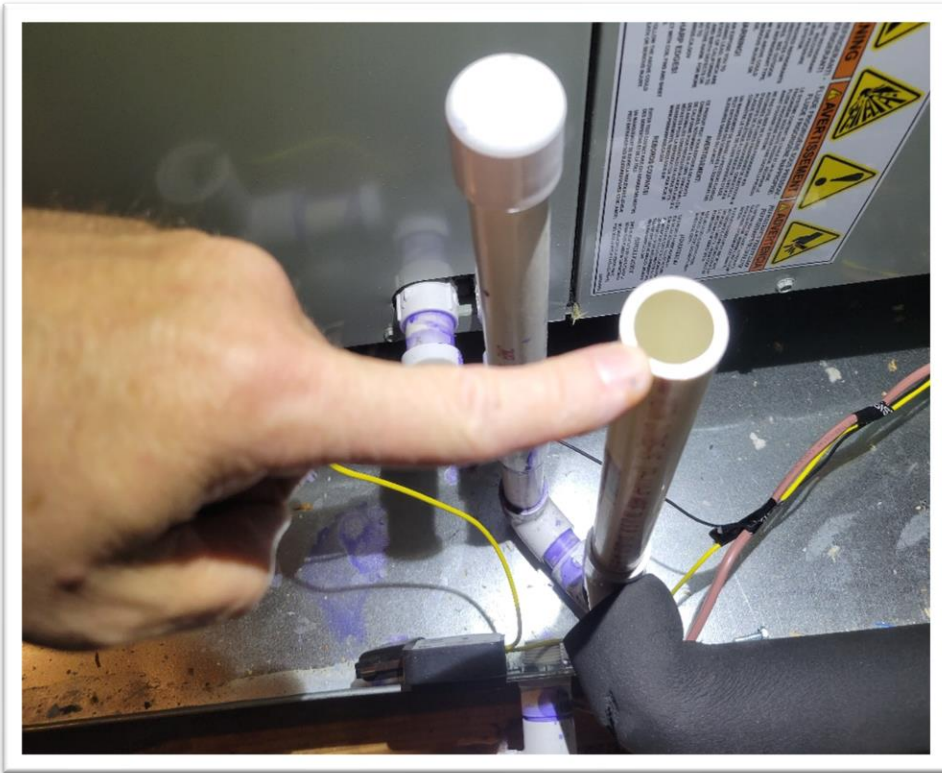
- The surface heating temperatures were out of the normal range which can be a safety hazard. In the inspector's opinion it is recommended that a licensed HVAC technician examine the unit and make the necessary repairs. See the thermal images on page 19.
- There were various surface temperature readings observed during the heating mode.
- A sweet smell was observed coming from the ventilation when the heat was on. In the inspector's opinion it is recommended that a licensed HVAC technician inspect the unit to determine if repairs are needed.
- There were exposed wiring on top of the HVAC unit in the attic. All wiring should be placed within a junction box with a cover for safety reasons.

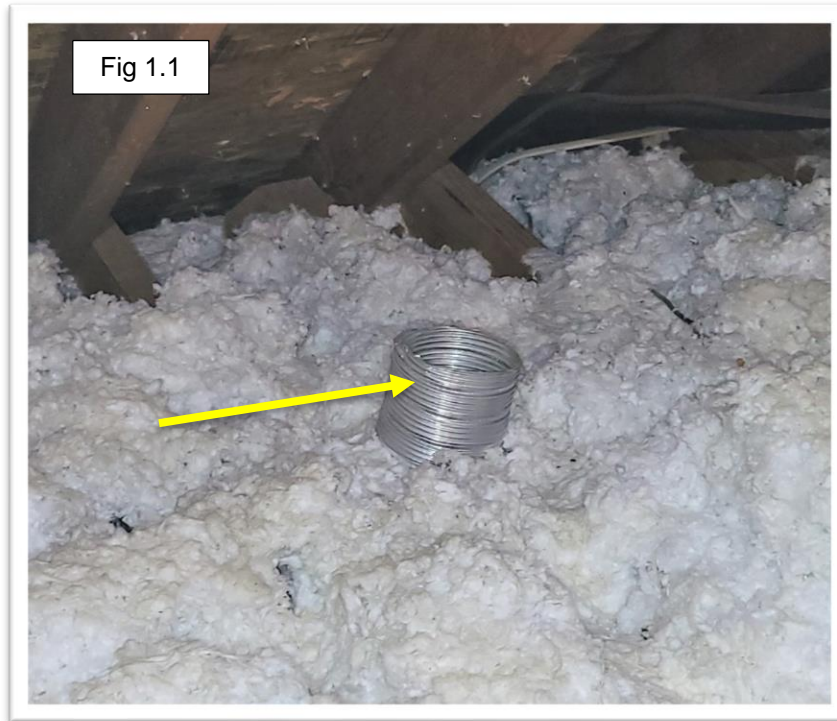
- The bathroom mechanical exhaust vents terminate to the attic and not through the roof. This adds moisture and humidity in the attic which can lead to further damage and even biological growth. See Fig 1.1 on page 29.

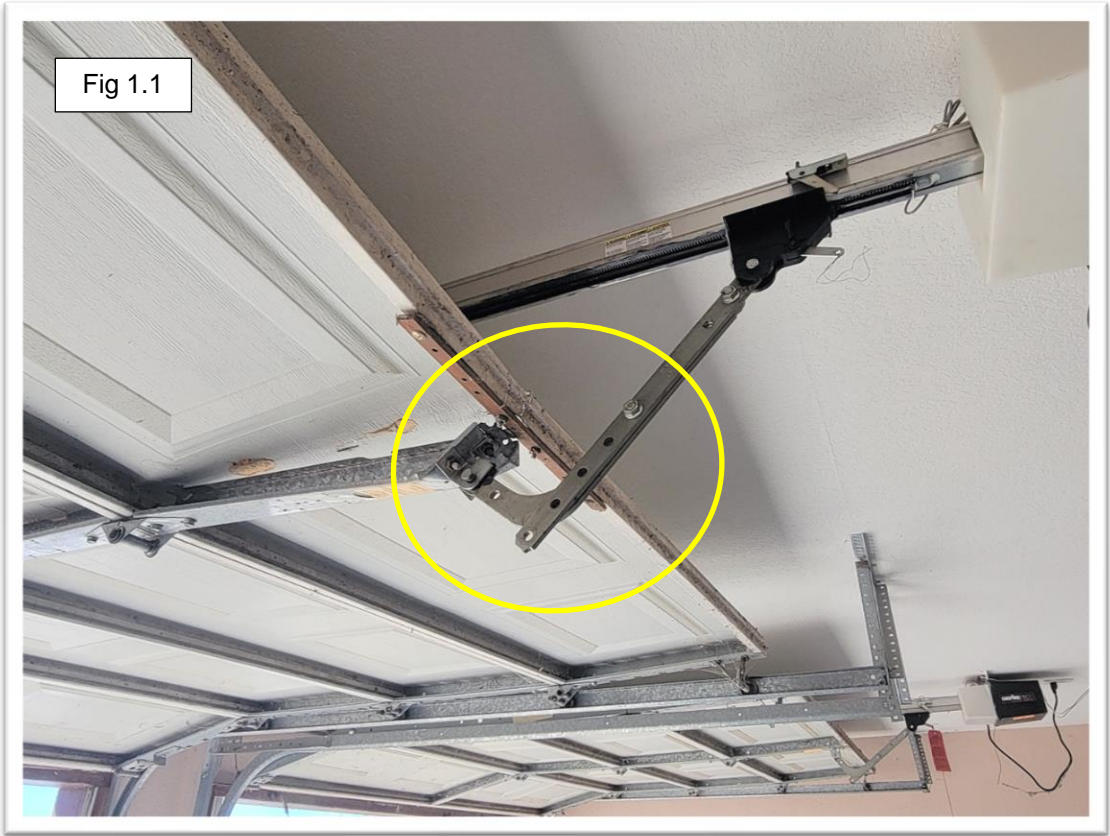
- The "J" bars which extend from the track to the door were installed near the end of each door which will damage the doors and the operator. For best results the bars should be installed near the center of the door. In the inspector's opinion it is recommended that a garage door company make the necessary repairs. See Fig 1.1 on page 31.
The top support bar was damaged and removed from the door by the "J" bar. This causes additional damage to the door. In the inspector's opinion it is recommended that a garage door company make the necessary repairs. See Fig 1.2 on page 32.
