PROPERTY INSPECTION REPORT

374 Citadella Court, Johns Creek, GA.

May 22, 2021

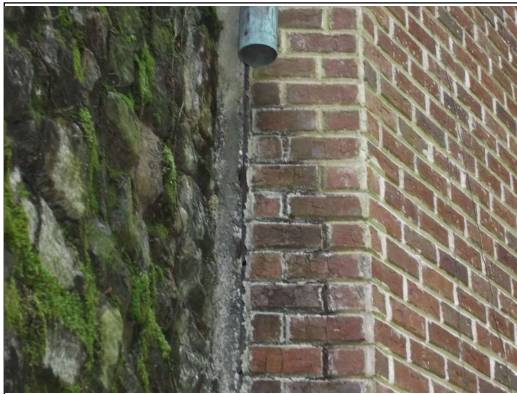
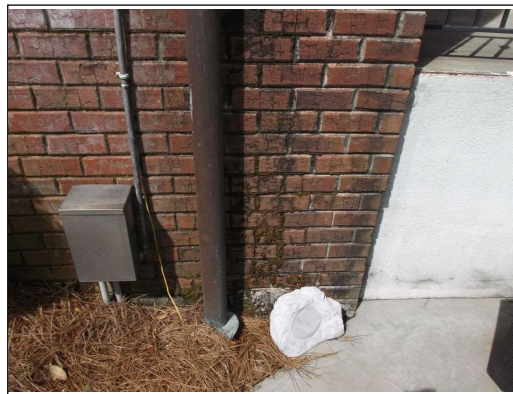
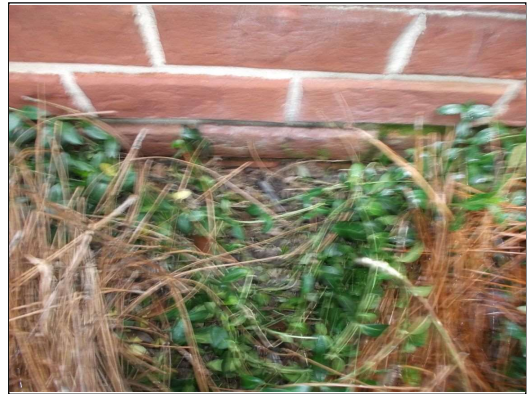
Copper gutters need cleaning; stucco trim needs pressure wash and may or may not need painting after wash; there is a downspout slightly detached from the ground drain pipe at the left side of the front porch; there is a section of downspout that has come loose at the rear of the home at the left side; there appears to be missing gutters at the rear left of the roof area and at the left side based on the drone photo; missing caulk around light fixtures mounted on the brick veneer can allow water to get in holes in the brick behind light fixtures; front door frame has slight water intrusion at the bottoms and need caulk and pant; brick and mortar contact soil at various areas (water in soil can deteriorate mortar); window screens not installed; Algae growing on the brick veneer at the rear of the home and the rear on the left side; there is a settling crack between the brick veneer, foundation wall and retaining wall junction area at the rear left corner of the building at the basement level;

Movement crack/downspout detached/Algae

Algae on brick from leaking or overflow gutte

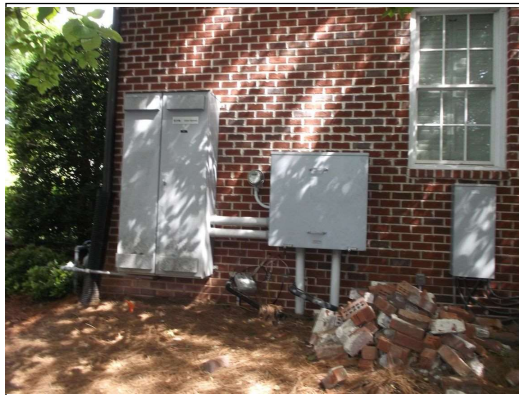
Main panels side of garage 5x200 watt breake

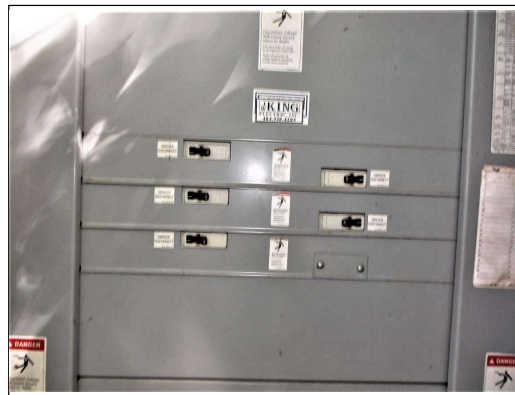
Five 200 watt breakers in main panel

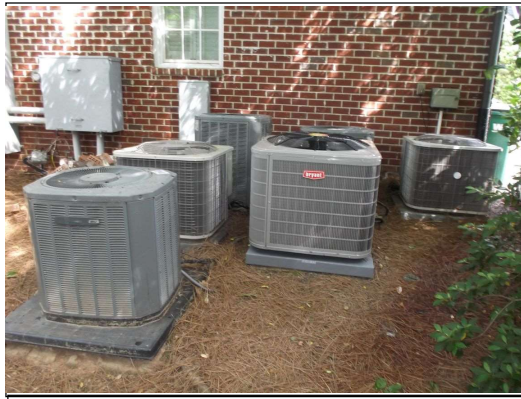
Refrigerant line insulation deteriorated and missing at the exterior at the AC units on the right side of the garage (all damaged, deteriorated and missing refrigerant line insulation shall be replaced);

6 AC units on the right side of garage
