# Property Inspection Report

680 Trinity Place, Suwanee, Ga. 30024

Apr 12, 2021

1599

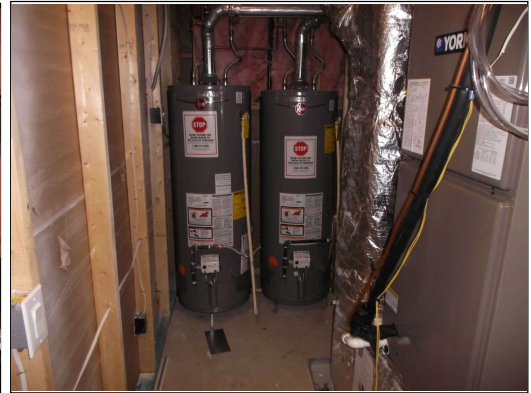
Utility room furnace

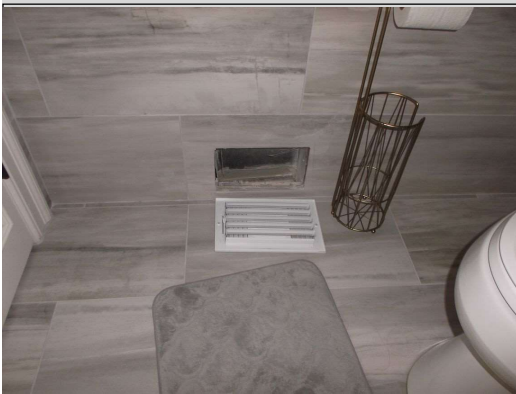
## Bathroom6 Pictures

Master bath has low water flow at the left sink faucet hot water side; excessive hum in exhaust fan; air vent not secured to the toilet room wall;
