PROPERTY INSPECTION REPORT

141 Greenville St. Newnan, GA. 30263

Dec 8, 2021

1599

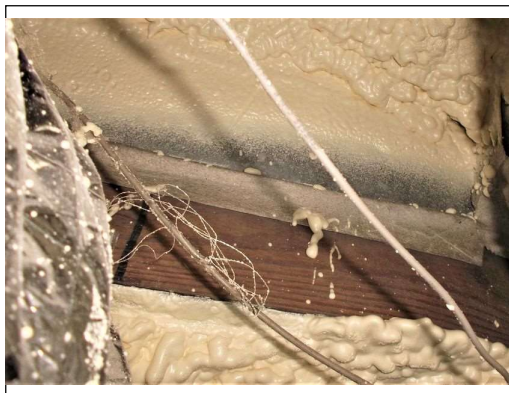
Possible Asbestos tape

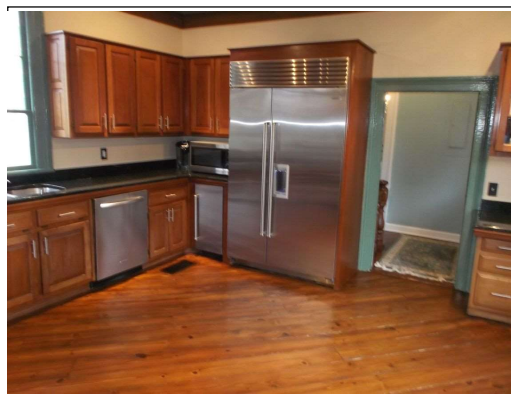
Base cabinet doors bump right of D/W

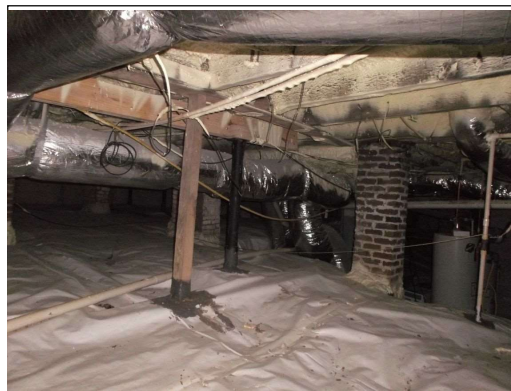
Floor covered with foam
