Property Inspection Report

3161 E Point St., east Point, GA

4-22-2021

Paris Pressley: R-5 Master Residential Building Inspector & State License Residential Building Contractor

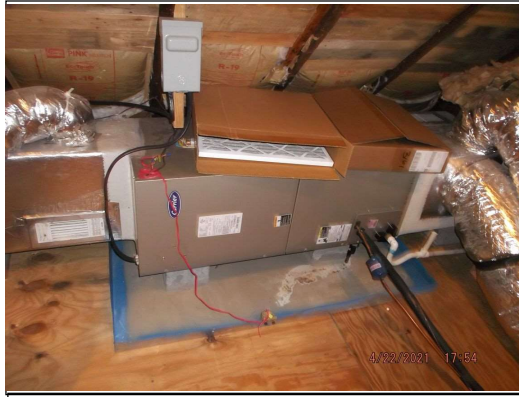
Furnace in attic

It is advised to have both Furnaces and or HVAC systems checked and serviced for operation before closing; when I arrived the agent rep and buyer stated they turned on the systems (verify both systems operational);

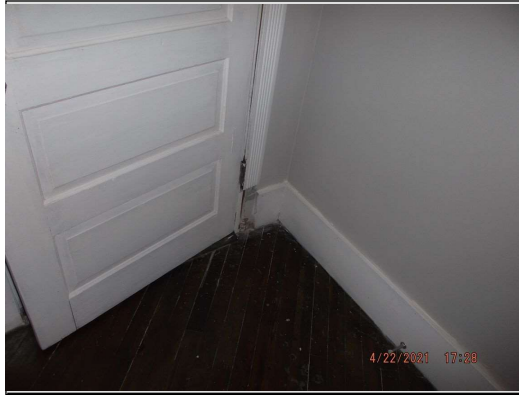
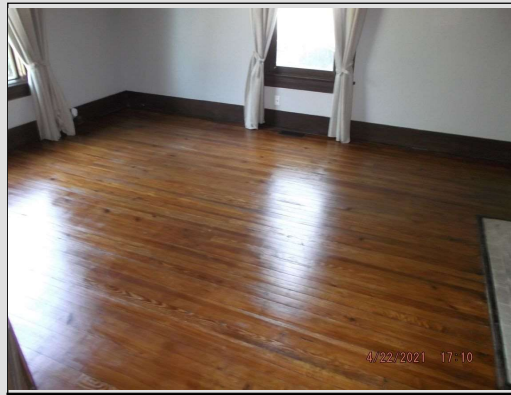
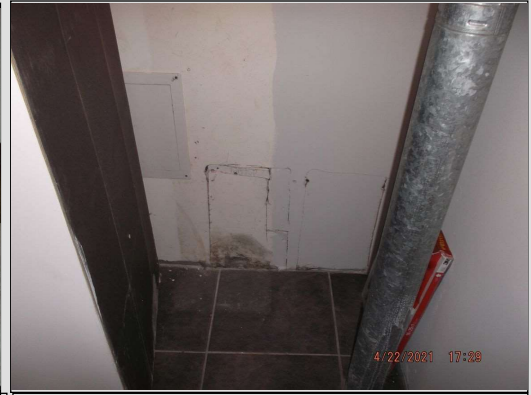
Main Level: Some windows original and have defective hardware; floor system is settling and sloping at several rooms; missing base cap molding at some base boards; there is a missing door trim base block at the hall bath; there are utility light fixtures at some ceilings; left front room floor slopes to the exterior wall; foyer outlets tested open ground; not enough outlets around the walls at several rooms; left rear bed light switch located away from the entry door and ceiling fan did not shut off when the switch was shut off; mold on the sheetrock in the closet behind the bath wall may indicate water leak at the tub faucet;
