PROPERTY INSPECTION REPORT

2950 Duke of Gloucester, East Point, GA.

Jun 4, 2021

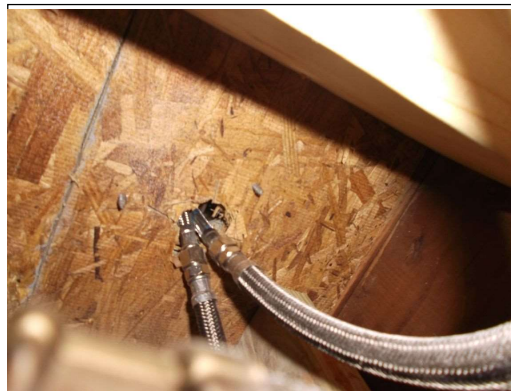
Water heater service side installed away from approach; old water heater still in utility room; water pipes above water heater not supported; expansion tank not supported properly can break pipes and cause damage; water faucet supply lines used for pipe in the basement hall ceiling behind small plastic access door; there are no anti siphon devices on the front and rear hose faucets; no water at the front hose faucet;

Water faucet supply pipes in crawlspace

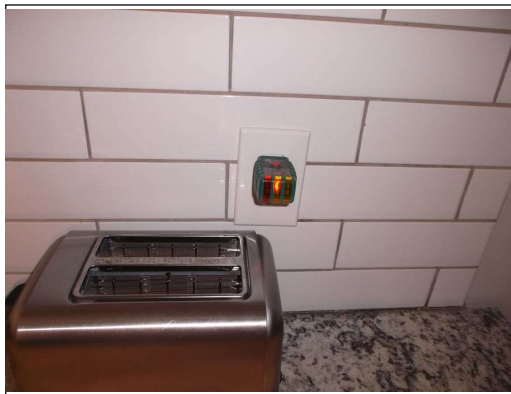
There are electrical wires entering the top of the distribution panel contacting sharp metal can be a shock hazard; several outlets tested open ground at the main level and at the basement level;

Outlets not grounded
