PROPERTY INSPECTION REPORT

2161 Peachtree Rd. NE #102, Atlanta, GA.

Feb 5, 2024

1599

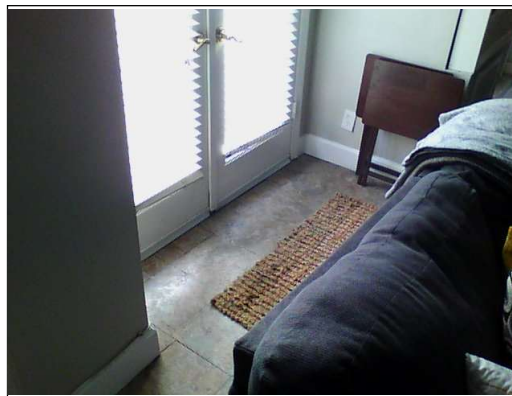
Bedroom floor photo

There is no foam insulation sprayed onto the garage concrete ceiling-condo floor to reduce condo energy consumption and heat loss. There was a infra red scan of the condo and the concrete floor, which is above the public garage, that shows low temperatures in the concrete slab. A concrete floor exposed to the weather can cause extreme heat loss in the condo through the floor and walls and heat gain in the summer that can cause higher energy bills. Without insulation covering the concrete, it can cause excessive energy use. All exterior walls and floors should be insulated.
