Property Inspection Report

65 Creek Breeze Way, Oxford, GA

May 7, 2021

1599

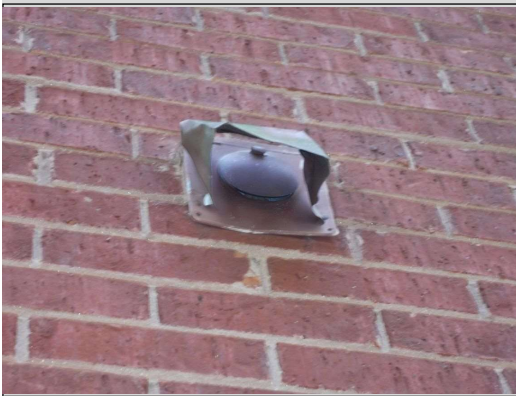
Bathroom1 Pictures

1/2 Bath exhaust fan has excessive vibration noise when operating, missing caulk where toilet rest on the floor, entry door rub door frame, exhaust fan terminal at the exterior wall is damaged;
